COLORADO DIVISION OF RECLAMATION, MINING AND SAFETY
MINERALS PROGRAM INSPECTION REPORT
PHONE: (303) 866-3567

MINE NAME: London Mine	MINE/PROSPECTING ID#: P-2016-020	MINERAL: Silver and gold	COUNTY: Park
INSPECTION TYPE: Monitoring	INSPECTOR(S): Michael A. Cunningham	INSP. DATE: June 20, 2017	INSP. TIME: 14:00
OPERATOR: Minewater Finance LLC	OPERATOR REPRESENTATIVE: Joe Harrington	TYPE OF OPERATION: MP - Mineral Prospecting	
REASON FOR INSPECTION: Normal I&e Program	BOND CALCULATION TYPE: None	BOND AMOUNT: \$40,670.00	
DATE OF COMPLAINT: NA	POST INSP. CONTACTS: State Engr. (Water Resources)	JOINT INSP. AGENCY: None	
WEATHER: Clear	INSPECTOR'S SIGNATURE:

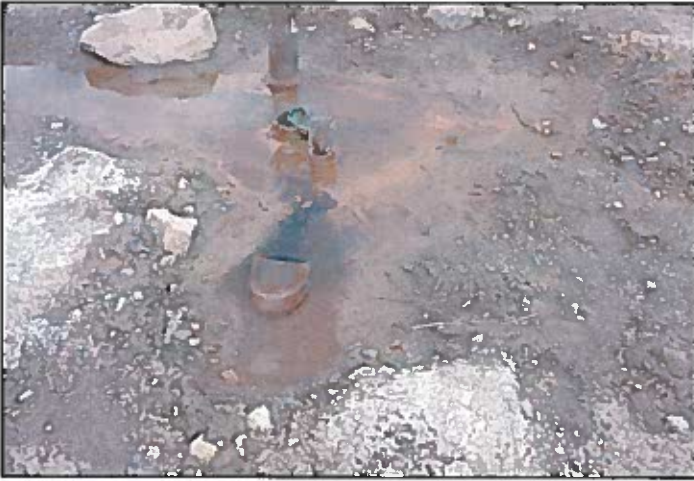
The Division also inspected the exploration holes which were drilled under Phase 1 of the NOI. The Prospector drilled 3 of the 6 holes which were proposed. One exploration hole was drilled at location No. 3 and two exploration holes were drilled at location No. 5. The Prospector notified the Division in June that they discovered artesian conditions at the exploration holes. Water was encountered during drilling, but did not result in artesian flow immediately after drilling was complete. The artesian flow at each drill hole is approximately 1-2 gpm. The water from the drill hole at location No. 3 was flowing off of the drill pad and comingling with snow-melt runoff before flowing into South Mosquito Creek. The water from the drill holes at location No. 5 was flowing into the mud pit and was fully contained at the time of the inspection. One of the proposed boreholes under Phase 2 will be drilled at location No. 5 adjacent to the two exploration drill holes. The Prospector has indicated the drill holes may be converted to monitoring wells and used in conjunction with the dewatering wells.

1. Drill holes at location No. 5.

CORRECTIVE ACTIONS: The Operator shall update the Division as to which of the drill holes will be abandoned and which will be converted to monitoring wells and shall provide a timeline for completing the work.

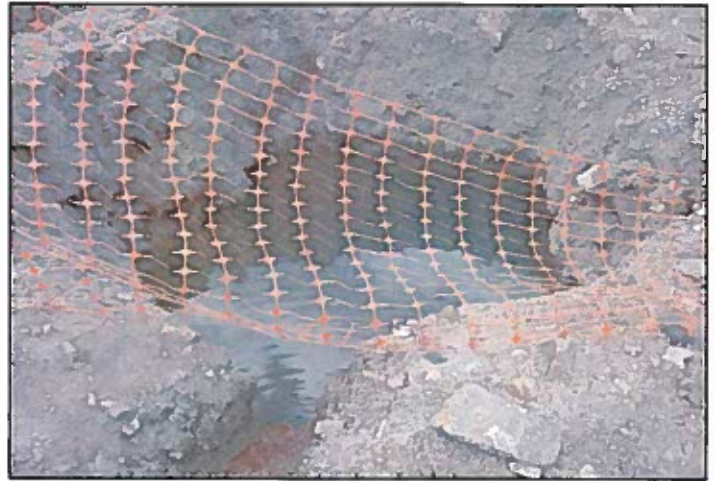
PROBLEM/POSSIBLE VIOLATION: Problem: The exploration drill holes which were completed under Phase 1 of the NOI have exhibited artesian flow at the surface. This is a problem pursuant to Hard Rock Rule 3.1.6(1) which requires disturbances to the prevailing hydrologic balance of the affected land and of the surrounding area and to the quantity or quality of water in surface and groundwater systems to be minimized.

2. Artesian flow captured in mud pit at location No. 5.

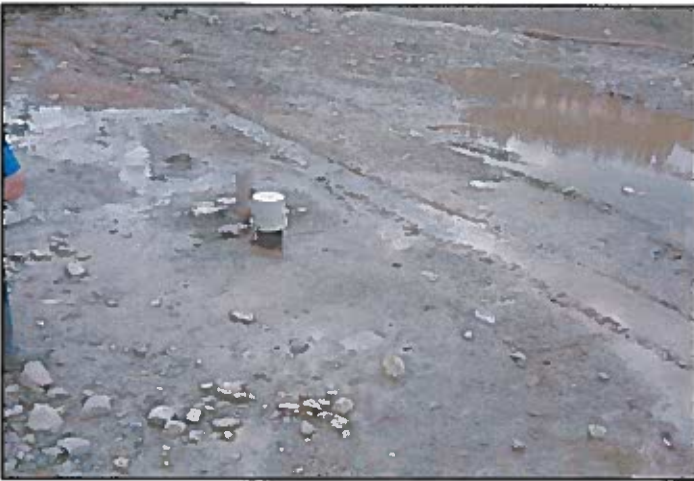
3. Drill hole at location No. 3.

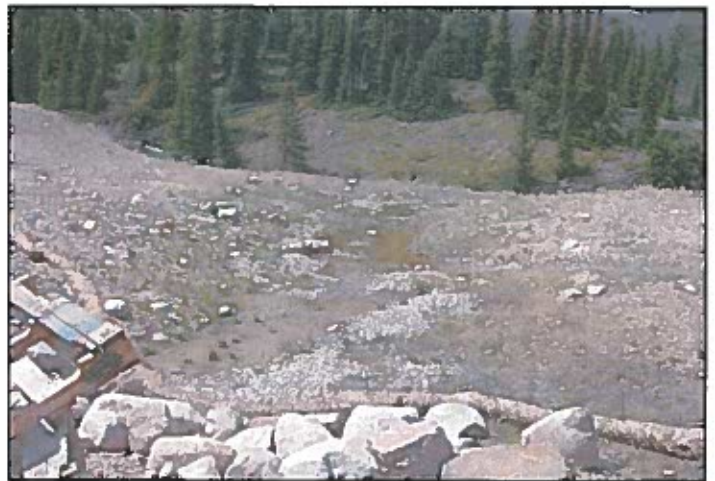
4. Artesian flow from location No. 3 flowing into South Mosquito Creek.
