Permit Number: C-1984-065

Mine Name: Coal Ridge No. 1 Mine Operator: C.B. Minerals Company, LLC

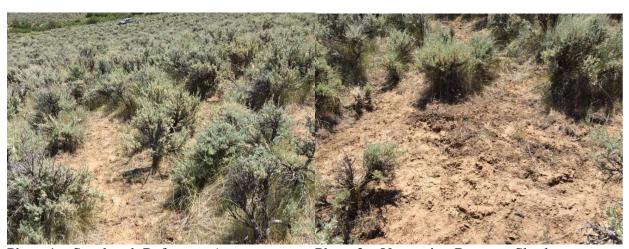
The sagebrush reference area is located approximately 1.5 miles east of the reclaimed minesite on BLM land. The reference area was not fenced and no markers were noted that defined the area. The area was located by using Figure 3.6-1 Vegetation Map. Sagebrush was the dominant plant species with grass species growing mostly under the sagebrush plants (photo 1). The area was recently grazed by cattle noted by the amount of old and new cow dung. The vegetation between the sagebrush was either very short or trampled (photo 2).

Photo 1 – Sagebrush Reference Area

Photo 2 – Vegetation Between Shrubs

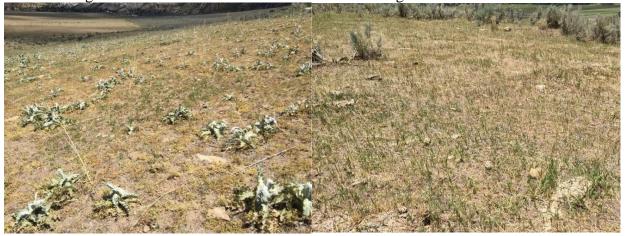
The thistle plants on the entire minesite were recently treated and appeared to be dying (photo 3).

The reclamation areas were recently grazed. Most of the vegetation was very short (less than 3 inches) and there were many piles of cow dung (photo 4). The electric fence that surrounds the area was not up.

Photo 3 – Thistles Have Been Treated

Photo 4 – Vegetation Recently Grazed
