**MINERALS PROGRAM INSPECTION REPORT**  
**PHONE: (303) 866-3567**

<b>MINE NAME:</b> Cresson Project	<b>MINE/PROSPECTING ID#:</b> M-1980-244	<b>MINERAL:</b> Gold	<b>COUNTY:</b> Teller
<b>INSPECTION TYPE:</b> Monitoring	<b>INSPECTOR(S):</b> Timothy A. Cazier	<b>INSP. DATE:</b> May 30, 2017	<b>INSP. TIME:</b> 10:00
<b>OPERATOR:</b> Cripple Creek & Victor Gold Mining Company	<b>OPERATOR REPRESENTATIVE:</b> Clara Steward, Erik Munroe	<b>TYPE OF OPERATION:</b> 112d-3 - Designated Mining Operation	
<b>REASON FOR INSPECTION:</b> Normal I&E Program	<b>BOND CALCULATION TYPE:</b> None	<b>BOND AMOUNT:</b> \$173,934,420.00	
<b>DATE OF COMPLAINT:</b> NA	<b>POST INSP. CONTACTS:</b> None	<b>JOINT INSP. AGENCY:</b> None	
<b>WEATHER:</b> Clear	<b>INSPECTOR'S SIGNATURE:</b>

## **OBSERVATIONS**

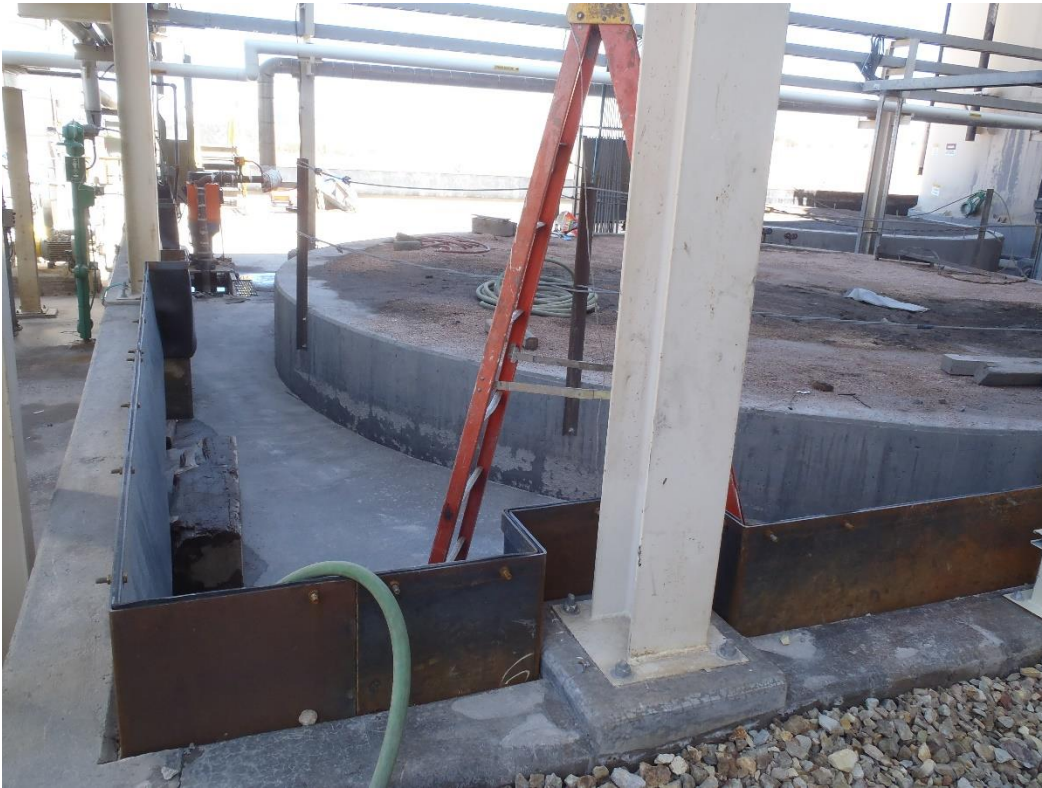
High Grade Mill: The Division was accompanied by Dillon Noble at the HGM to perform an exterior walk-around inspection. The focus was to observe the completed secondary containment capacity construction project in the vat leach area (**Photo 1**) and perform a visual inspection for leaks, spills and secondary containment problems. Mr. Noble pointed out the sump on the southwest corner of the high pH thickener tank where the 50-gallon spill took place on May 21, 2017 (**Photo 2**). He further explained the spill was caused by a pump failure where the resulting surge overwhelmed the sump. CC&V plans to add a syphon valve to prevent future occurrences. Several empty flotation reagent containers (**Photo 3**) were observed on the east side of the mill building. Mr. Dillon indicated CC&V was expecting to ship them offsite soon. No problems were observed.

Photo 1. Completed vat leach tank secondary containment construction (steel plate & rubber membrane).

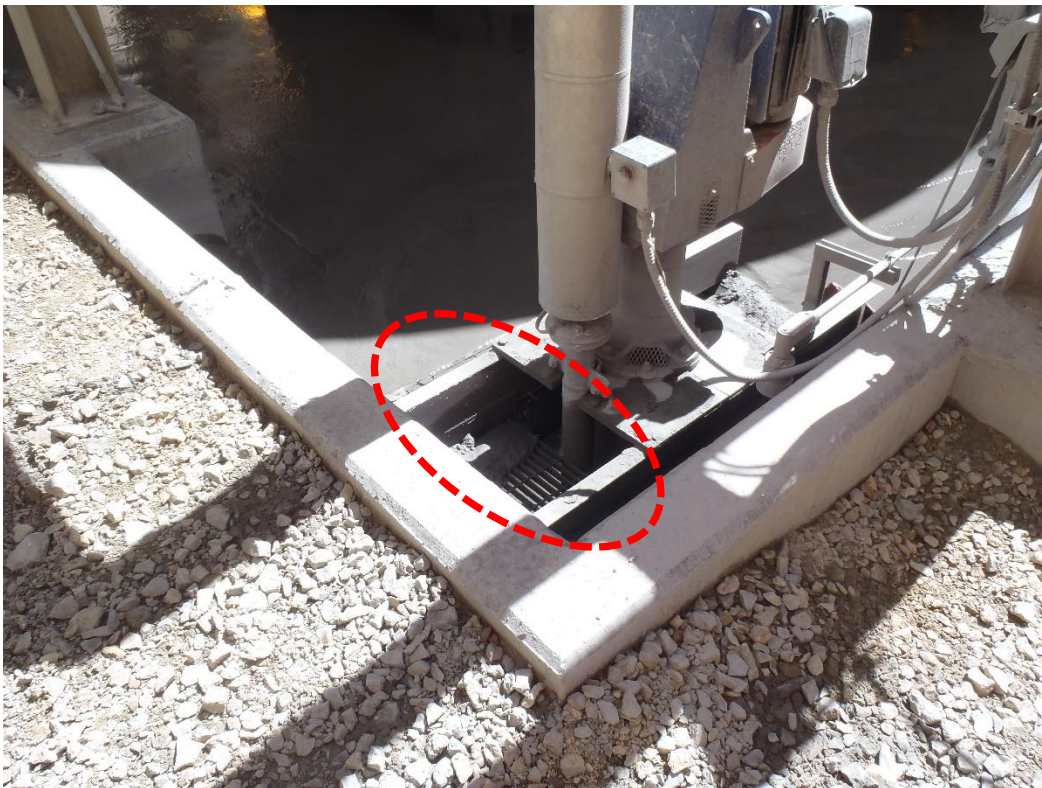
Photo 2. Sump on SW corner of high pH thickener tank where the 50-gallon spill took place.

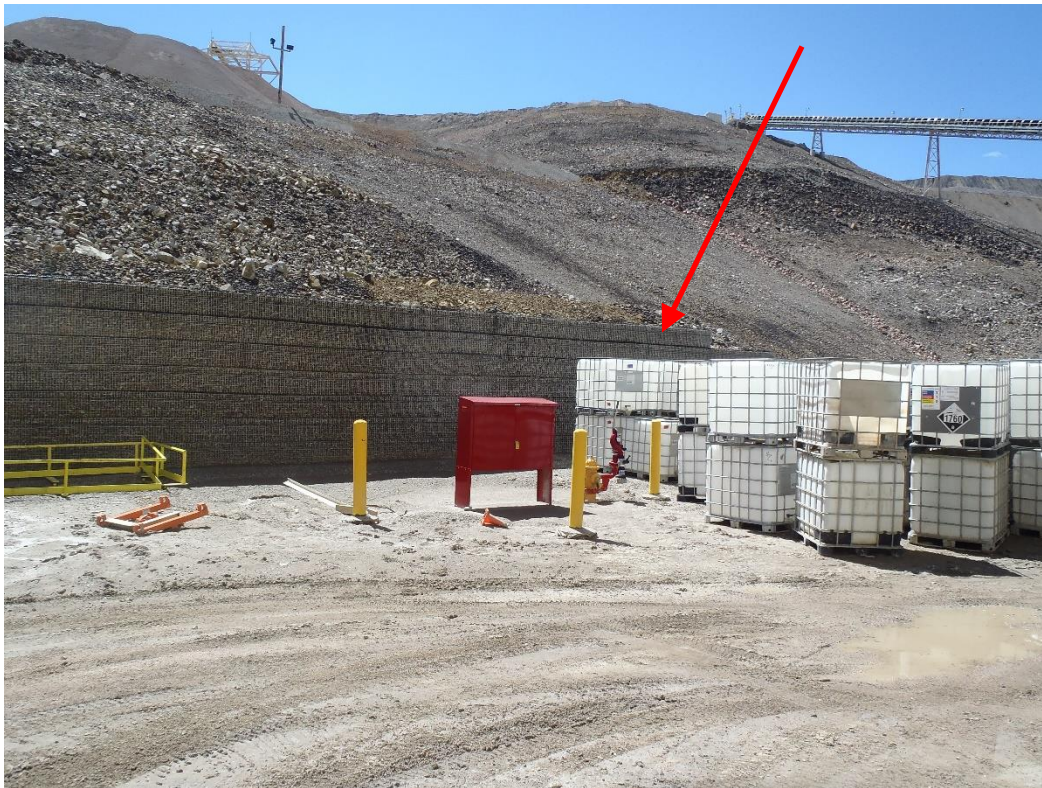
Photo 3. Empty flotation reagent containers on east side of High Grade Mill.

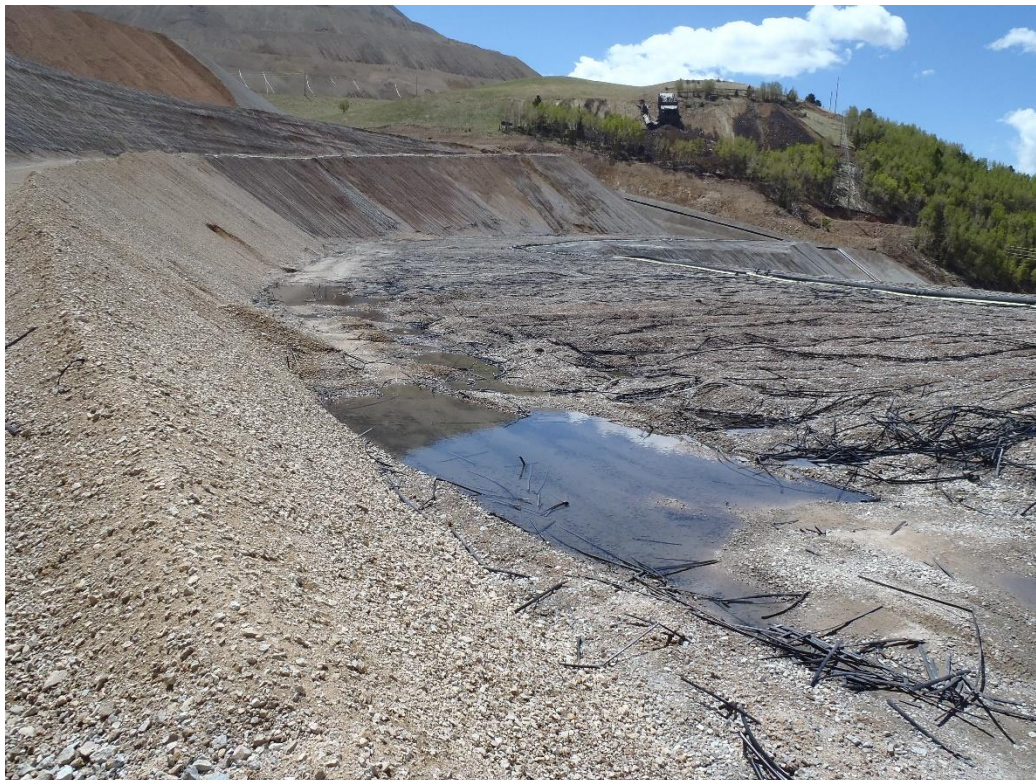
Squaw Gulch Valley Leach Facility: The Division was accompanied by Ms. Steward and Mr. Munroe to inspect the surface for ponded solution. Several areas with greater than the required 3 foot x 3 foot limit for ponded solution were observed (**Photo 4**). CC&V submitted photographic evidence of correcting the problem to the Division on May 31, 2017 (**Photo 5**). As such, the ponded solution was not cited as a problem in this report. The Division noted bird balls in the stormwater collection trench northeast of ADR2, at the toe of the SGVLF (**Photo 6**). The addition of bird balls should reduce the potential for wildlife drinking potentially impacted stormwater runoff from the ADR2 area.

Photo 4. Poned solution on SGVLF.

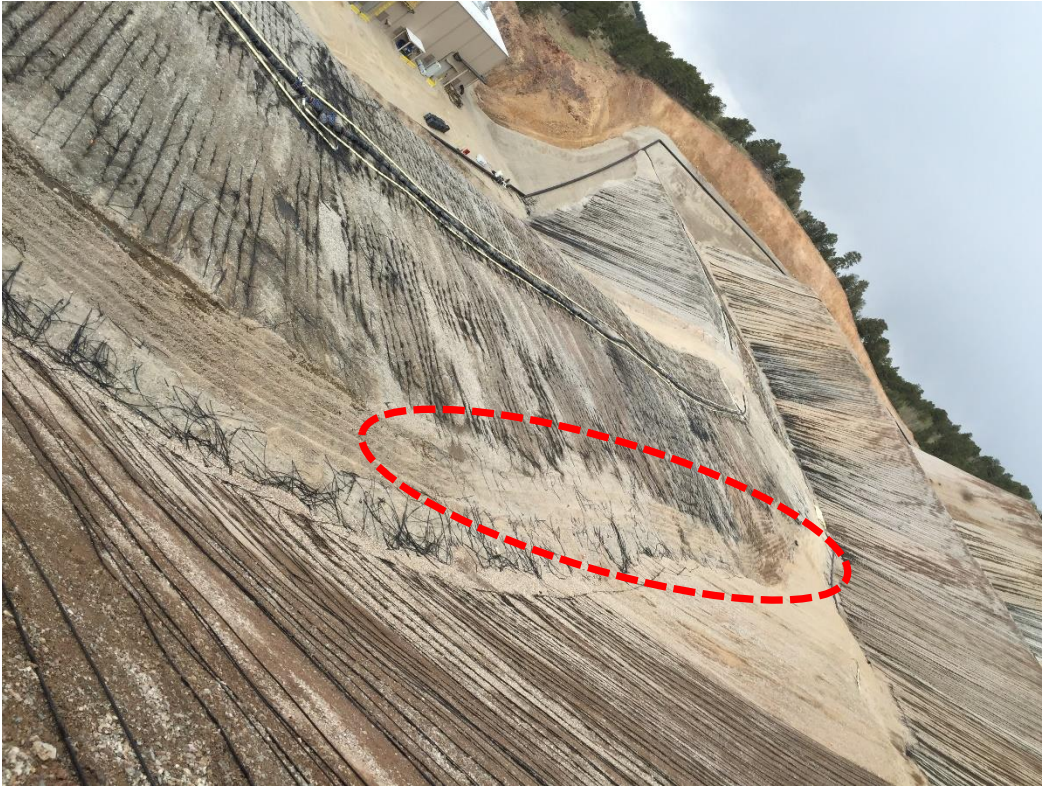
Photo 5. Photo provided by CC&V showing ponded solution mitigated on SGVLF (looking NW).

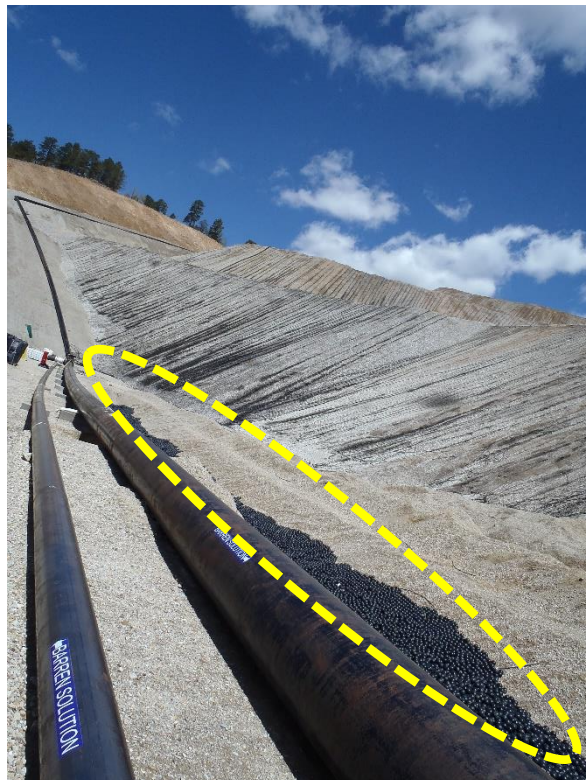
Photo 6. Bird balls in the stormwater collection trench northeast of ADR2 (looking NE).

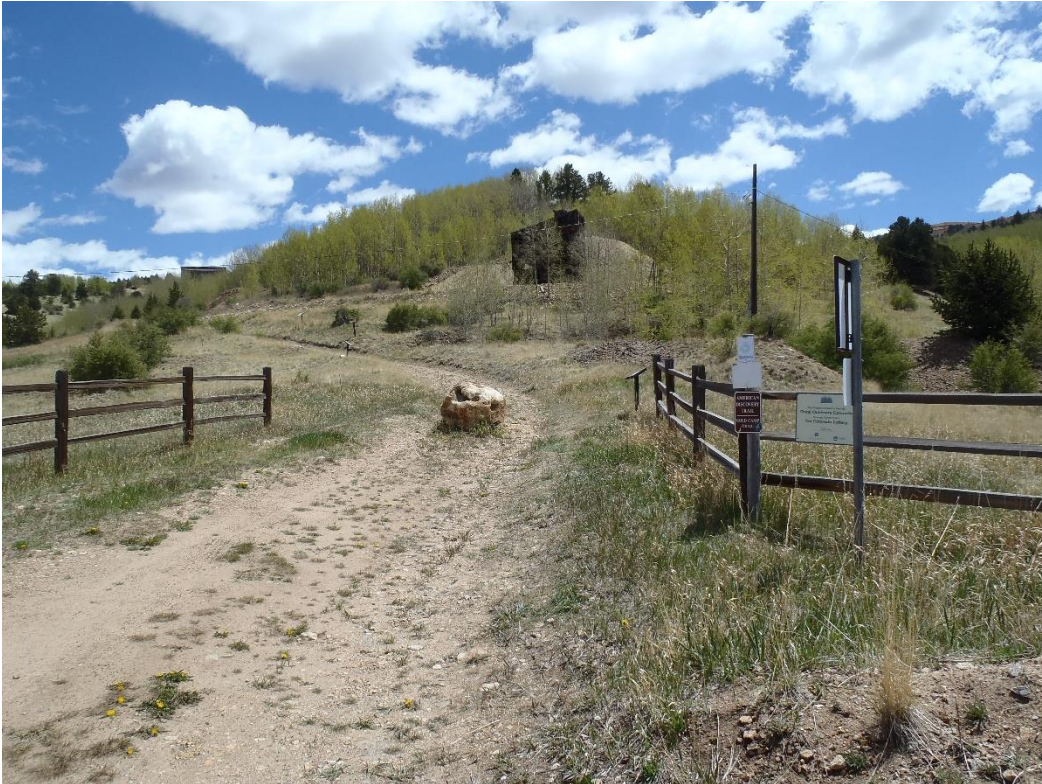
The area has hiking trails (**Photo 7**) and numerous historic mine structures (**Photo 8**). However, no evidence of disturbance related to CC&V's mining activities was observed. The Division will recommend approval of AR-04. CC&V will be notified of the decision under separate cover.

Photo 7. Hiking trailhead near AR-01 release area (near E. Bennett Ave & Silver St).

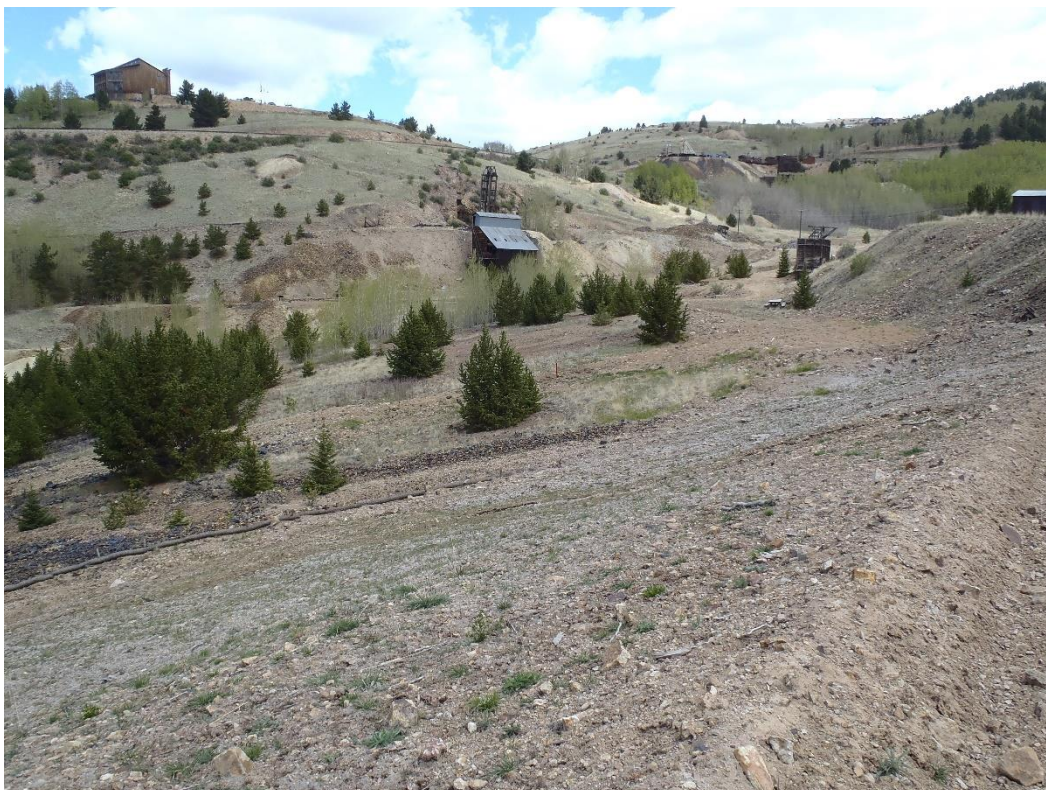
Photo 8. Historic mine structures near AR-01 release area (looking north just NE of Chicago Tunnel).

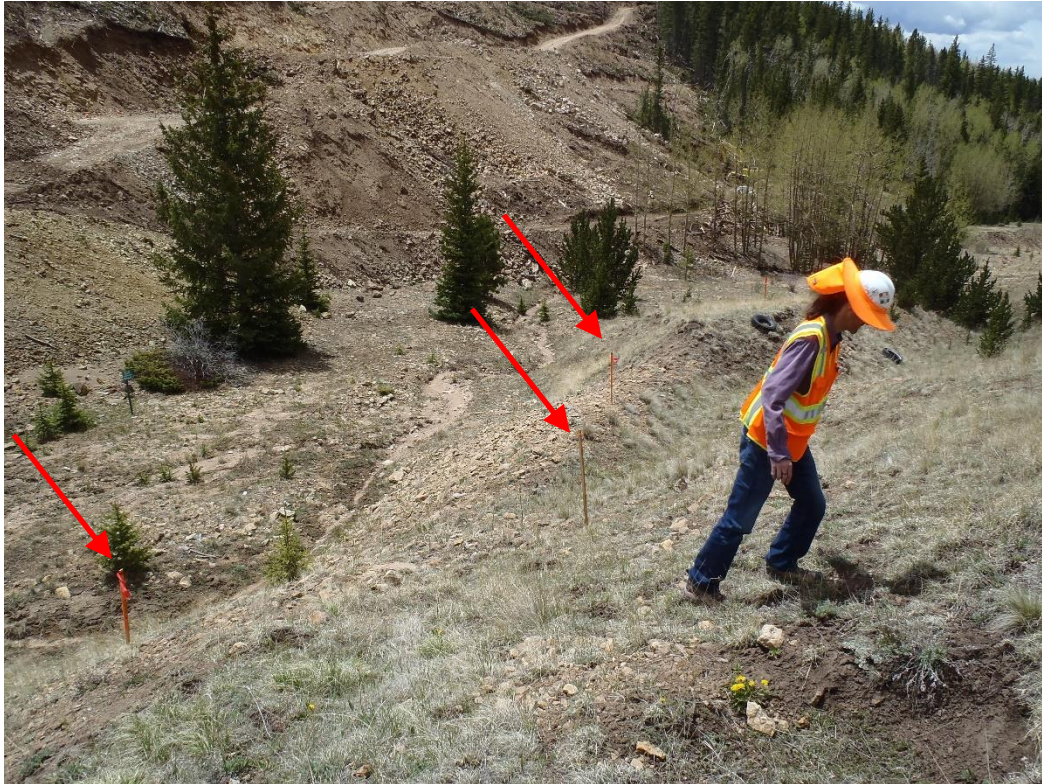
Globe Hill stormwater diversion: Mr. Munroe pointed out the survey stakes (**Photo 9**) for the Globe hill stormwater diversion project approved as part of TR-86. Ms. Steward indicated the clearing and grubbing on the north side of Globe Hill (**Photo 10**) was for the purpose of investigating underground workings that may pose blasting problems during the North Cresson Mine development.

Photo 9. Survey stakes for the Globe hill stormwater diversion project (TR-86).

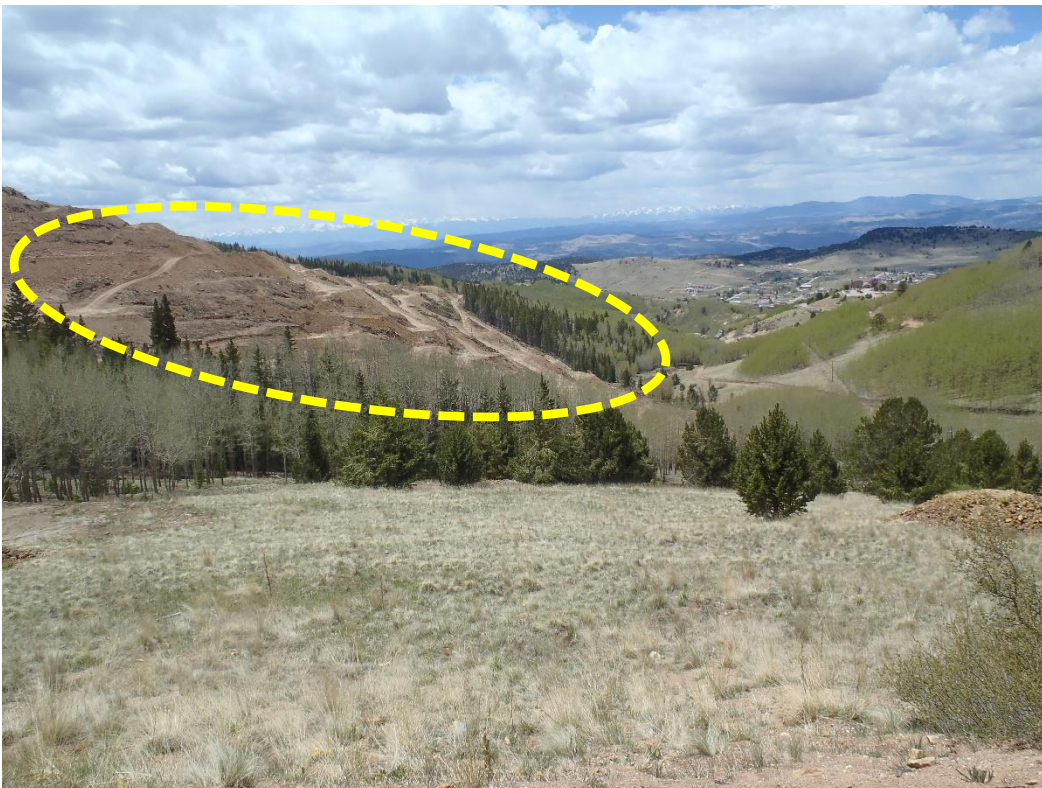
Photo 10. Clearing and grubbing on the north side of Globe Hill (Looking SW)

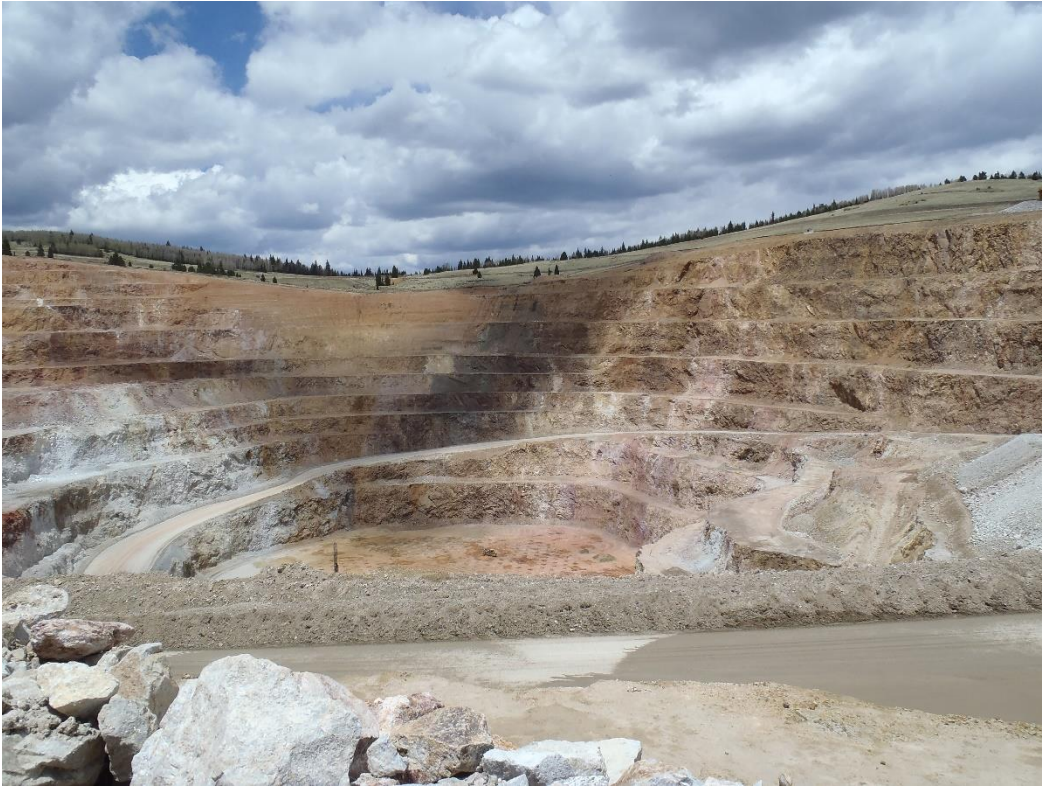
WHEX highwall: The north to east highwalls (**Photo 11**) of the Wild Horse Extension (WHEX) that parallel Teller Co Rd 82 (CR 82) were observed from the south side of the WHEX. Some minor sloughing was observed (**Photo 12**) on some benches as expected. However, overall these highwalls appeared clean and stable. No areas of concern were observed.

Photo 11. WHEX highwall (looking north).

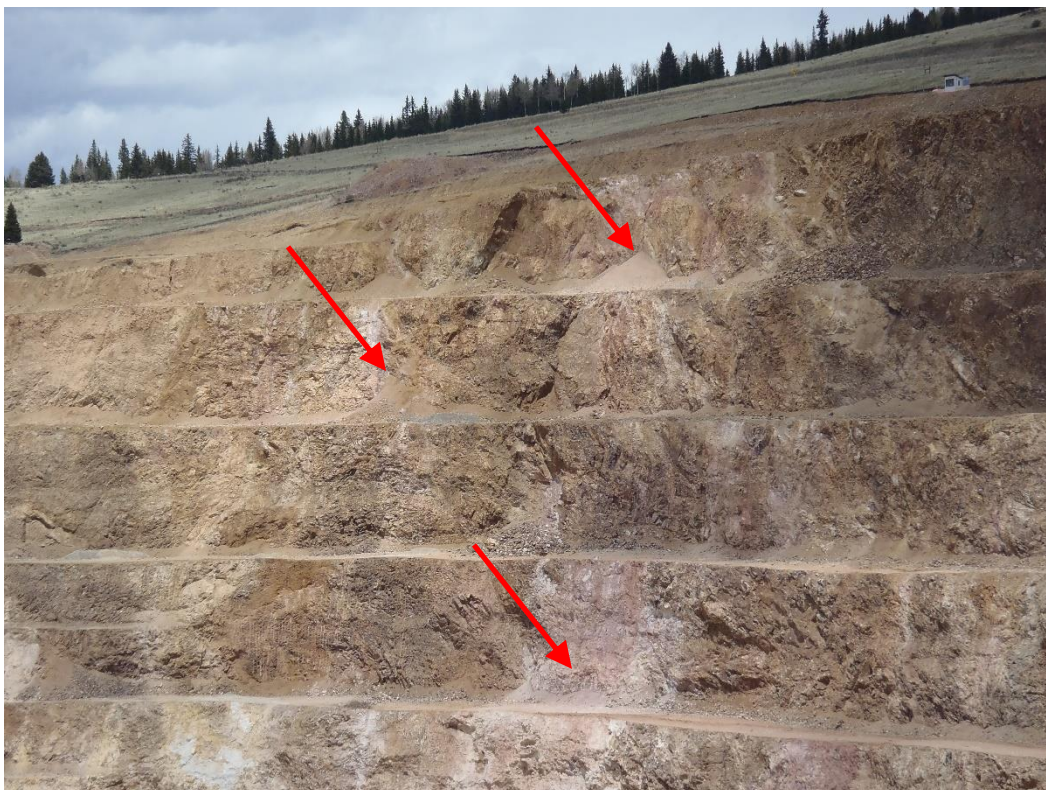
Photo 12. WHEX highwall – minor sloughing (looking NE).

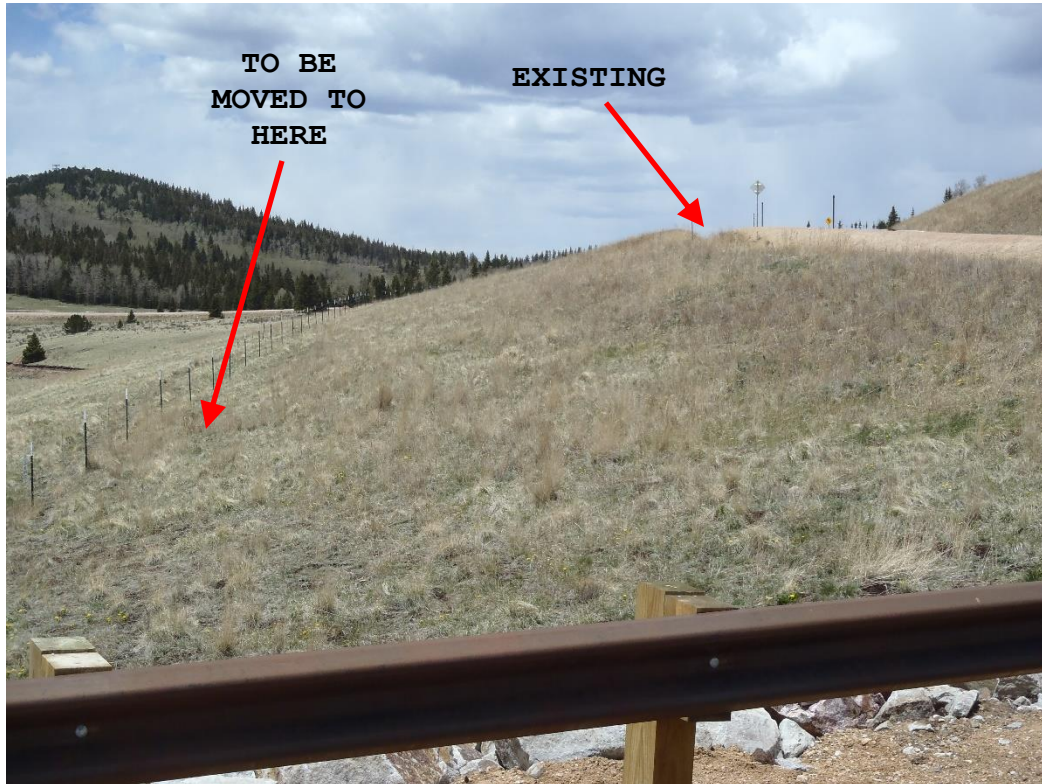
The Division requested the CC&V representatives provide an overview in the field of the proposed safety improvements for CR 82. Mr. Munroe explained from the new Grassy Valley overlook that the recovery ditch paralleling CR 82 would be moved down the slope to near where the existing fence is located (**Photo 13**).

Photo 13. Recovery ditch paralleling CR 82 (Looking north from the new Grassy Valley overlook).
