**MINERALS PROGRAM INSPECTION REPORT**  
**PHONE: (303) 866-3567**

<b>MINE NAME:</b> Cresson Project	<b>MINE/PROSPECTING ID#:</b> M-1980-244	<b>MINERAL:</b> Gold	<b>COUNTY:</b> Teller
<b>INSPECTION TYPE:</b> Monitoring	<b>INSPECTOR(S):</b> Amy Eschberger	<b>INSP. DATE:</b> April 18, 2017	<b>INSP. TIME:</b> 10:30
<b>OPERATOR:</b> Cripple Creek & Victor Gold Mining Company	<b>OPERATOR REPRESENTATIVE:</b> Cheyne Mann, Tyler O'Donnell, etc.	<b>TYPE OF OPERATION:</b> 112d-3 - Designated Mining Operation	
<b>REASON FOR INSPECTION:</b> Normal I&E Program	<b>BOND CALCULATION TYPE:</b> None	<b>BOND AMOUNT:</b> \$173,934,420.00	
<b>DATE OF COMPLAINT:</b> NA	<b>POST INSP. CONTACTS:</b> None	<b>JOINT INSP. AGENCY:</b> None	
<b>WEATHER:</b> Clear	<b>INSPECTOR'S SIGNATURE:</b>

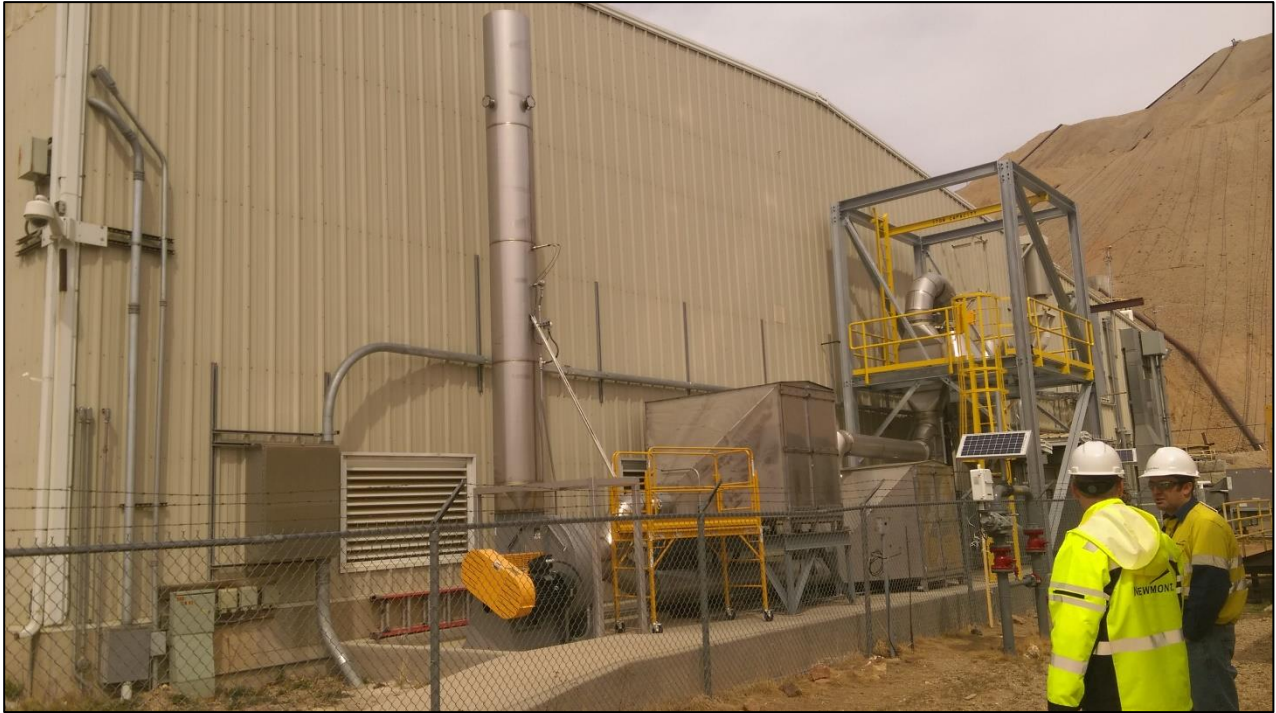
The Division inspected the portion of the Arequa Gulch ADR-1 refinery where Technical Revision No. 90 (TR-90) proposed the installation of a 6 cu. ft. mercury retort (**Photos 1-3**). The retort will be used to remove mercury from the gold concentrate generated through the electrowinning cells at both the Squaw Gulch and Arequa Gulch ADR facilities. The retort control system is to include a retort, two condenser tubes, a collector, an aftercooler, two carbon columns, and a chiller. An additional foundation (approximately 5 inches thick) will need to be constructed on top of the current refinery floor to support the retort. Foundations will also need to be constructed to support the chiller and ventilation stack. The chiller will be constructed outside of the ADR-1 facility, at its southeastern corner. The outside area is currently enclosed by a chain-link fence with barbed wire across the top. Access to the inside of the refinery is controlled by a security guard unit, with only a limited number of employees allowed to enter at once.

**Photo 1.** View of southeastern exterior of ADR-1 refinery, showing area where two carbon columns will be installed to support the new mercury retort (note one column already present).

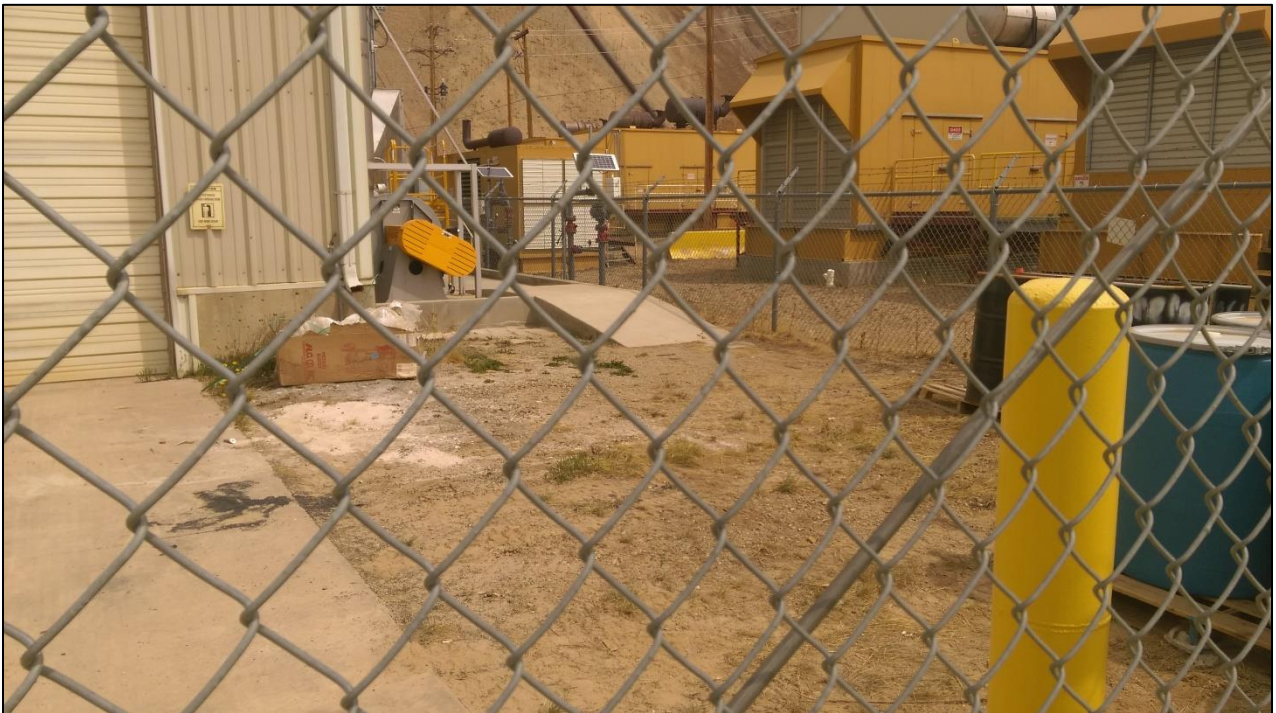
**Photo 2.** View of fence-enclosed area outside southeastern corner of ADR-1 refinery, where chiller will be installed to support the new mercury retort.

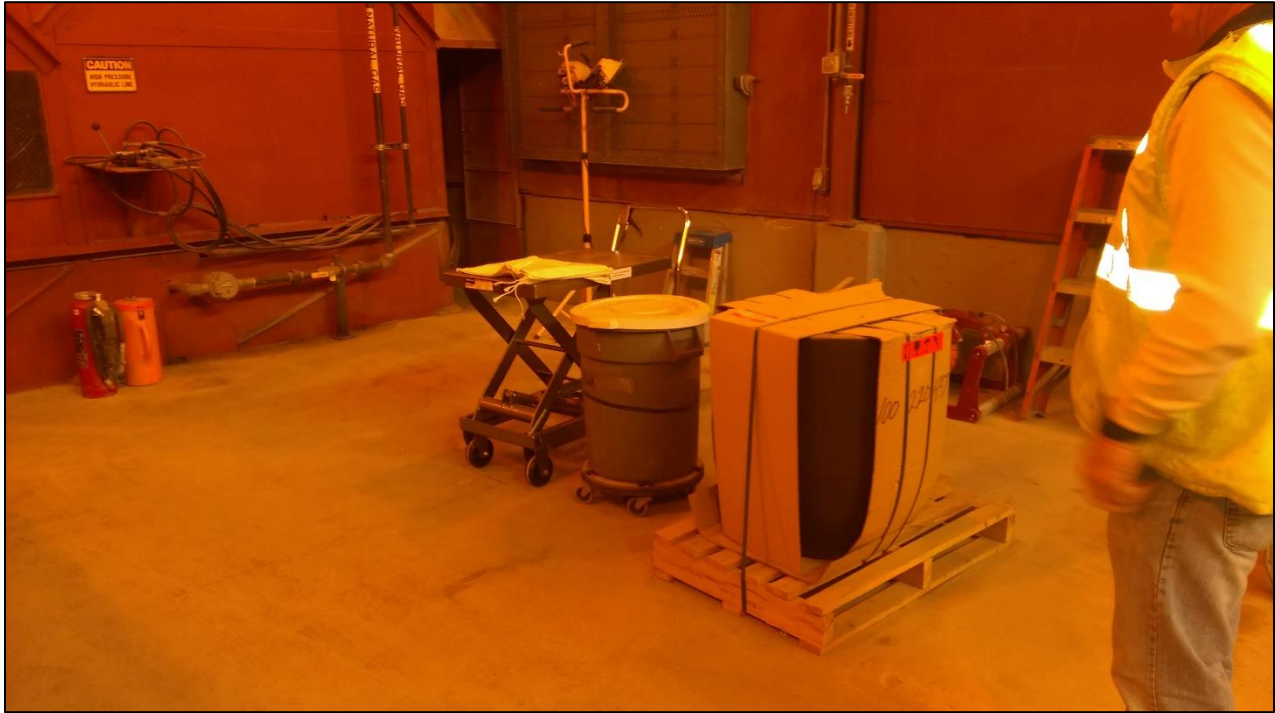
During the inspection of the ADR-1 refinery, no issues were identified that would hinder the approval of TR-90.

**Photo 3.** View of area inside ADR-1 refinery where mercury retort will be installed.

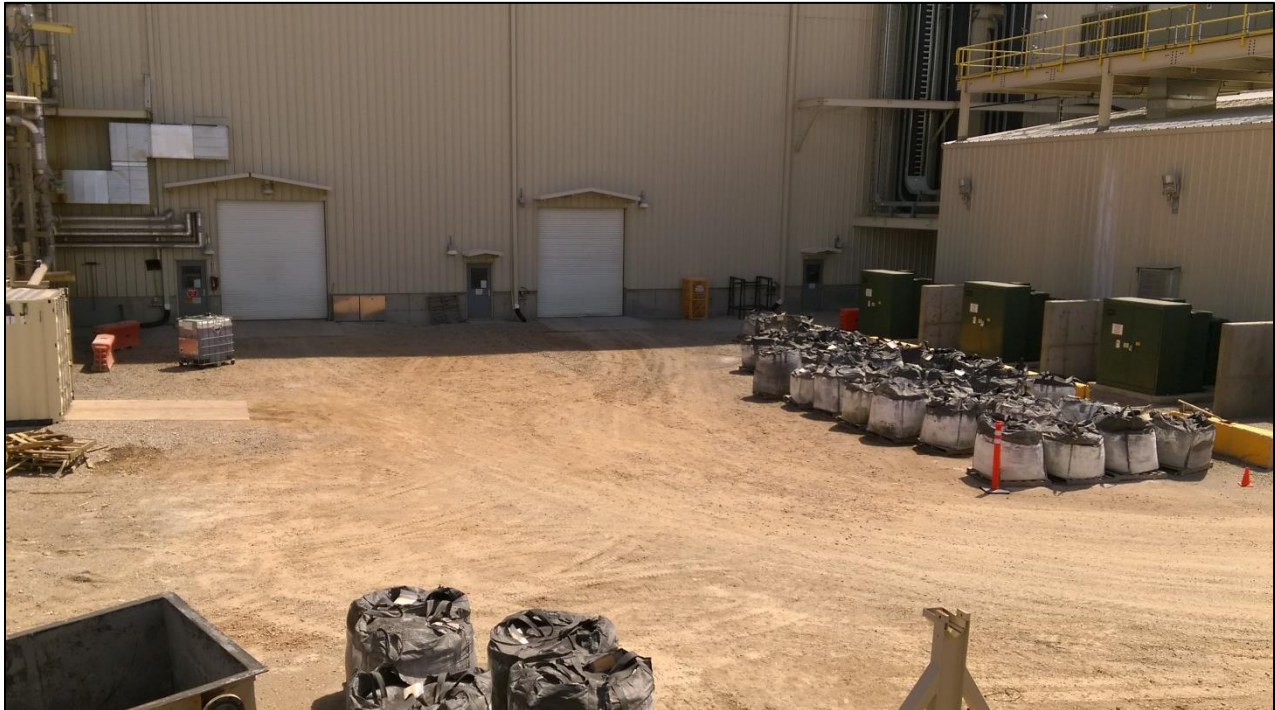
The Division inspected the exterior perimeter of the HGM facility to look for any leaks, spills, or secondary containment problems. The Division observed the area on the west side of the HGM where the operator indicated a spill had occurred on April 14, 2017 (**Photo 4**). As of the inspection, the Division had not yet received notice of the spill from the operator. After the inspection, on April 20, 2017, the Division received the required notice. According to this notice, the slurry was released from the mill carbon-in-pulp (CIP) circuit, and approximately 100 gallons exited the facility via one of the garage doors on the west side of the facility. The spilled slurry had an estimated WAD Cyanide concentration of 100-200 ppm. All slurry material that exited the facility was collected and placed on the mill tailings stockpile for transport to the Squaw Gulch Valley Leach Facility.

During the inspection, the Division observed no indication of the spill in the area around the west garage doors. The area was recently excavated and dry. In efforts to prevent recurrence of this type of spill from the CIP circuit, the operator may install enhanced level controls on each tank within the circuit to provide earlier indication of high slurry levels. To reduce potential for released slurry to exit the HGM facility, the operator is reviewing all doorway locations to ensure sufficient containment is in place. Additional infrastructure will be installed if needed (i.e., concrete curbing).

**Photo 4.** View of area located on west side of High Grade Mill where slurry spilled out of garage door (at right). Note spill had been mitigated.

- a) HGM spill that occurred on April 14, 2017 will require proper notification to the Division immediately.
- b) What aspects of the mercury retort proposed for installation in the ADR-1 refinery could be constructed prior to TR-90 approval, if any (i.e., concrete foundation work). The Division explained any features requiring additional bond costs for reclamation could not be constructed prior to Division approval of TR-90 and receipt of the required bond. Additionally, any features of TR-90 pertaining to the importation, use, or storage of designated chemicals could not be implemented prior to TR-90 approval. Finally, the construction of any features prior to TR-90 approval, such as the concrete foundation work, would be at the risk of the operator, as the Division may require modifications to the proposed plan in review of TR-90. (TR-90 was approved by the Division on June 1, 2017.)

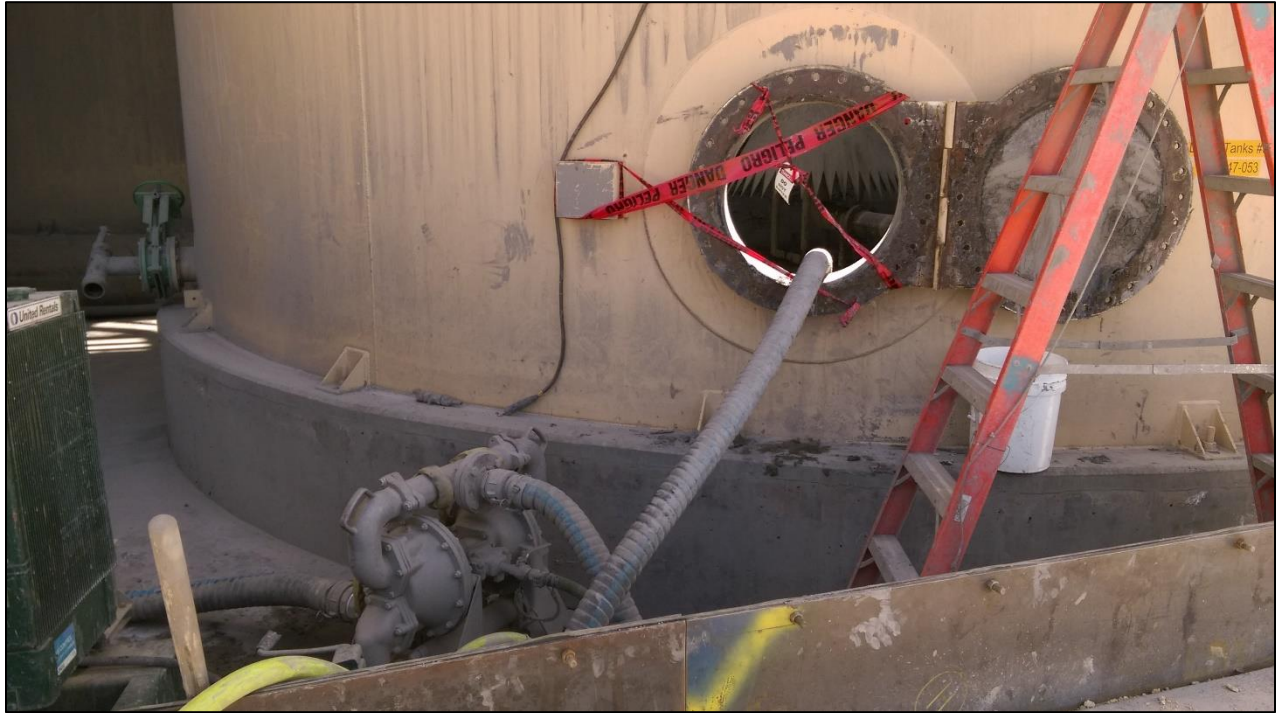
In the vat leach area on the west side of the facility, the Division observed that one of the six vat leach tanks was out of operation (**Photo 5**). The operator explained that a new air distribution system was being installed for all vat leach tanks, and the tank out of operation was the last tank to receive this modification. The Division observed the secondary containment wall around the vat leach tanks had been extended 12 inches (**Photo 6**) in accordance with Technical Revision No. 81, approved on January 18, 2017. This extension increases the secondary containment capacity to 110% of the volume of one leach tank. The secondary containment for the vat leach tanks was clear and dry at the time of the inspection (**Photo 7**).

**Photo 5.** View of vat leach tank out of operation during inspection to receive new air distribution system.

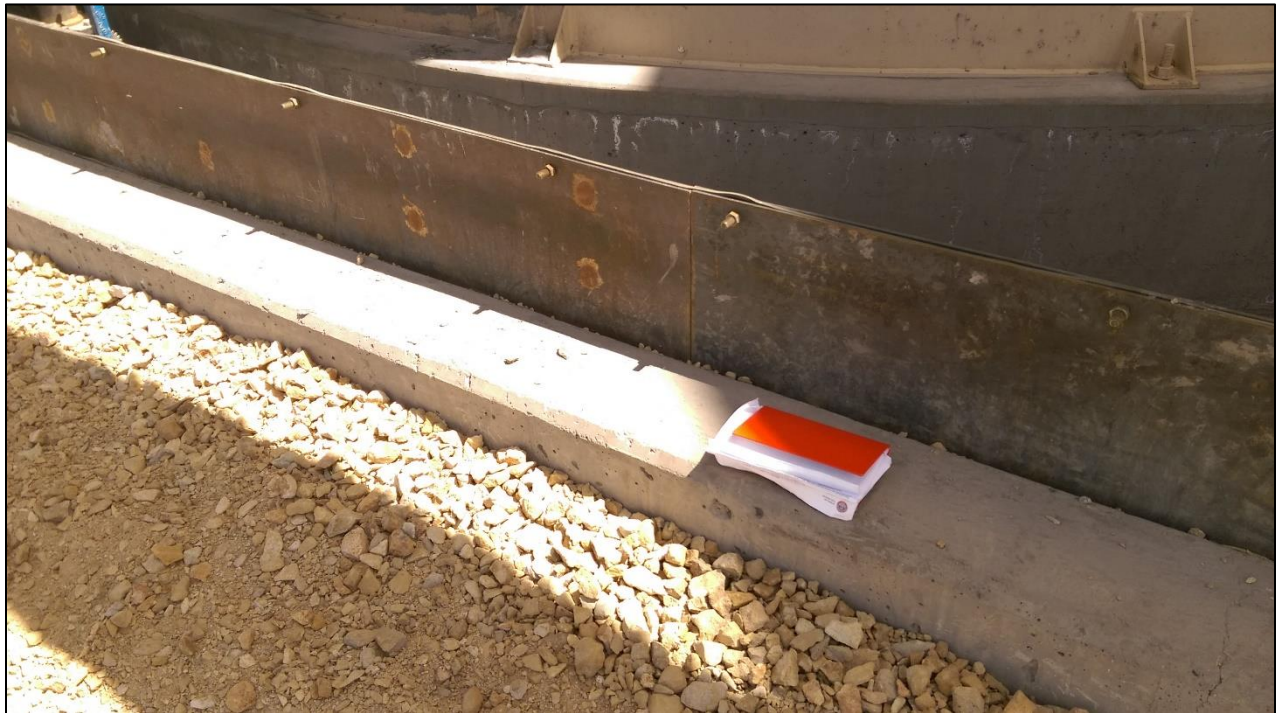
**Photo 6.** View of extension (steel plate and rubber membrane) added to secondary containment of vat leach area to increase capacity.

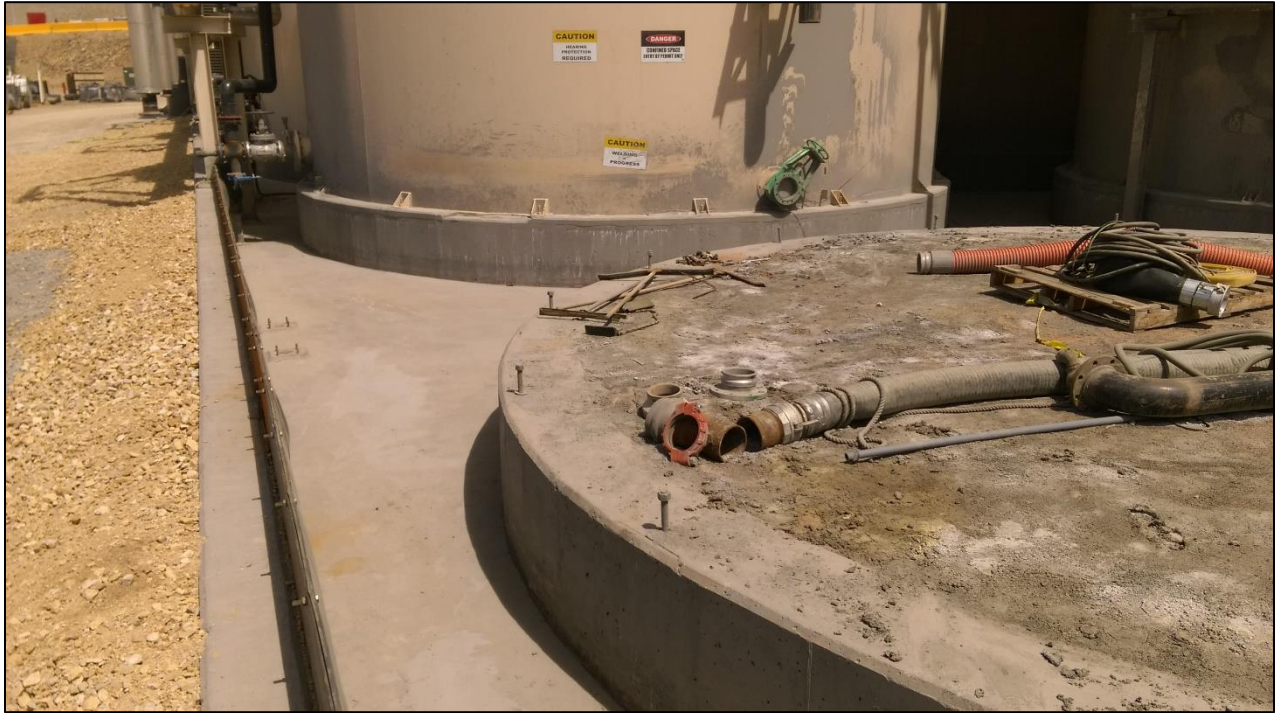
**Photo 7.** View of vat leach area showing secondary containment clear.

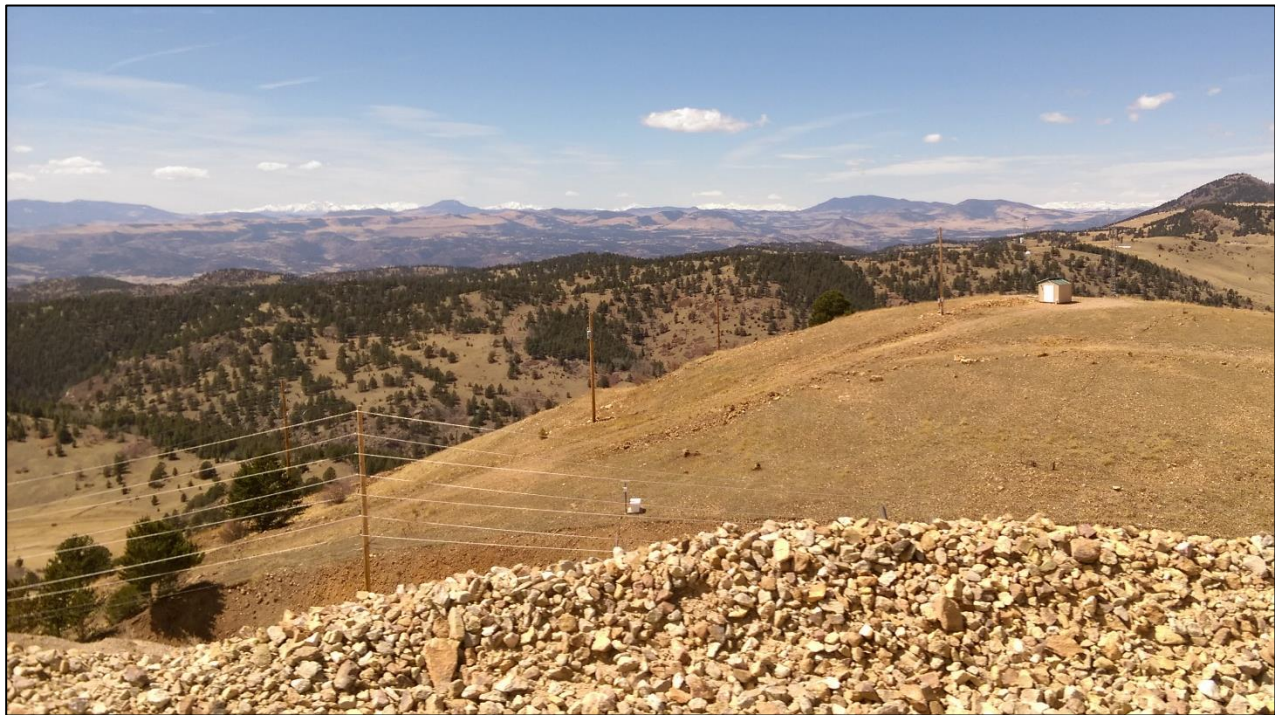
The Division inspected the Guyot Hill area where Technical Revision No. 73 (TR-73) proposed installing an alternate power line for Squaw Gulch (**Photos 8-10**). The additional 1,500 foot, 13.2 KV powerline was to be installed from the crusher power line to the Squaw Gulch ADR-2 in time for construction of that facility. The new line was to start at an existing pole on the existing mill circuit located on the edge of Arequa Gulch Valley Leach Facility, Phase 4. The poles were to contour down Guyot Hill, past the Chickenhawk, onto the old railroad grade, and down to the new ADR-2 security building. The rest of the poles and powerline would be on the pad side of the toe berm, over the ADR-2 facility. TR-73 was approved by the Division on October 29, 2014. Installation of the powerline was to occur in October/November of 2014.

The Division confirmed the powerline was installed in accordance with TR-73. No issues were observed.

**Photo 8.** View looking southwest at Guyot Hill showing alternate powerline installed to support Squaw Gulch ADR-2 facility.

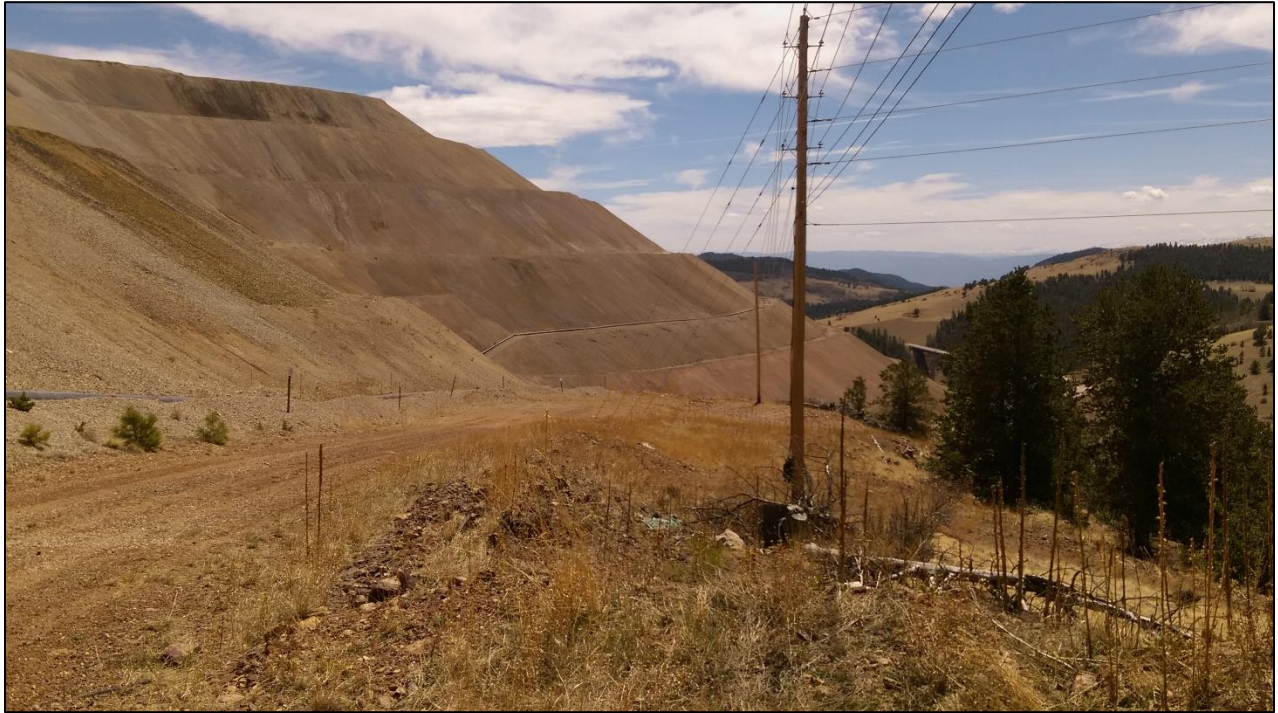
**Photo 9.** View looking south from eastern edge of Guyot Hill showing pole on existing mill circuit located on edge of Arequa Gulch Valley Leach Facility, Phase 4 (at left) where alternate Squaw Gulch powerline was started.

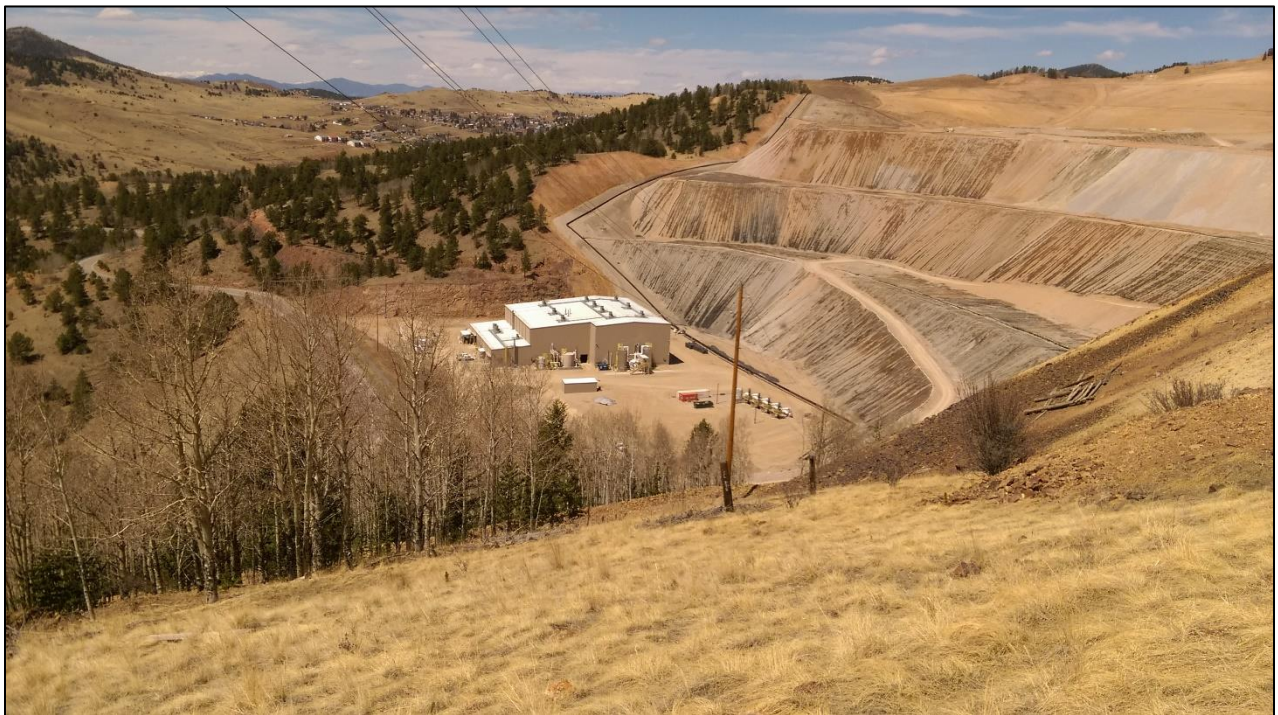
**Photo 10.** View looking down northern side of Guyot Hill showing powerline installed downhill to Squaw Gulch ADR-2 security building. Note ADR-2 facility shown in distance (at center).

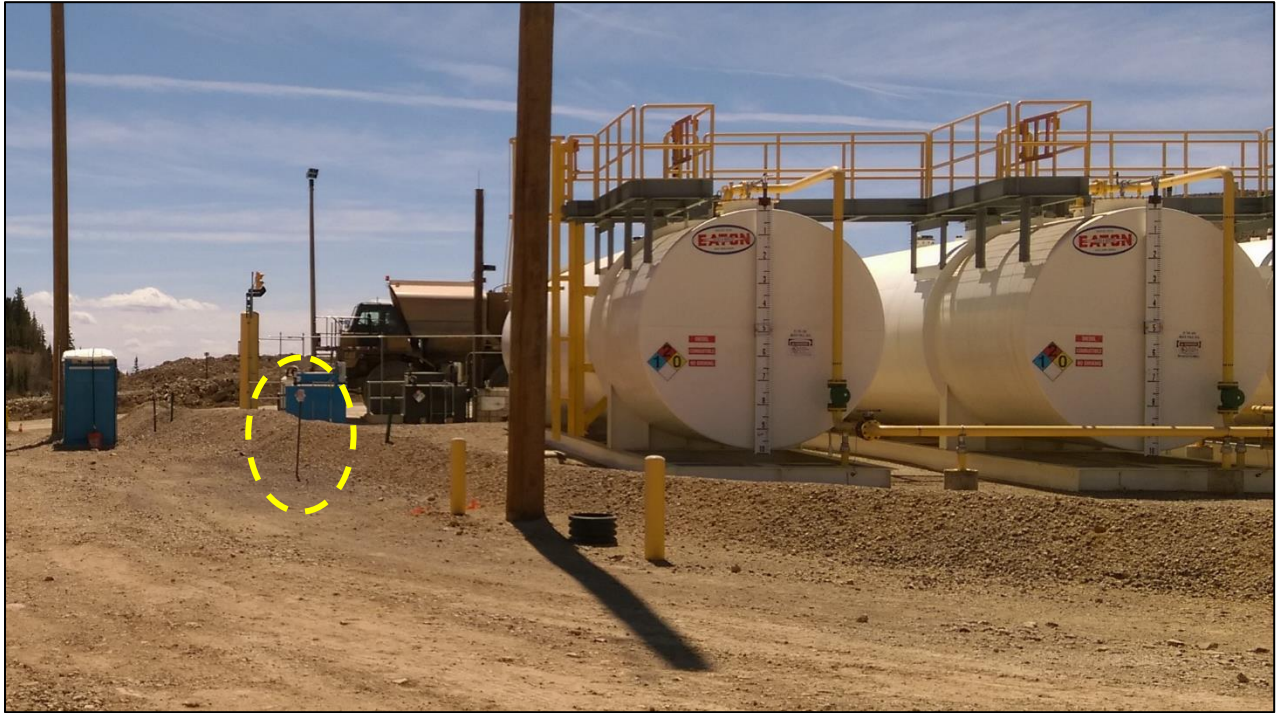
While waiting on the operator to refuel the truck at Fuel Island, the Division observed the edge of liner buried beneath the fueling station had been marked as recommended by the Division in its March 28, 2017 inspection report. The Division had recommended the edge of the subgrade liner be marked to help show whether or not potential petroleum product spills occur over the liner, and also to help prevent damage to the liner during potential construction activities. The operator has placed posts along the edge of the buried liner with signage that reads "Do Not Disturb – Buried Liner" (**Photos 11 and 12**). Therefore, the Division considers this item to have been completed satisfactorily.

**Photo 11.** View of Fuel Island showing one of posts placed to mark edge of buried liner (circled).

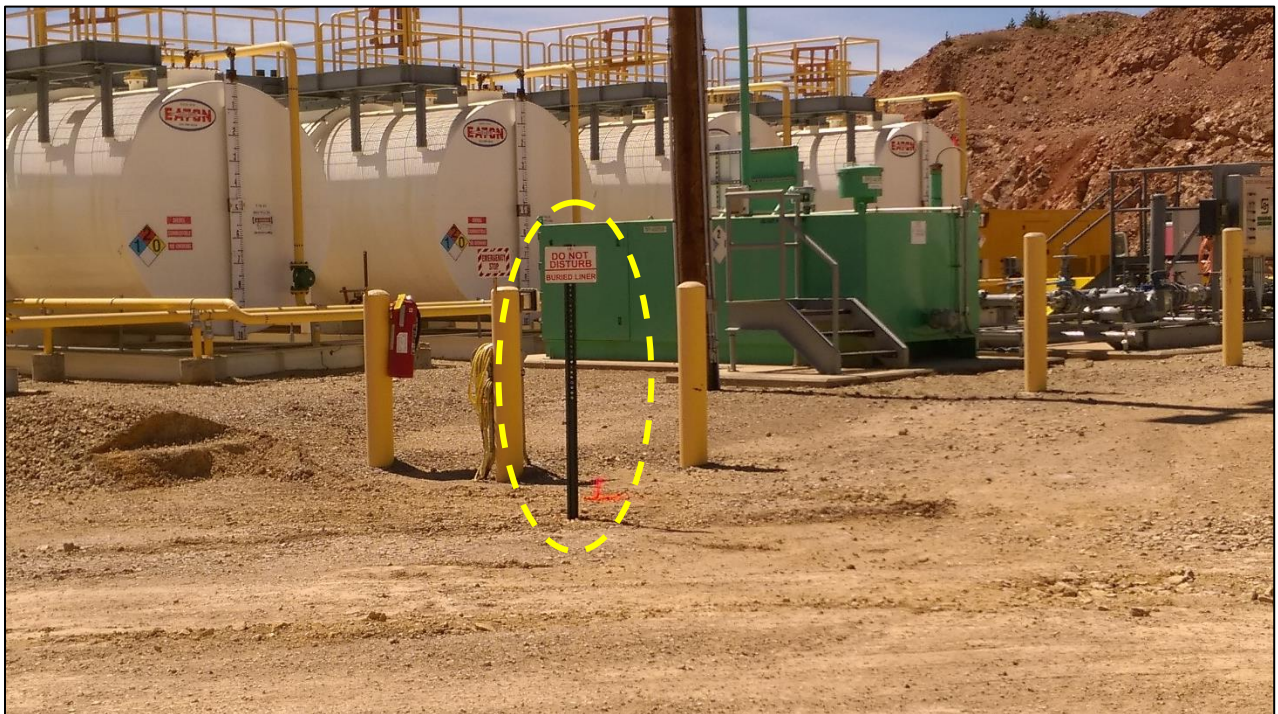
**Photo 12.** View of Fuel Island showing another one of posts placed to mark edge of buried liner (circled). Signs on posts read "Do Not Disturb – Buried Liner".

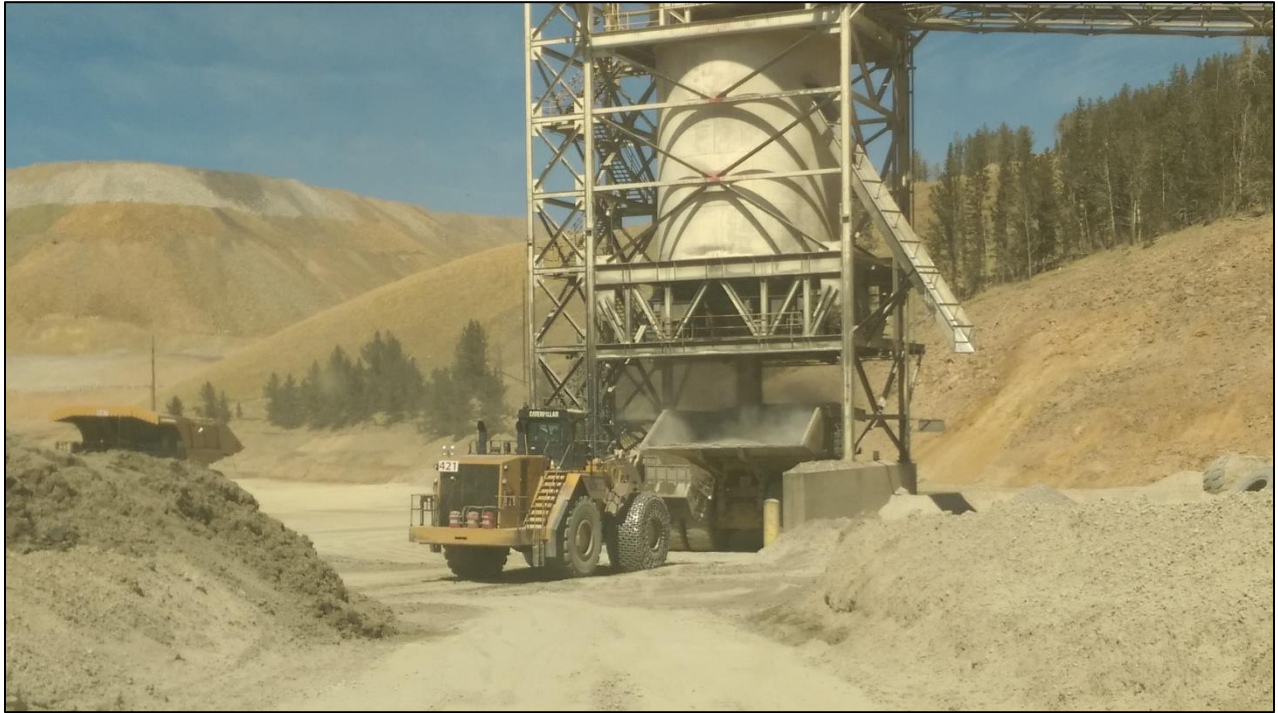
were first partially loaded with crushed ore (**Photo 13**), then loaded with tailings (**Photo 14**), and topped off with additional crushed ore (**Photo 15**). The operator explained this was a new loading process initiated in January of 2017 to help reduce spills from the haul trucks. Also to help reduce spills, the operation adjusted the travel pattern in the loading area to create a straighter pathway for haul trucks as they exit the LOB.

**Photo 13.** View of Load Out Bin area showing haul truck being partially loaded with crushed ore.

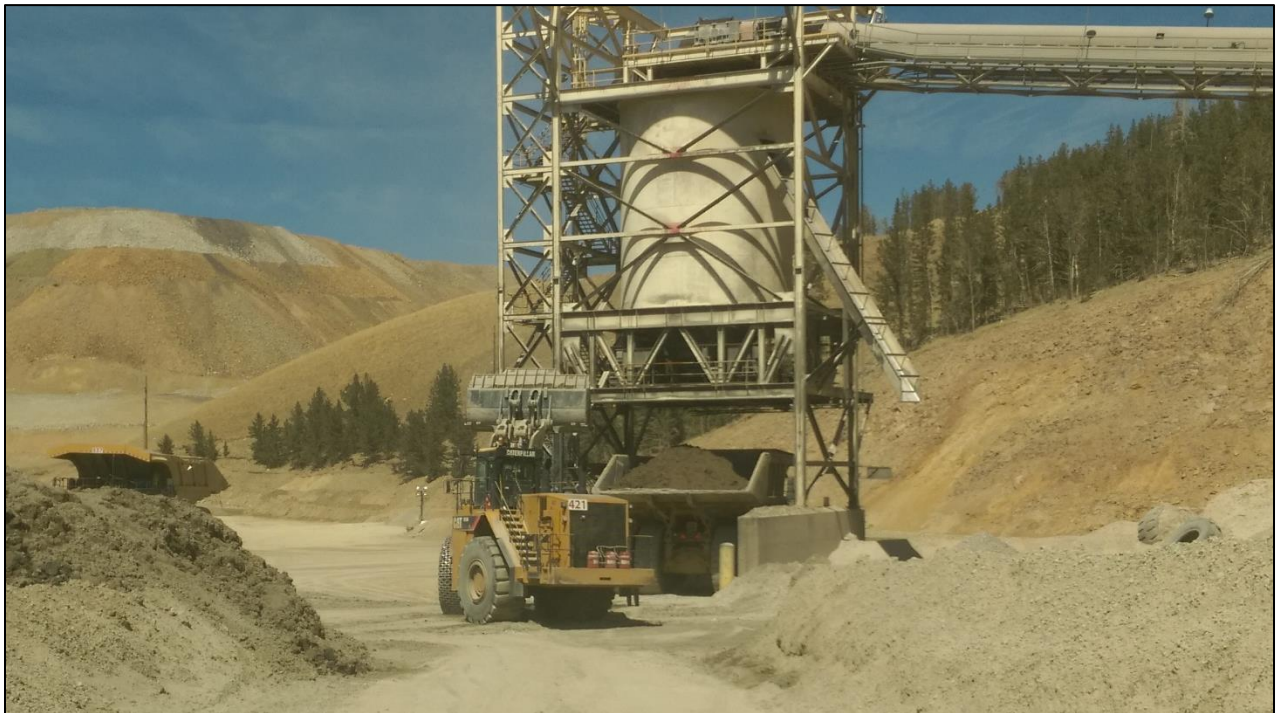
**Photo 14.** View of Load Out Bin area showing haul truck being partially loaded with mill tailings after first being partially loaded with crushed ore.

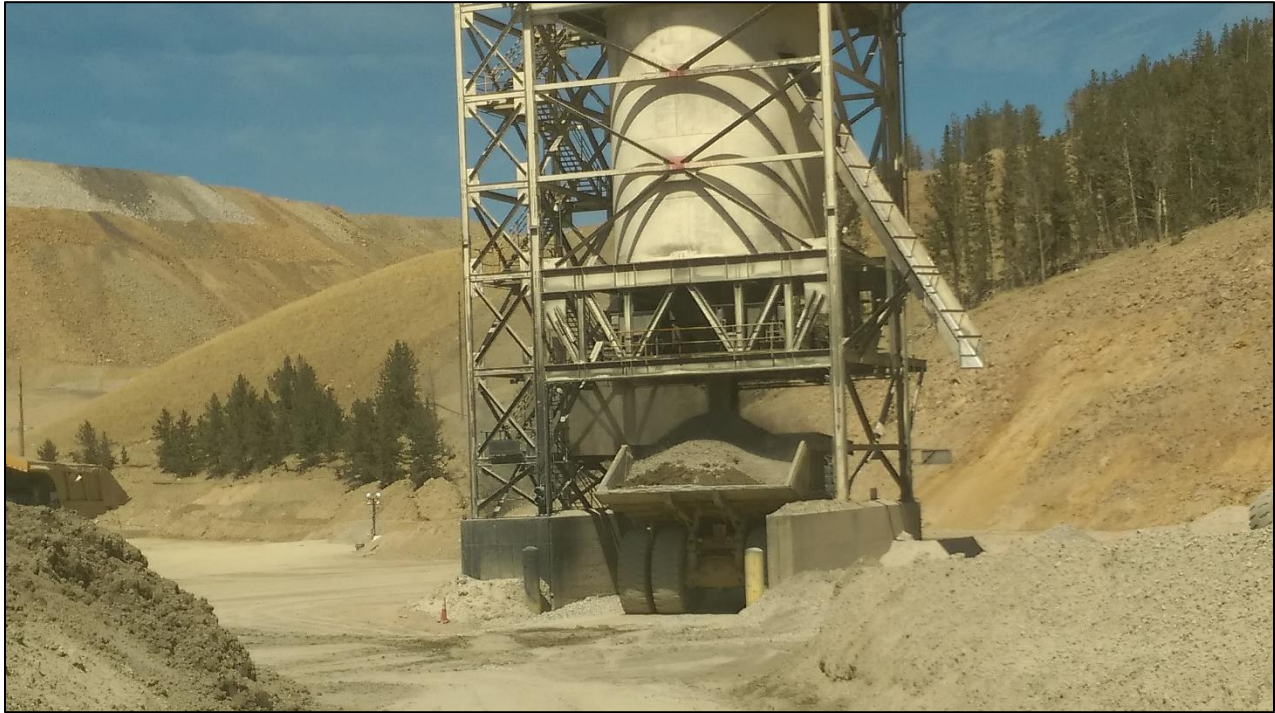
**Photo 15.** View of Load Out Bin area showing haul truck receiving final partial load of crushed ore to cover mill tailings.

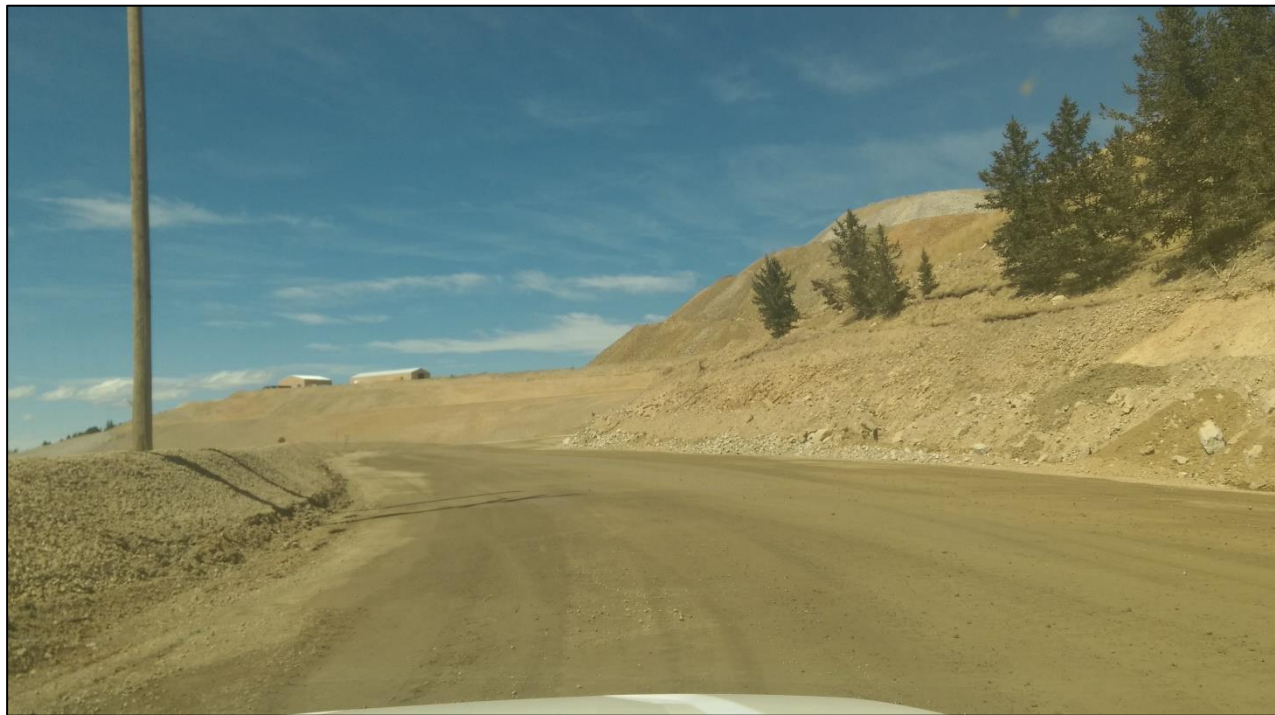
The Division travelled the entire length of the haul road from the LOB to the SGVLF, including the lined and unlined portions (**Photos 16-19**). The Division noted that haul trucks travel downgradient for much of the length of the haul road as they enter the SGVLF, which should help minimize spills from occurring in these areas. The Division did not observe any spilled material on the haul road during the inspection.

**Photo 16.** View of portion of haul road between Load Out Bin (LOB) and Squaw Gulch Valley Leach Facility closer to LOB area. Note road is clear of spilled material from haul trucks.

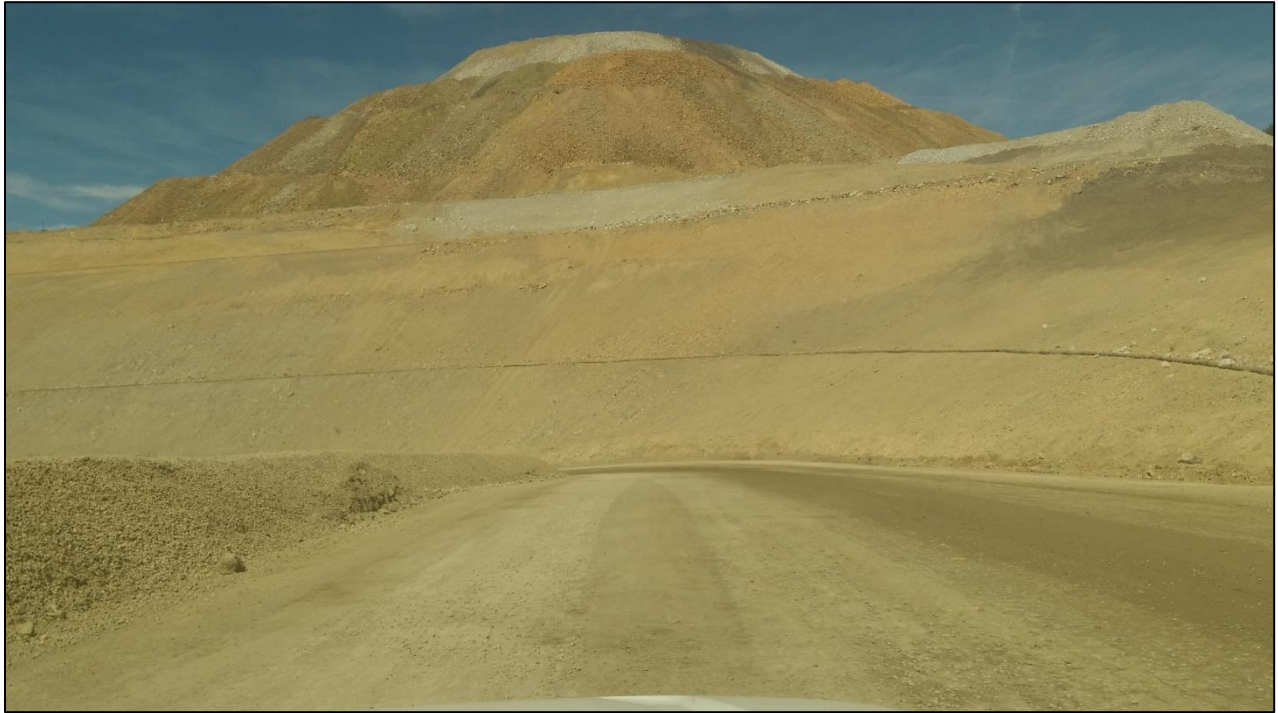
**Photo 17.** View of portion of haul road between Load Out Bin and Squaw Gulch Valley Leach Facility (SGVLF) after entering SGVLF footprint. Note road is clear of spilled material from haul trucks.

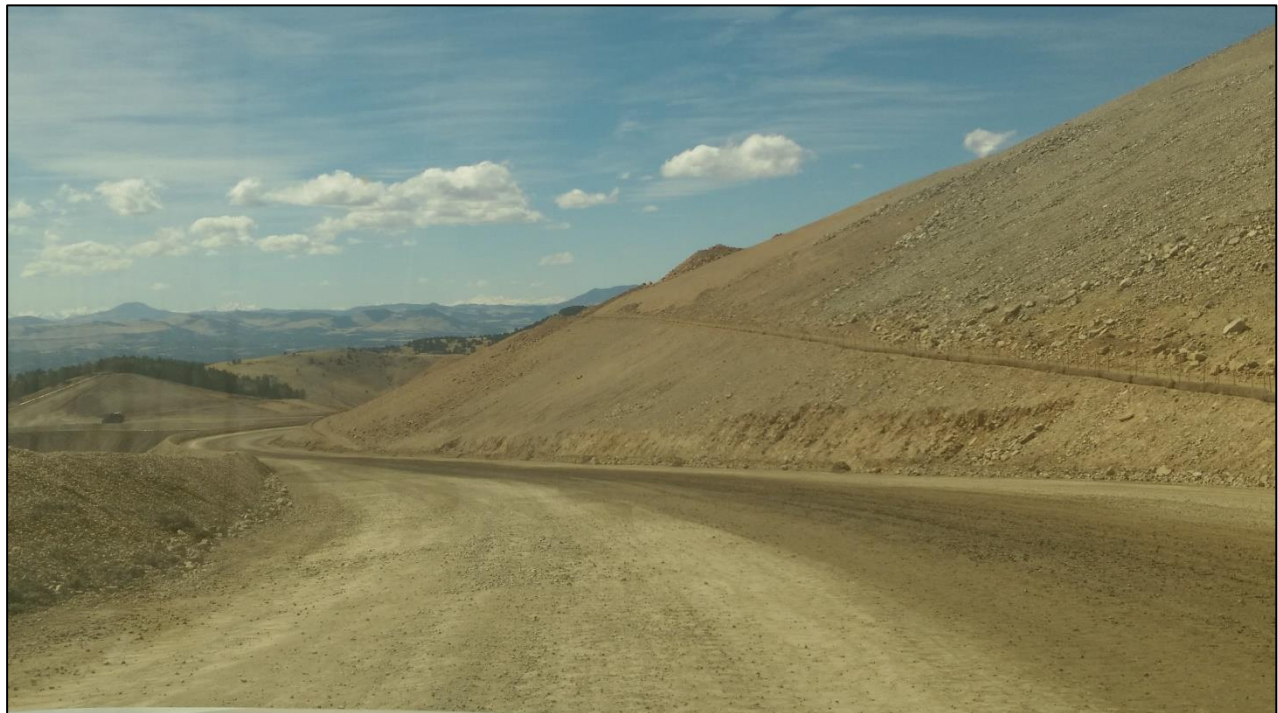
**Photo 18.** View of unlined portion of haul road between Load Out Bin and Squaw Gulch Valley Leach Facility. Note road is clear of spilled material from haul trucks.

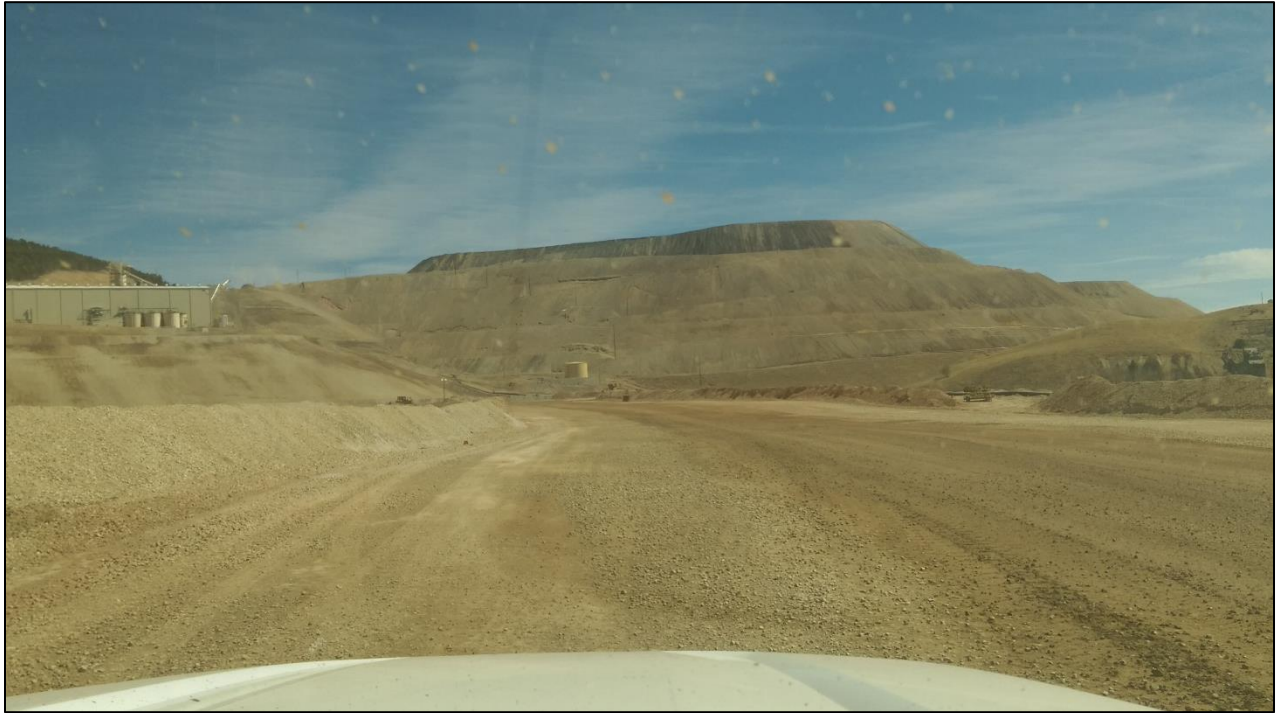
**Photo 19.** View of portion of haul road between Load Out Bin and Squaw Gulch Valley Leach Facility (SGVLF) as crossing top of ore lift placed inside SGVLF. Note road is clear of spilled material from haul trucks.

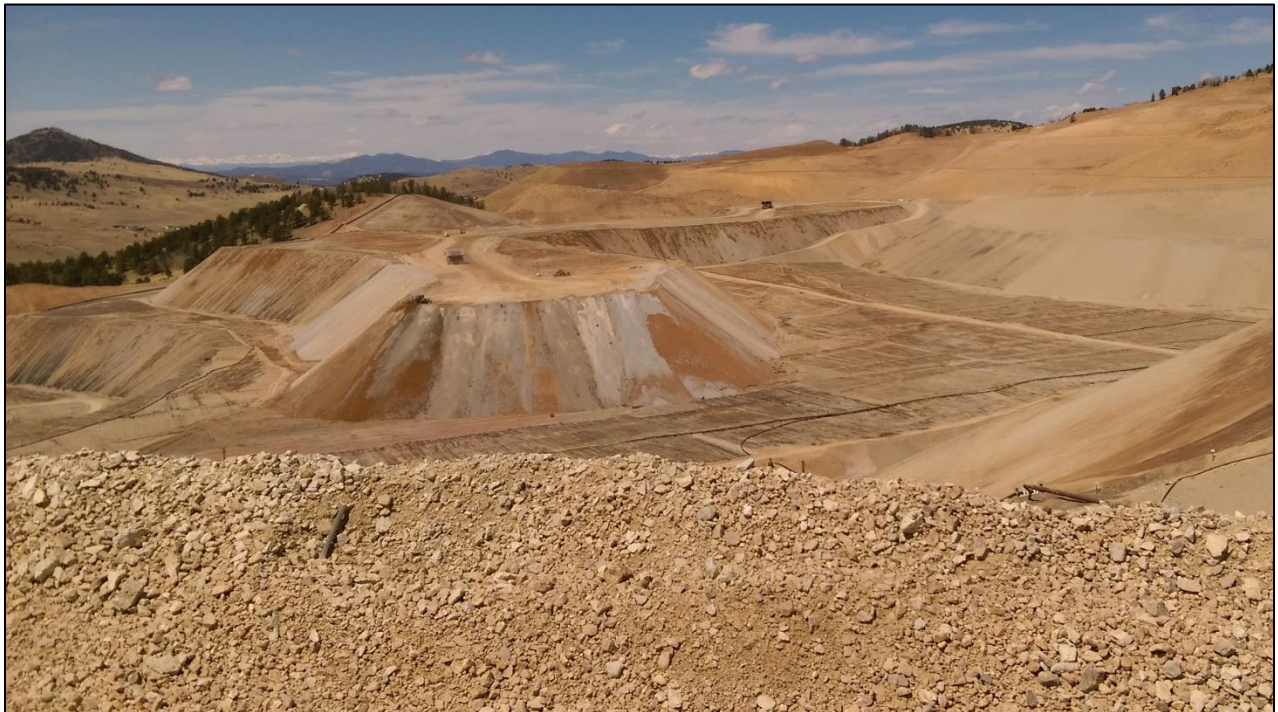
The operation was in the process of placing the third ore lift on the SGVLF (**Photo 20**). The Division inspected the surface of the SGVLF to check for ponded solution. The surface of the top (3<sup>rd</sup>) lift appeared to have little to no ponding (**Photo 21**). The surfaces of the 2<sup>nd</sup> and 1<sup>st</sup> lifts had some ponded solution (**Photos 22 and 23**). Most of the “ponds” had surface areas well beneath the 3 foot by 3 foot limit for protection of wildlife. However, the Division did observe a few, especially on the 2<sup>nd</sup> lift, that were near the size limit (**Photo 24**). Because these areas did not exceed the limit, a problem is not cited in this report. However, the Division recommends the operator closely monitor the leaching surface of SGVLF and work to reduce or eliminate ponding solution (e.g., cross-ripping the surface to allow solution to penetrate the material more easily).

**Photo 20.** View looking west across Squaw Gulch Valley Leach Facility showing placement of third ore lift.

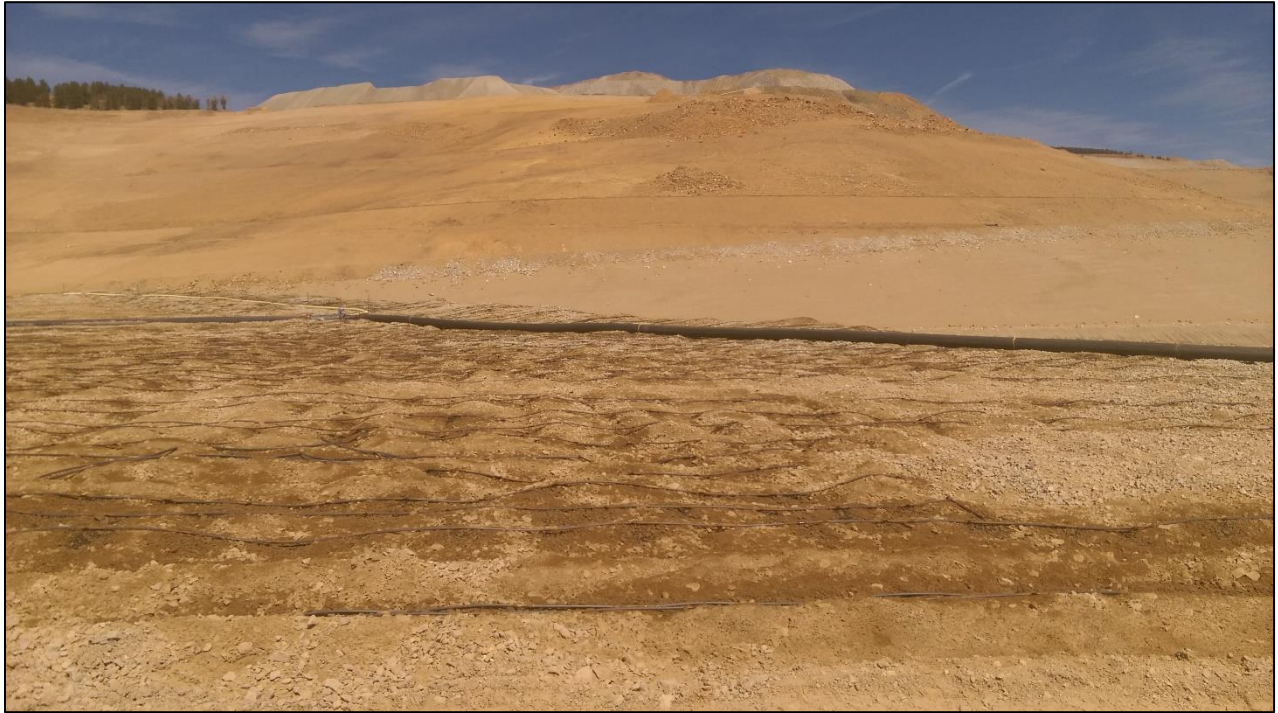
**Photo 21.** View looking across surface of top (3<sup>rd</sup>) ore lift in Squaw Gulch Valley Leach Facility where very little to no ponded solution was observed.
