**MINERALS PROGRAM INSPECTION REPORT**  
**PHONE: (303) 866-3567**

<b>MINE NAME:</b> Cresson Project	<b>MINE/PROSPECTING ID#:</b> M-1980-244	<b>MINERAL:</b> Gold	<b>COUNTY:</b> Teller
<b>INSPECTION TYPE:</b> Monitoring	<b>INSPECTOR(S):</b> Amy Eschberger	<b>INSP. DATE:</b> April 18, 2017	<b>INSP. TIME:</b> 10:30
<b>OPERATOR:</b> Cripple Creek & Victor Gold Mining Company	<b>OPERATOR REPRESENTATIVE:</b> Cheyne Mann, Tyler O'Donnell, etc.	<b>TYPE OF OPERATION:</b> 112d-3 - Designated Mining Operation	
<b>REASON FOR INSPECTION:</b> Normal I&E Program	<b>BOND CALCULATION TYPE:</b> None	<b>BOND AMOUNT:</b> \$173,934,420.00	
<b>DATE OF COMPLAINT:</b> NA	<b>POST INSP. CONTACTS:</b> None	<b>JOINT INSP. AGENCY:</b> None	
<b>WEATHER:</b> Clear	<b>INSPECTOR'S SIGNATURE:</b>

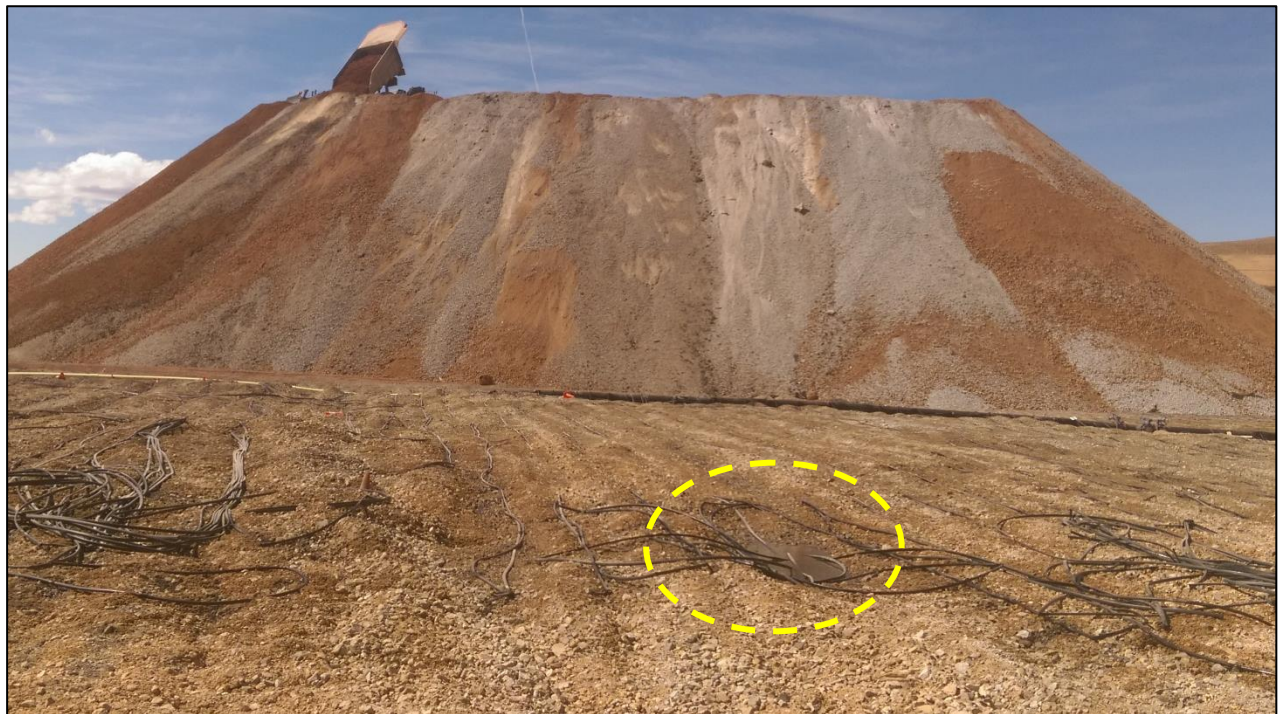
The operation was in the process of placing the third ore lift on the SGVLF (**Photo 20**). The Division inspected the surface of the SGVLF to check for ponded solution. The surface of the top (3<sup>rd</sup>) lift appeared to have little to no ponding (**Photo 21**). The surfaces of the 2<sup>nd</sup> and 1<sup>st</sup> lifts had some ponded solution (**Photos 22 and 23**). Most of the “ponds” had surface areas well beneath the 3 foot by 3 foot limit for protection of wildlife. However, the Division did observe a few, especially on the 2<sup>nd</sup> lift, that were near the size limit (**Photo 24**). Because these areas did not exceed the limit, a problem is not cited in this report. However, the Division recommends the operator closely monitor the leaching surface of SGVLF and work to reduce or eliminate ponding solution (e.g., cross-ripping the surface to allow solution to penetrate the material more easily).

**Photo 22.** View looking across surface of 2nd ore lift in Squaw Gulch Valley Leach Facility where some ponded solution was observed (circled). Note haul truck dumping onto 3<sup>rd</sup> ore lift in background.

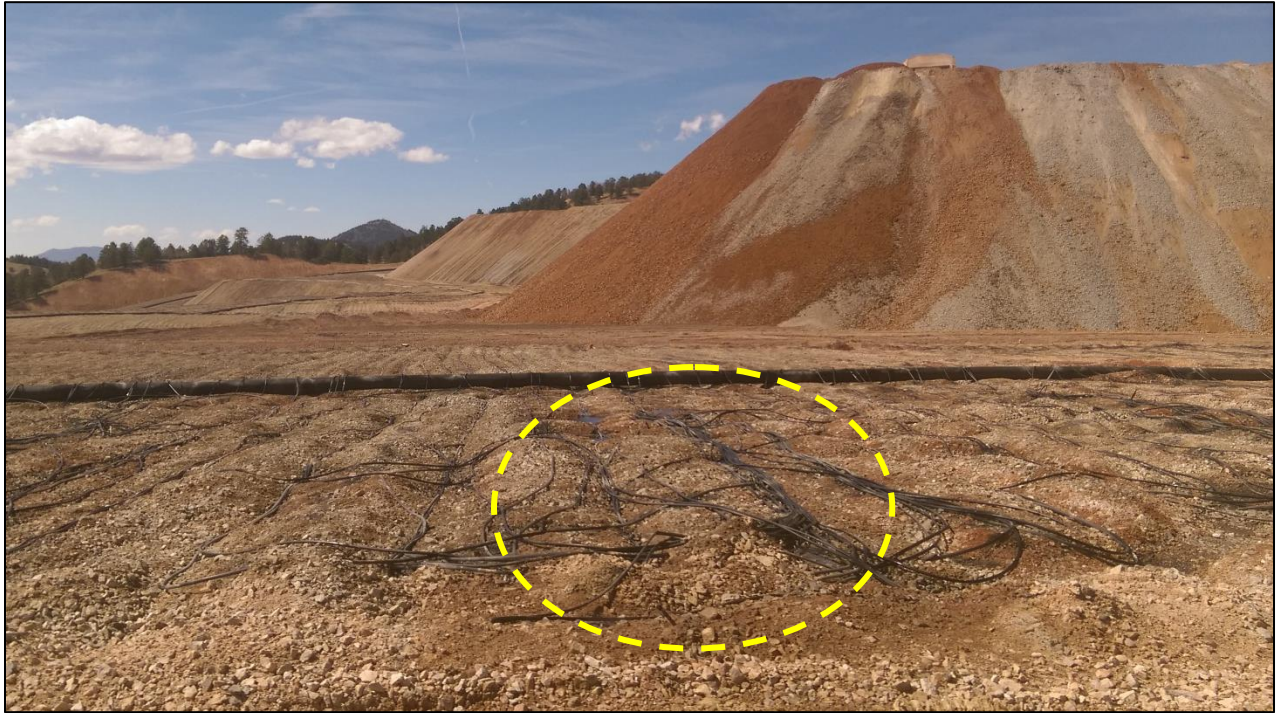
**Photo 23.** View looking across surface of 2nd ore lift in Squaw Gulch Valley Leach Facility where some ponded solution was observed (circled).

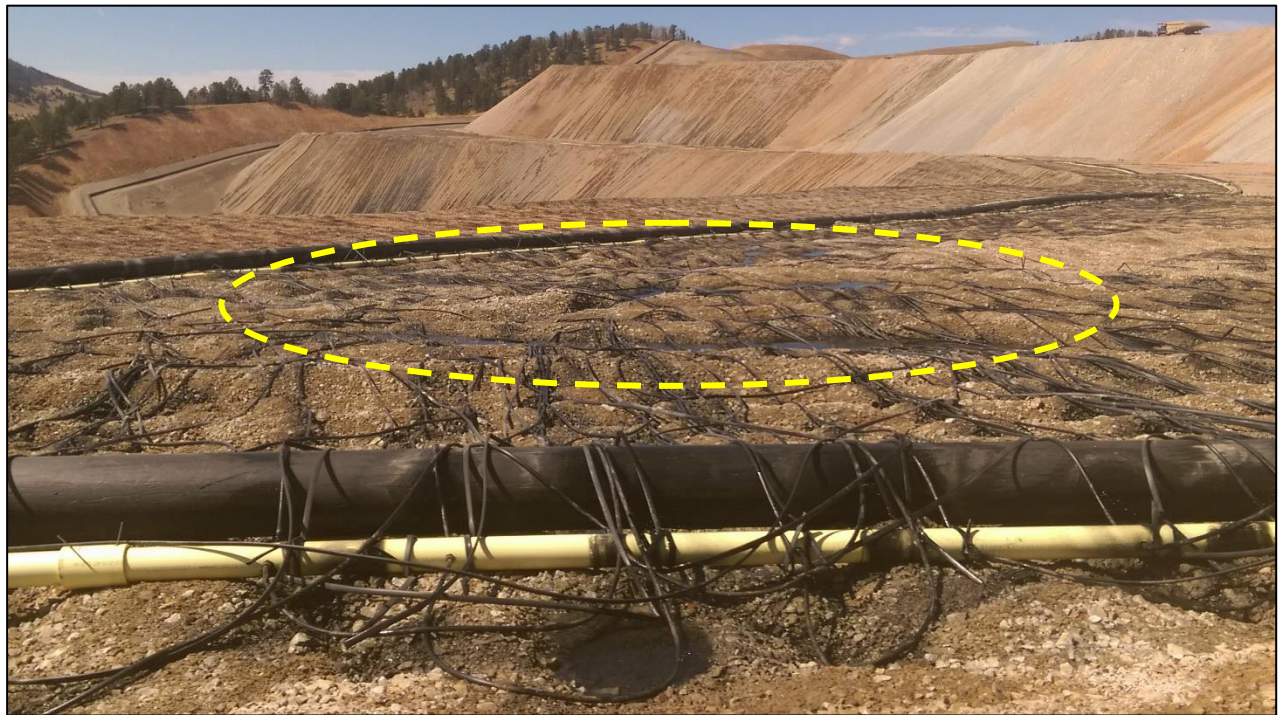
**Photo 24.** View looking across surface of 2nd ore lift in Squaw Gulch Valley Leach Facility where a few solution “ponds” appeared to be near the 3 foot x 3 foot surface area limit. The irregular surface of the trenches broke up the “ponds” so that no one pond seemed to form a consistent 3 foot length.

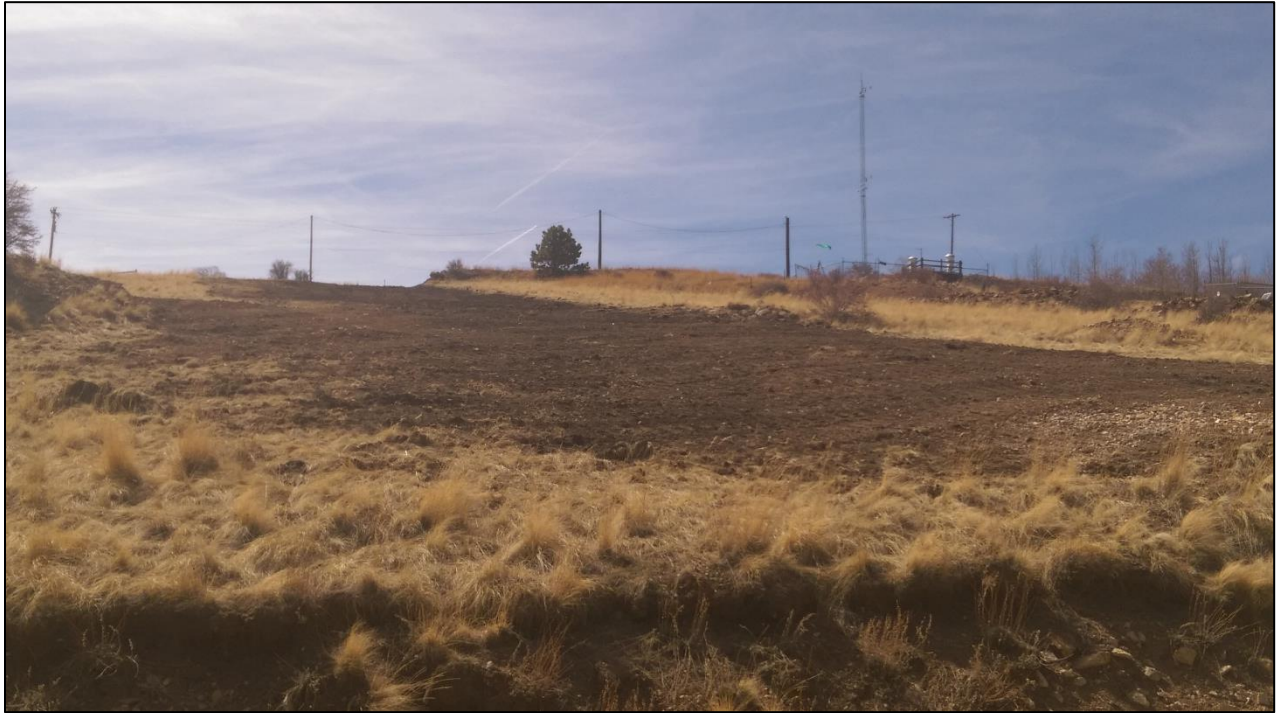
During the inspection, the Division observed the road had been successfully graded and retopsoiled (**Photo 25**). According to the operator, the area would most likely be seeded this spring. Because the operator is promptly reclaiming the road, the Division will not require a bond increase to cover costs for this task.

**Photo 25.** View of haul road constructed just east of South Cresson portion of Main Cresson Mine. Note road has been graded and retopsoiled.

The operator notified the Division of the newly constructed road on March 29, 2017. The operator immediately implemented reclamation of the road, to include grading the area, replacing topsoil with salvaged material that was bermed along the sides of the road, and broadcast seeding the area with an approved seed mixture for road reclamation. The operator also committed to constructing stormwater controls (i.e., straw waddles) as necessary to control erosion of the area until it has been sufficiently stabilized and revegetated.
