MINERALS PROGRAM INSPECTION REPORT
PHONE: (303) 866-3567

MINE NAME: Hukill Gulch Millsite	MINE/PROSPECTING ID#: M-2009-076	MINERAL: Silver and gold	COUNTY: Clear Creek
INSPECTION TYPE: Monitoring	INSPECTOR(S): Michael A. Cunningham	INSP. DATE: June 13, 2017	INSP. TIME: 11:30
OPERATOR: Venture Resources, Inc.	OPERATOR REPRESENTATIVE: Patrick Maher	TYPE OF OPERATION: 110d - Designated Limited Impact	
REASON FOR INSPECTION: Normal I&E Program	BOND CALCULATION TYPE: None	BOND AMOUNT: \$96,827.69	
DATE OF COMPLAINT: NA	POST INSP. CONTACTS: None	JOINT INSP. AGENCY: None	
WEATHER: Clear	INSPECTOR'S SIGNATURE:

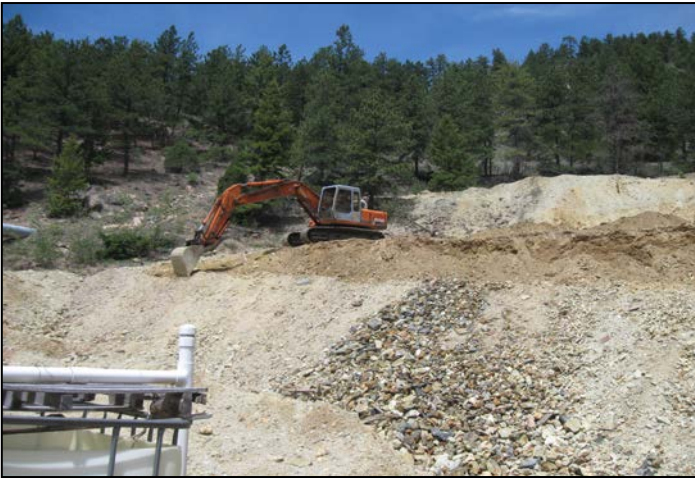
At the time of the inspection, an excavator was removing material from within the tailings impoundment and was placing it in the designated area located immediately north of the tailings impoundment. The Operator has pumped approximately 4,000 gallons of fluid from within the impoundment into a holding tank adjacent to the concrete barrier wall. The Operator estimates an additional 4,000 gallons of fluid will need to be pumped from the tailings impoundment. The Operator inquired if a second tank could be placed within the sediment pond located immediately below the tailings impoundment, due to limited space near the concrete barrier wall. The Division informed the Operator that placing a large tank within the sediment pond would diminish the capacity of stormwater control feature and would not be allowed. Any additional tanks which are needed to store the residual liquids in the tailings impoundment must be located adjacent to the concrete barrier wall as approved in TR04.

1. Excavator removing material from within tailings impoundment.

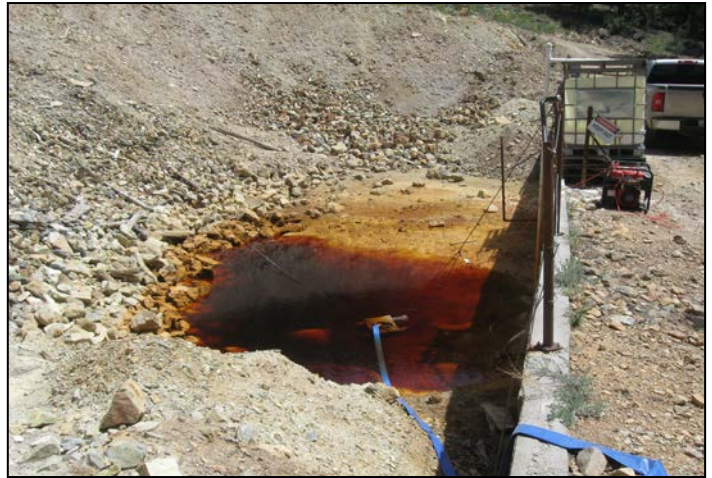
2. Residual liquid within tailings impoundment.

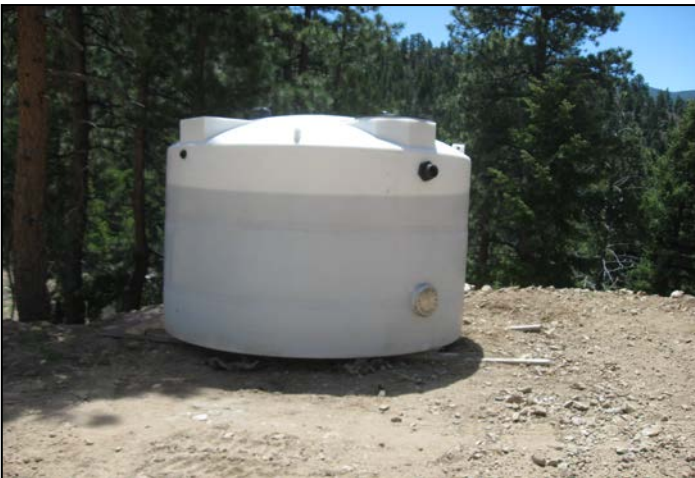
3. Tank used for the interim storage of liquid pumped from tailings impoundment.

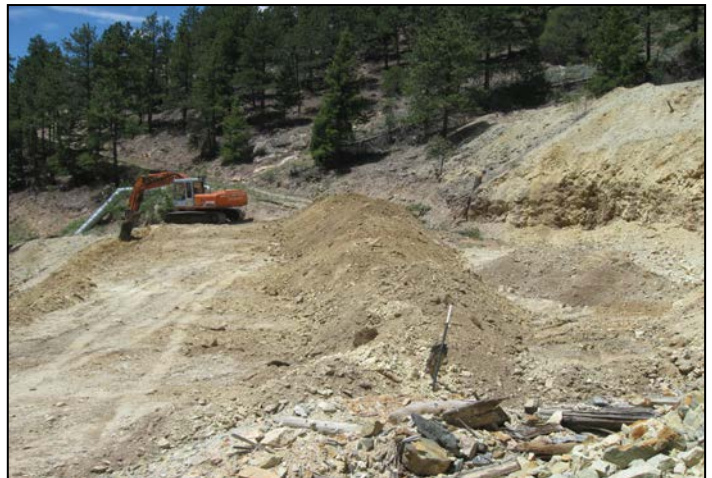
The Operator inquired about storing large pieces of country rock next to the storm water culverts which discharge just below the tailings impoundment or above the sediment pond. The Operator is reminded that TR04 identified a designated storage area above the tailings impoundment. The material which is being excavated from within the tailings impoundment may not be placed, even temporarily, outside of the designated staging/stockpile area. The non-authorized material which was placed on the liner consisted of natural or bank run weathered rock materials along with minor amounts of topsoil. The Operator inquired about salvaging the topsoil for use in reclamation. The Division informed the Operator that topsoil which could be screened out from the weathered rock material using a grizzly or similar method could be stockpiled and used for final reclamation. The handling and stockpiling of any salvaged topsoil must be done in accordance with the approved Mining and Reclamation Plans.

4. Designated storage/stockpile area.

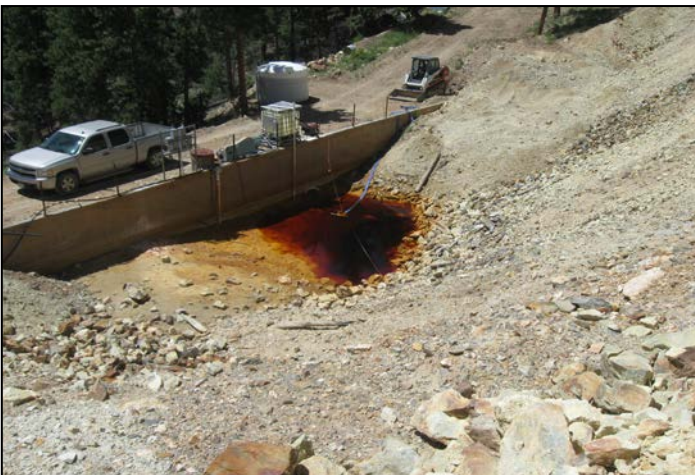
5. Overview of tailings impoundment.
