MINERALS PROGRAM INSPECTION REPORT**PHONE: (303) 866-3567**

MINE NAME: Leyden Pit	MINE/PROSPECTING ID#: M-1983-139	MINERAL: Sand and gravel	COUNTY: Jefferson
INSPECTION TYPE: Monitoring	INSPECTOR(S): Michael A. Cunningham	INSP. DATE: May 30, 2017	INSP. TIME: 09:00
OPERATOR: City of Arvada	OPERATOR REPRESENTATIVE: Jason O'Keefe	TYPE OF OPERATION: 112c - Construction Regular Operation

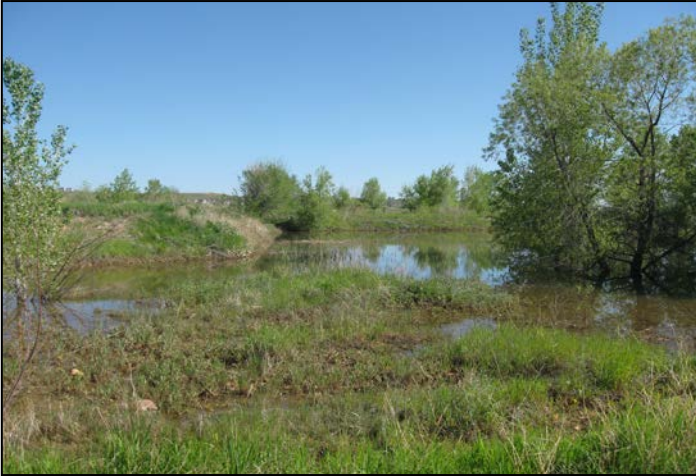
The northeastern portion of the permit area was inspected and the Division observed three ponds located in the East Pit. The three ponds contained water at the time of the inspection. Water was flowing through the ponds from north to south and discharged from a channel in the southernmost pond. The Division could not identify a source of surface water which fed into the ponds and it is assumed groundwater is being exposed within the ponds. The presence of hydrophytic vegetation indicates the ponds contain water throughout most of the year. The presence of water in these ponds was identified as a problem in an inspection conducted on July 6, 1994 and subsequently in an inspection conducted on November 21, 2013. The Division has previously requested the Operator submit documentation which demonstrates the ponds are in compliance with the Office of the State Engineer (SEO). If it is determined the water within the ponds is groundwater, then the Operator will need to either demonstrate compliance with the SEO or will need to backfill the pits to two feet above the static groundwater level. Alternately, the Operator may demonstrate the water within the ponds is the result of surface runoff, in which case the ponds can remain in their current condition. This matter has been cited as a problem and will require corrective action by the Operator, please see the first page of this report for additional information.

1. East Pit ponds.

CORRECTIVE ACTIONS: The operator shall demonstrate the operation is in compliance with the Office of the State Engineer, show evidence that the operator is taking measures to bring the site into compliance with the SEO, or backfill the pits to at least two feet above the groundwater surface by the corrective action date specified.

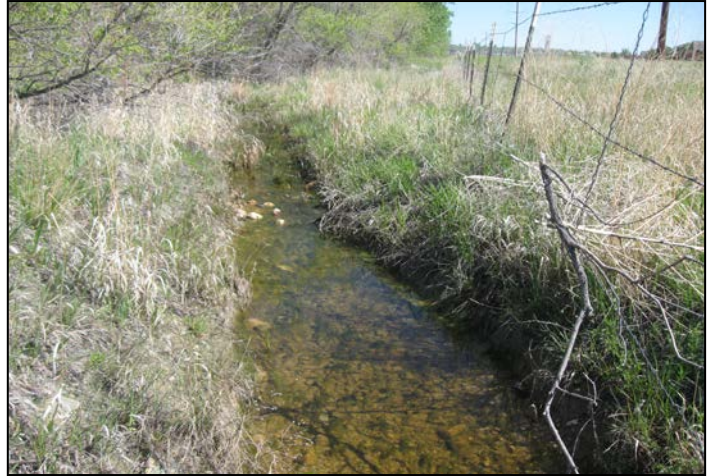
2. Canal draining East Pit ponds.

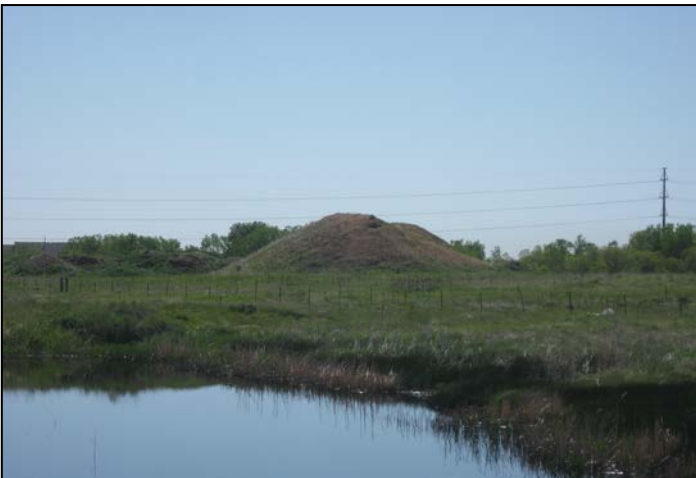
The Division observed several large product stockpiles located to the west of the above discussed ponds. These stockpiles must be removed or graded out during final reclamation of the site. The Division observed that mining which occurred adjacent to the power poles on site left small mounds with steep slopes. The approved Mining Plan specified mining would come no closer than 100 ft. to the power poles. The power pole mounds will need to be backfilled to a final grade 3H:1V or flatter. In addition, the Division does not have record of a structure agreement between the current Operator and the owner of the electrical lines as required by Rule 6.4.19. This matter has been cited as a problem and will require corrective action by the Operator, please see the first page of this report for additional information.

3. Product stockpiles located north of the sales yard.

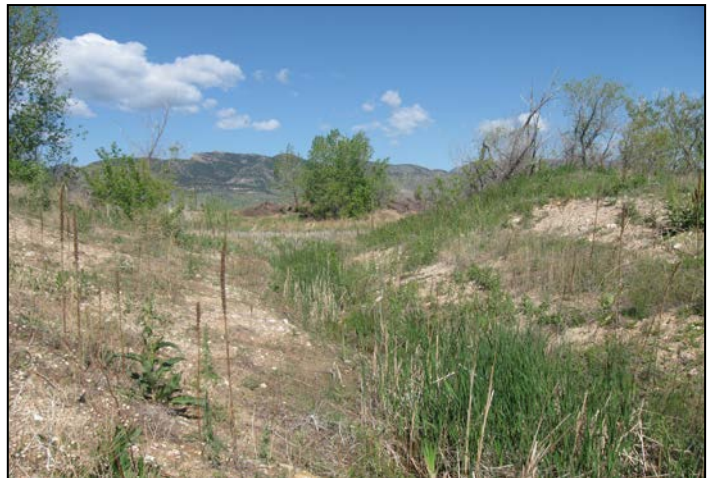
The Division inspected the three sediment ponds located immediately east of the Pioneer office which were the subject of Technical Revision No. 3. The sediment ponds were breached to maintain positive drainage and to restore the natural drainage pattern in this area. All of the ponds were dry at the time of the inspection. The northern pond is in need of additional grading and currently has minimal vegetation. The center pond has a constructed channel which allows surface water to discharge to the Coors pond located just outside of the

4. Sediment pond breach.

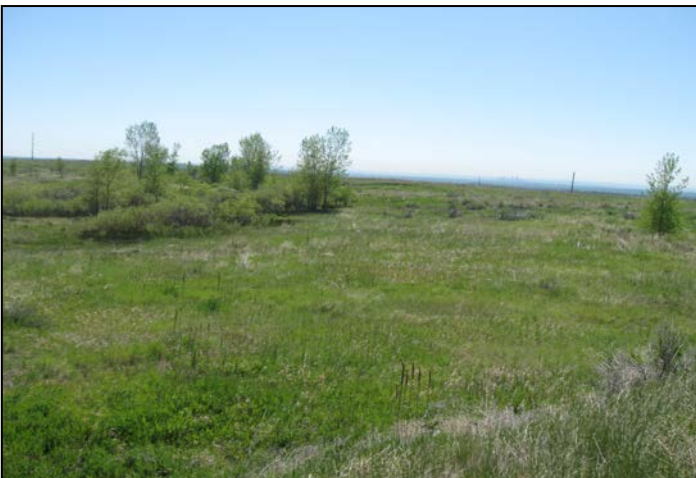
northern permit boundary. The southern pond has stable banks with dense willow establishment along the bottom of the pond, minor grading is required on the west side of this pond. The Division also inspected several pits located within the South Pit area and found the side slopes to be stable with adequate vegetation establishment. Minor areas of grading along the access road were identified.

5. South Pit.

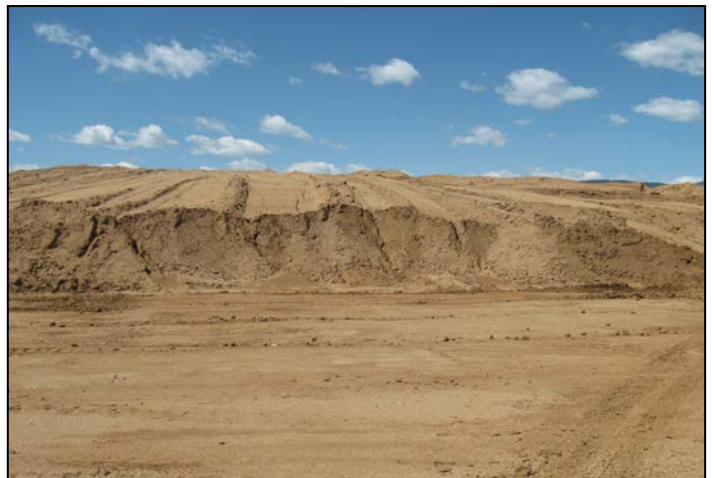
Pioneer Sand and Gravel (Pioneer) maintains a lease for 20 acres within the Leyden Pit to operate a product sales yard. A small stockpile product stockpile remains to the west of the office building which must be removed during final reclamation. In addition, Pioneer has a large sand stockpile located near the western permit boundary which will need to be removed. The approved post-mining land use for the Leyden Pit is rangeland, which would require reclamation of the sales yard and removal of all associated structures. In order for the sales yard to remain, an Amendment application would need to be filed to add a secondary post-mining land use for industrial/commercial use.

6. Product stockpile adjacent to western permit boundary.
