Re: King I Mine, C-1981-035
Stoner Engineering: Quarterly Inspection: Water Quality Improvements
2nd Quarter 2017

Date: June 27, 2017

Re: King Coal I – Quarterly Water Quality Improvements Inspection

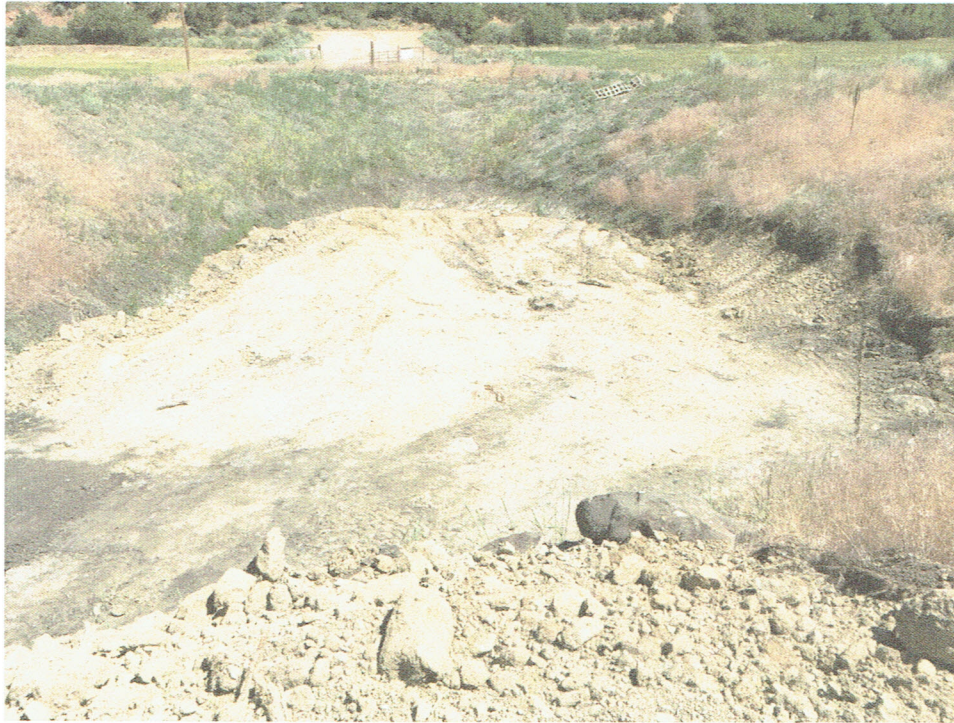
Both ponds were dry at the time of the inspection (see Pic. 1 & 2). The east pond was undergoing some work at the time of the inspection. You indicated that the bottom of the pond was being raised to ensure that no ground water was being held in the pond per a request from the Division of Reclamation, Mining and Safety. GCC is on the process of conducting a new survey of the east pond to determine the impacts of raising the pond bottom from the original design. As-built survey will be required to set proper gage level for sedimentation levels. The ponds are both in generally good condition. The required storage volume appears to be adequate at this time based upon the sedimentation gage installed in the west pond and the visual volume of the east pond (currently no sedimentation gaga). The sedimentation levels of the ponds should checked after the existing water dissipates from the ponds. The ponds should continue to be monitored after storm events to ensure that excess sediment does not reduce the required storage capacity available for storm water runoff.

Pic. 1 – East pond, fill material installed in base.

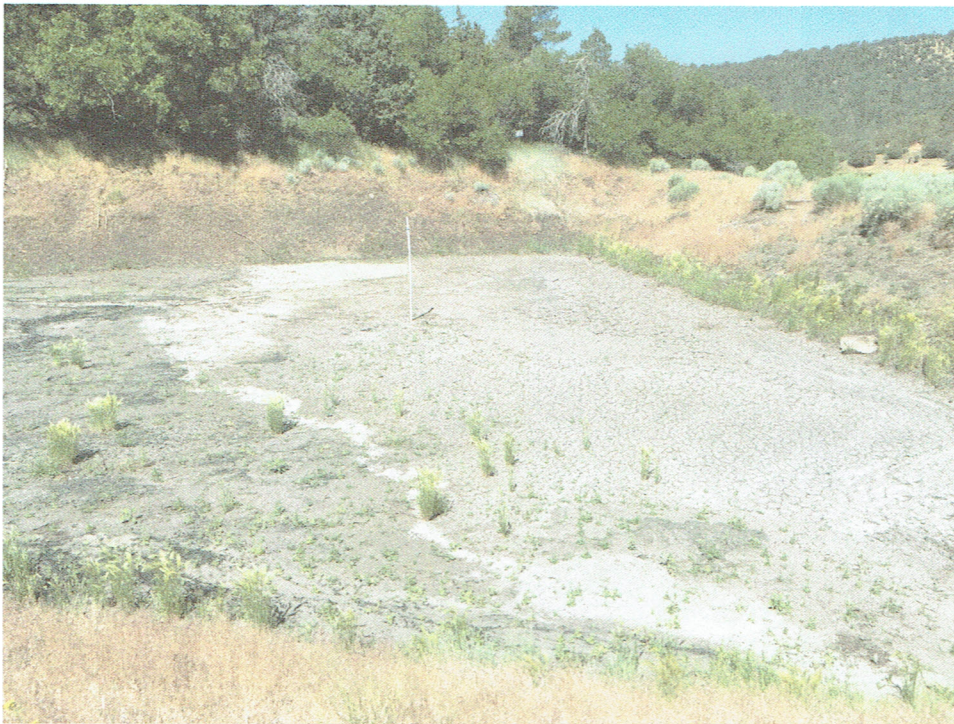
Pic. 2 – West pond dry.

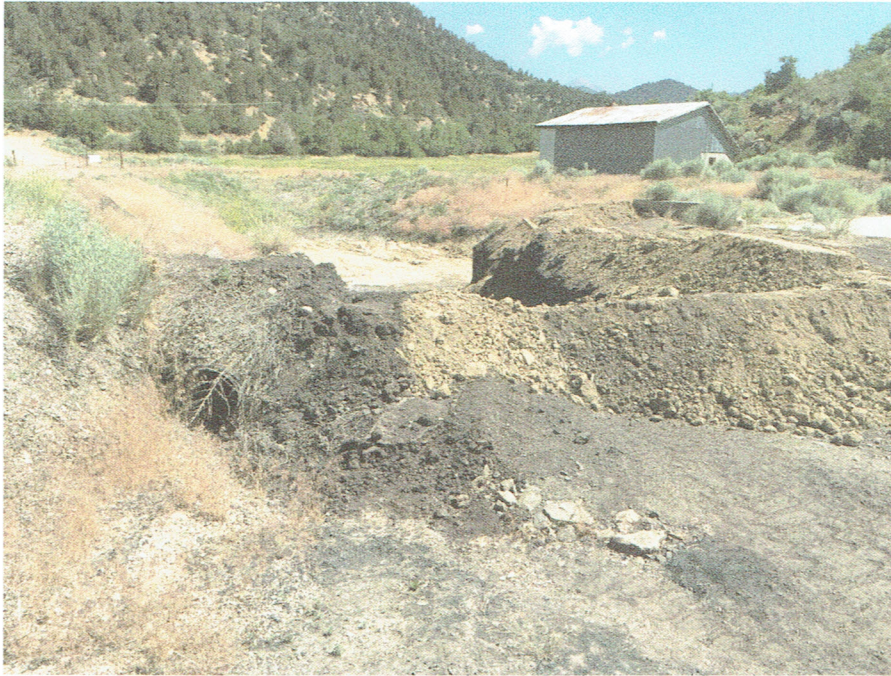
The drainage ditches and pipes were generally in good condition. The inlet pipe into the east pond has been temporarily improved until the improvements for the east pond are completed. (see Pic 3). All pipes, ditches and sediment traps should be inspected and repaired as necessary, especially after storm events.

Pic. 3 – Pipe inlet, east pond, temporary embankment material placed.

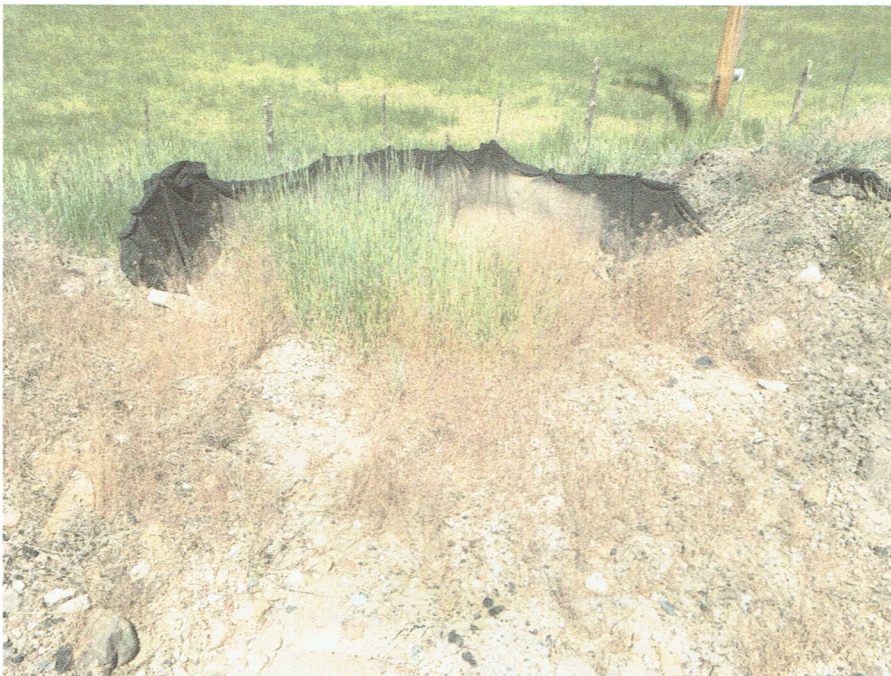
The sediment traps located along the west side of the driveway at the entrance are in good condition (see Pic 4).

Pic. 4 – Sediment traps along west side of driveway in good condition.
