Re: King I Mine, C-1981-035
Stoner Engineering: Quarterly Inspection: Refuse Pile
2nd Quarter 2017

Date: June 27, 2017

Re: King Coal I – Quarterly Waste Pile/Embankment Inspection

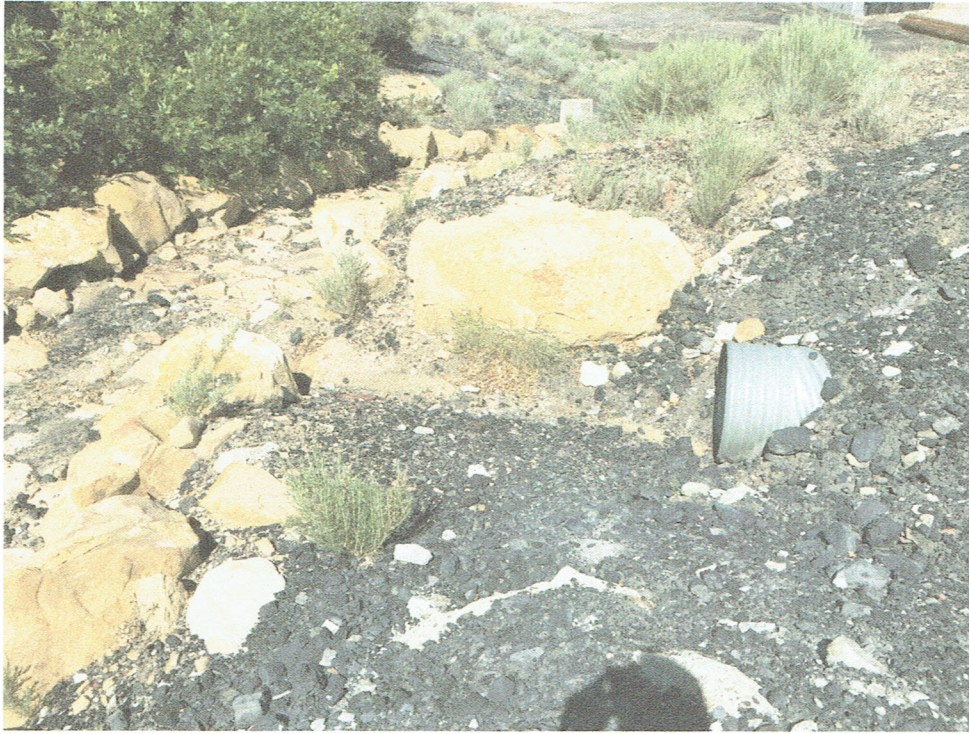
The condition of the perimeter ditches located along the north and south sides of the property were generally in good condition (see Pic. 1). The drainage channels were generally clear of debris and there was no damage observed to any of the channel sections.

Pic. 1 – North channel, good overall condition.

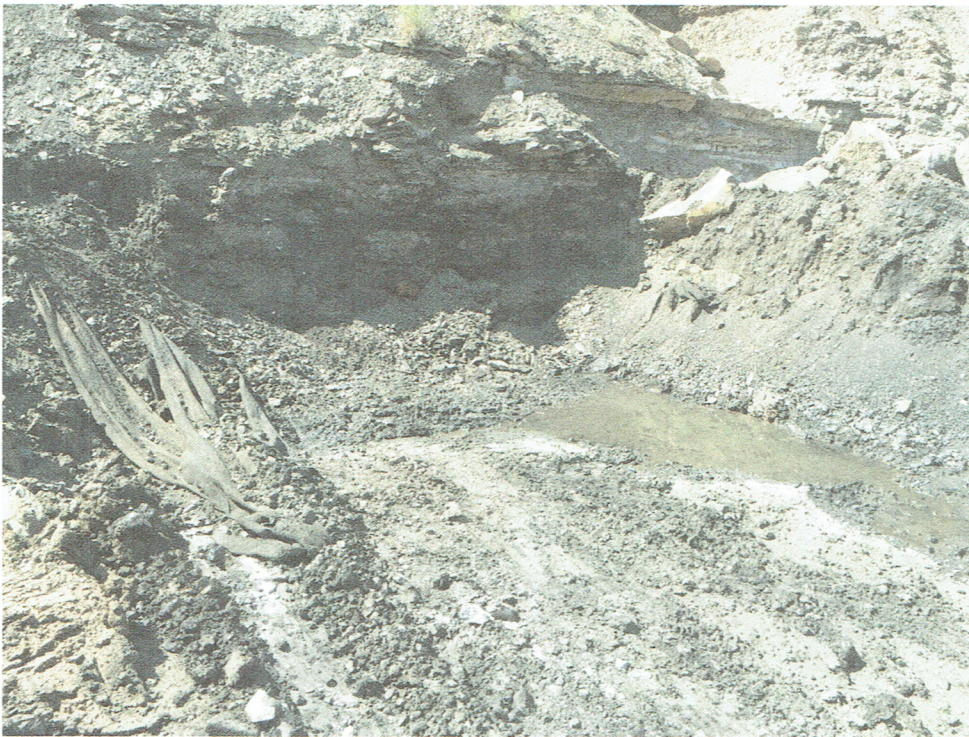
There had been some work done at the base of the waste pile/embankment. GCC had been asked to install some additional fill material at the base of the embankment/waste pile by the Division of Reclamation, Mining and Safety to ensure that the slope meets the 2.5:1 specified in the original design. You indicated that the slope is currently about 2.2:1. In preparation for placing additional fill material along the base of the embankment, the under drain was exposed. The drain appears to have been uncovered near its endpoint along the south edge of the waste pile (see Pics. 2 and 3). GCC shall carefully excavate the under drain back to an undisturbed portion before repairing and extending the under drain (match existing section) to the west into the existing ditch at the base of the native slope.

Pic. 2 –Under drain exposed at base (south end) of the embankment/waste pile .

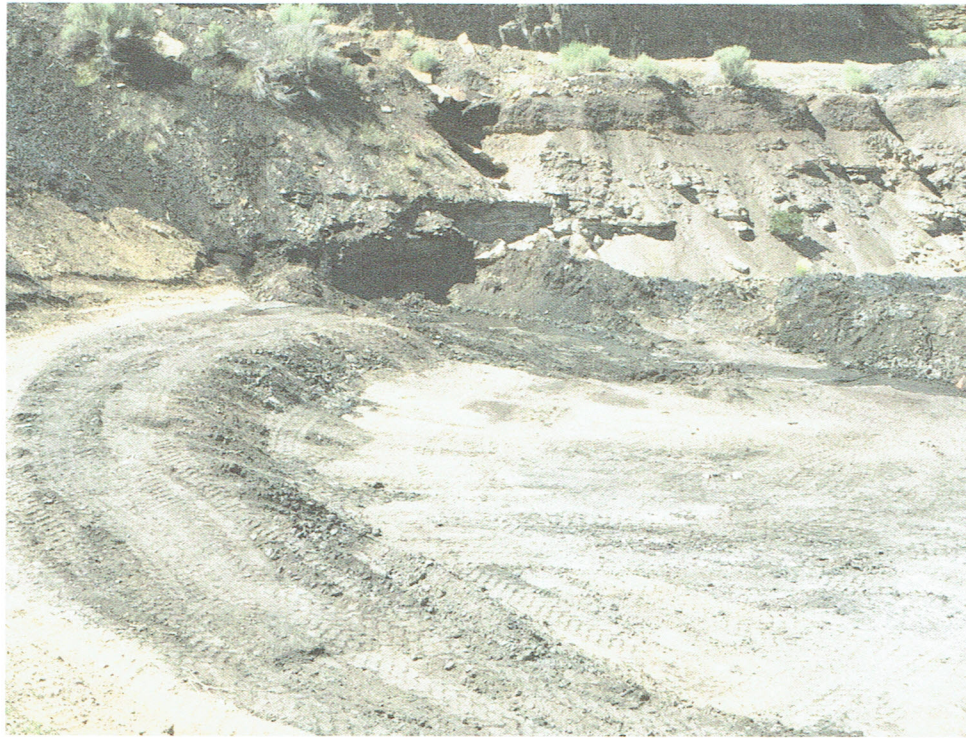
Pic. 3 –Exposed under drain, existing ditch located to west at base of natural embankment.

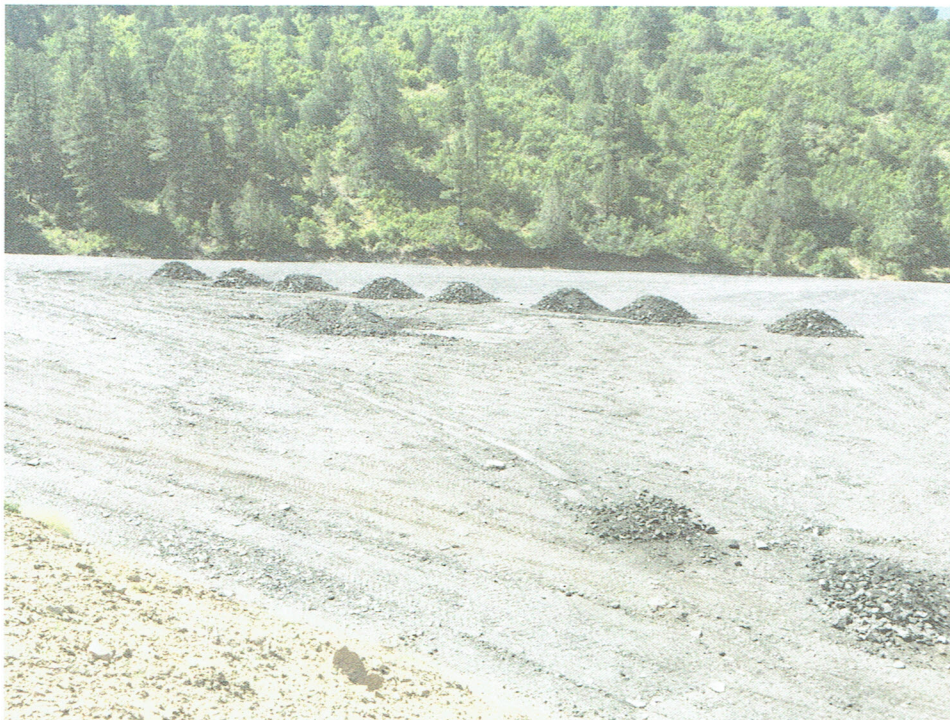
There was material stockpiled at the top of the embankment awaiting placement as embankment fill (see Pic. 4). The face of the embankment was in good condition and does not show any signs of excessive erosion, instability or weakness.

Pic. 4 – Embankment material ready for placement at top of embankment.
