**COLORADO**Division of Reclamation,
Mining and Safety

MINERALS PROGRAM INSPECTION REPORT**PHONE: (303) 866-3567**

MINE NAME: Munsch Pit	MINE/PROSPECTING ID#: M-2000-018	MINERAL: Sand and gravel	COUNTY: Cheyenne
INSPECTION TYPE: Preoperation Inspection	INSPECTOR(S): Timothy A. Cazier	INSP. DATE: July 6, 2017	INSP. TIME: 10:30
OPERATOR: Cheyenne County	OPERATOR REPRESENTATIVE: Jim Brown	TYPE OF OPERATION: 110c - Construction Limited Impact	
REASON FOR INSPECTION: Preoperation Inspection	BOND CALCULATION TYPE: None	BOND AMOUNT: \$0.00	
DATE OF COMPLAINT: NA	POST INSP. CONTACTS: None	JOINT INSP. AGENCY: None	
WEATHER: Clear	INSPECTOR'S SIGNATURE:

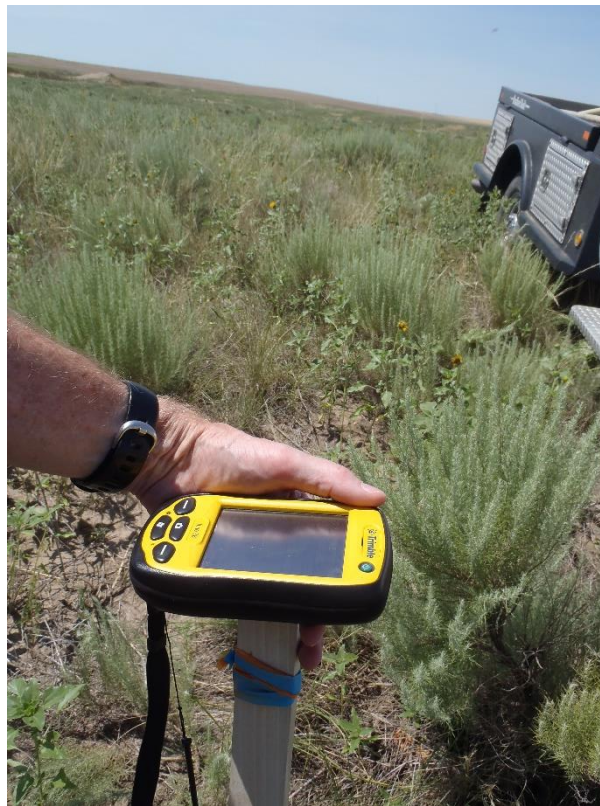
Complete Inspection: The entire permit area was inspected. All new corners proposed by the conversion application were marked with survey lathe (see **Photo 1**). This inspector used a Juno 3B handheld GPS unit to collect locations of each corner. This inspector noted an overhead powerline on the north side of County Road M. Mr. Brown indicated the road easement is 60 feet wide. The proposed affected area boundary extends to the south side of County Road M. Therefore, the affected area boundary, which includes the proposed new access road is within 200 feet of the utility. **Pursuant to Rule 6.4.19, a "no negative effect" letter will be required for this conversion.** No other structures were noted within 200 feet of the proposed permit boundary.

Photo 1. Typical new corner marked with survey lathe (NW corner, looking south).

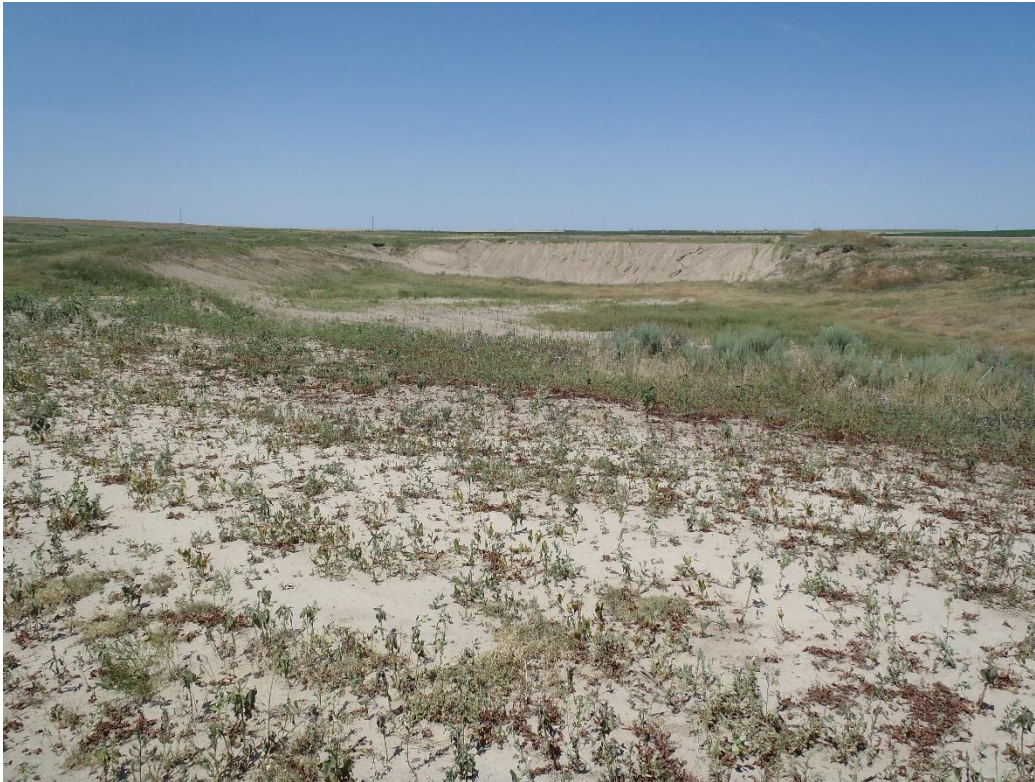
Reclamation Success: Most highwalls are 3H:1V or flatter and self vegetated except for the most recent working face (see **Photo 2**). The berm repair where the flood occurred as noted in the previously inspection was seeded and vegetation is progressing nicely (see **Photo 3**).

Photo 2. Most recent working face (background) and self vegetated surrounding areas (looking west).

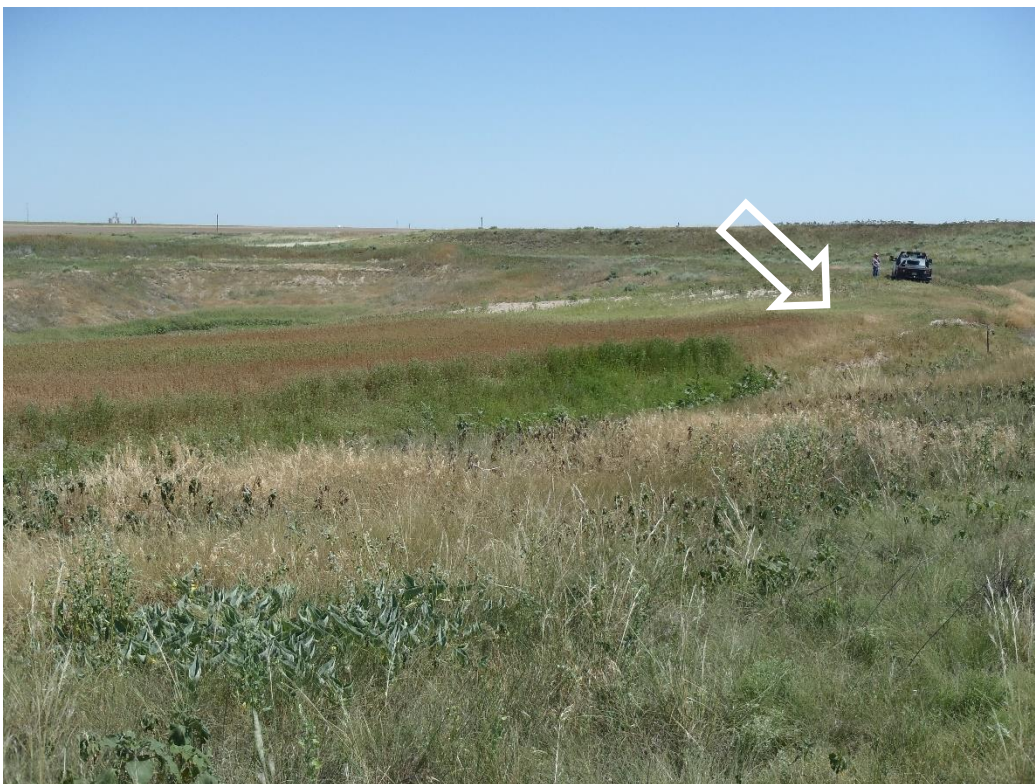
Photo 3. Berm repair vegetation progressing nicely (looking NE).

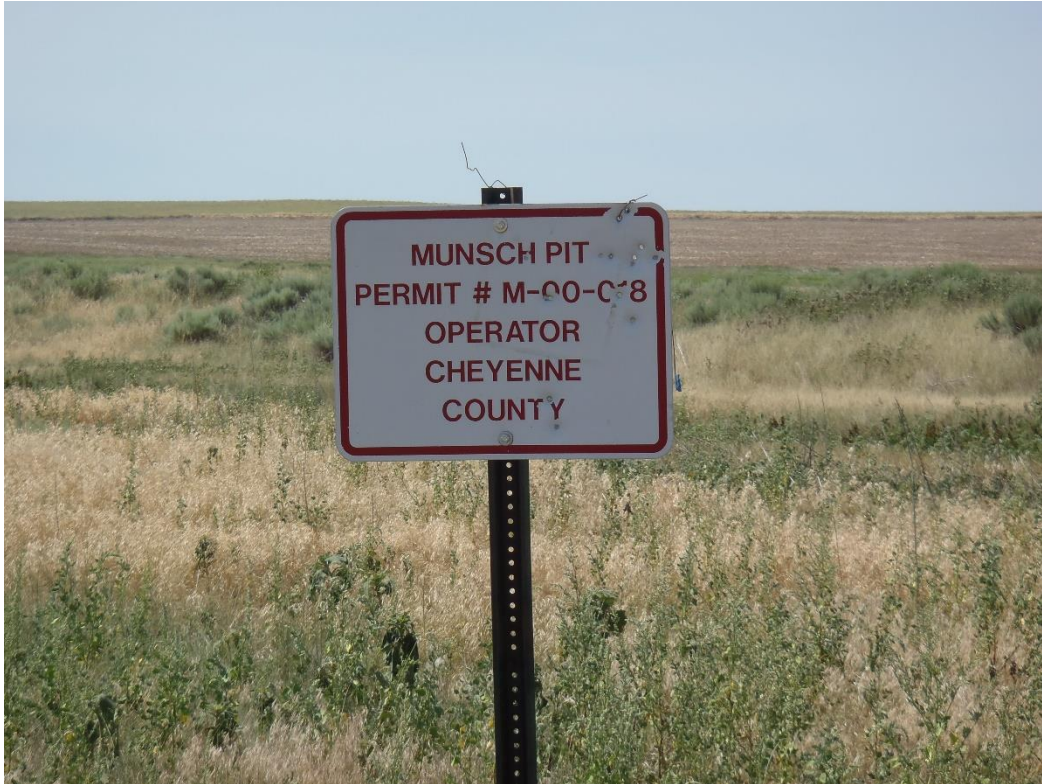
Signs and Markers: The permit sign was properly posted (see **Photo 4**) and boundary markers were observed to delineate the permit boundary (see **Photo 5**).

Photo 4. Permit sign properly posted.

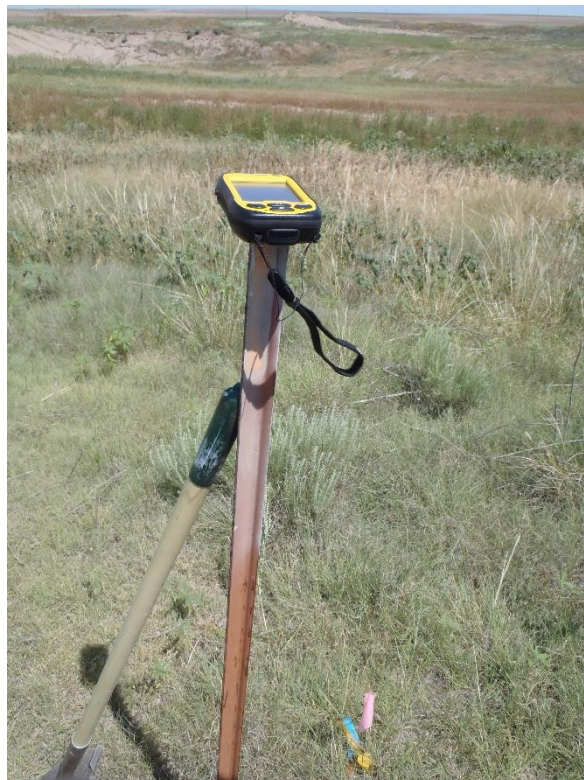
Photo 5. Typical T-post boundary marker.

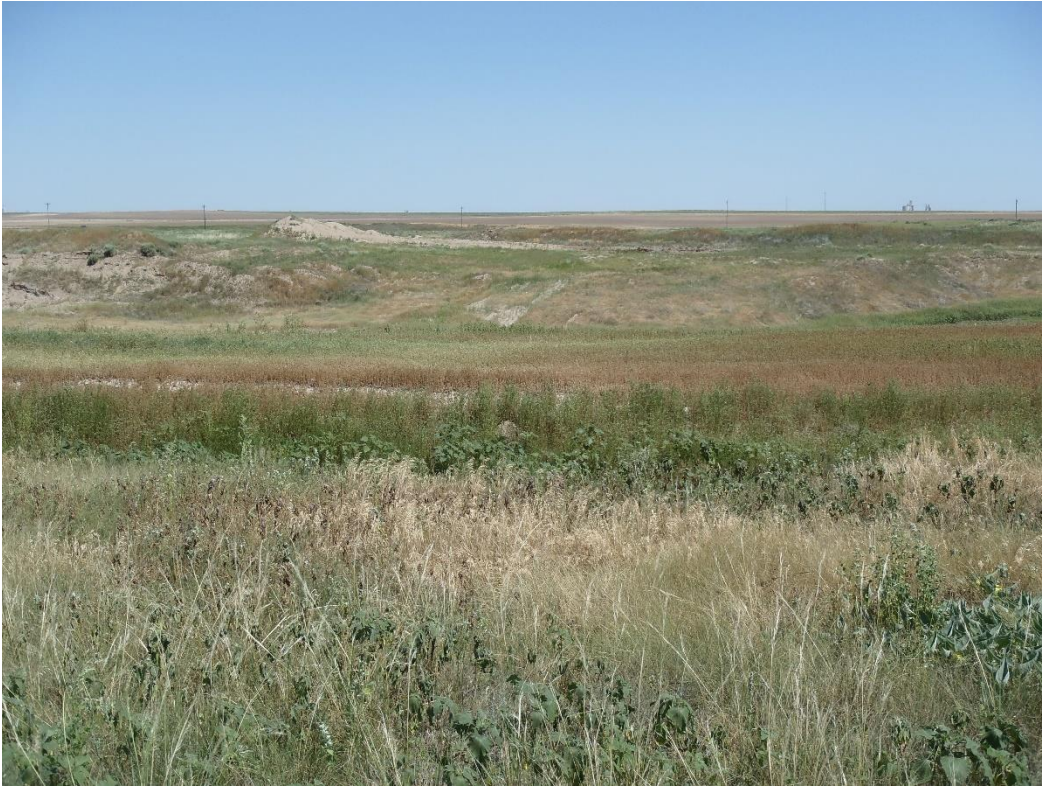
Topsoil: Topsoil stockpiles were located on the north side of the pit (see **Photo 6**).

Photo 6. Topsoil stockpiles located on north side of pit (looking NW).
