MINERALS PROGRAM INSPECTION REPORT

| MINE NAME: Henderson Mine | MINE/PROSPECTING ID#: M-1977-342 | MINERAL: Molybdenum | COUNTY: Clear Creek, Grand |
| INSPECTION TYPE: Monitoring | INSPECTOR(S): Michael A. Cunningham | INSP. DATE: May 25, 2017 | INSP. TIME: 09:00 |

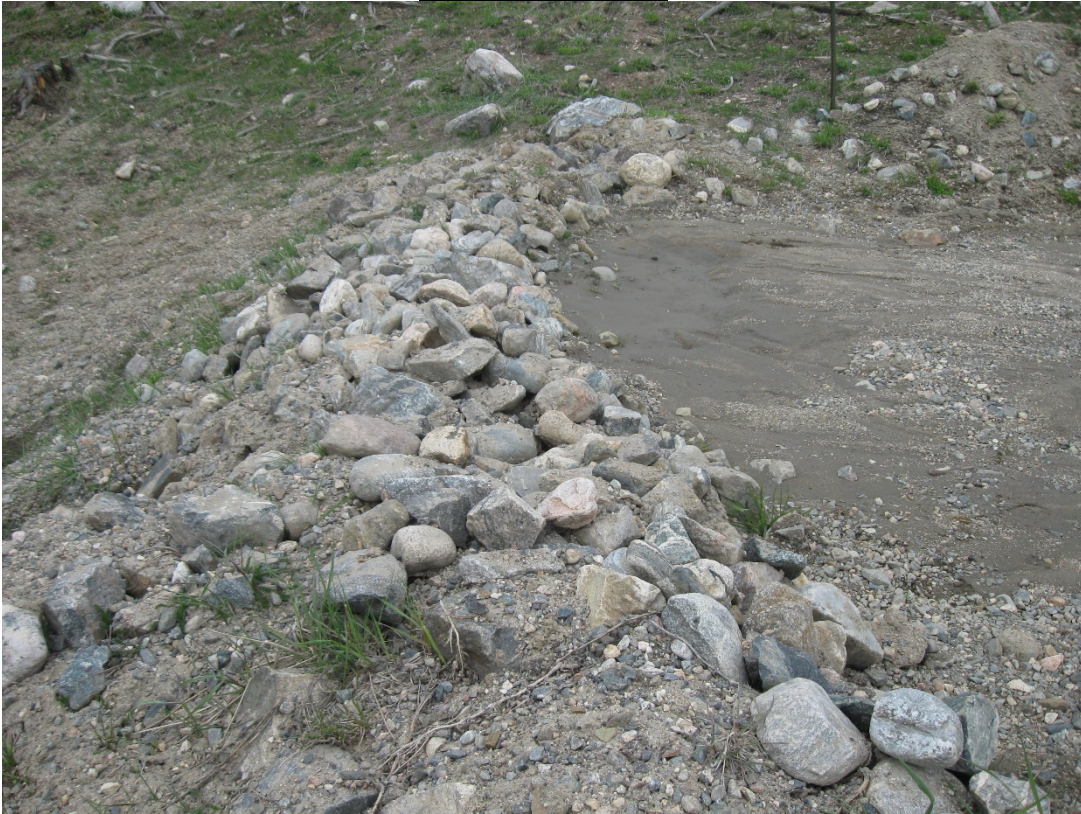
OF-M4: BMP's at this outfall location consist of rock dam. The rock dam at this outfall location had been overtopped during a runoff event. The Division observed sediment on top of and below the rock dam. The Operator will need to remove sediment from below the dam. In addition, the Operator will need to reconstruct the dam to a higher elevation to ensure it stormwater does not overtop the structure.

1. OF-M4 (Note: sediment on slope below rock dam)

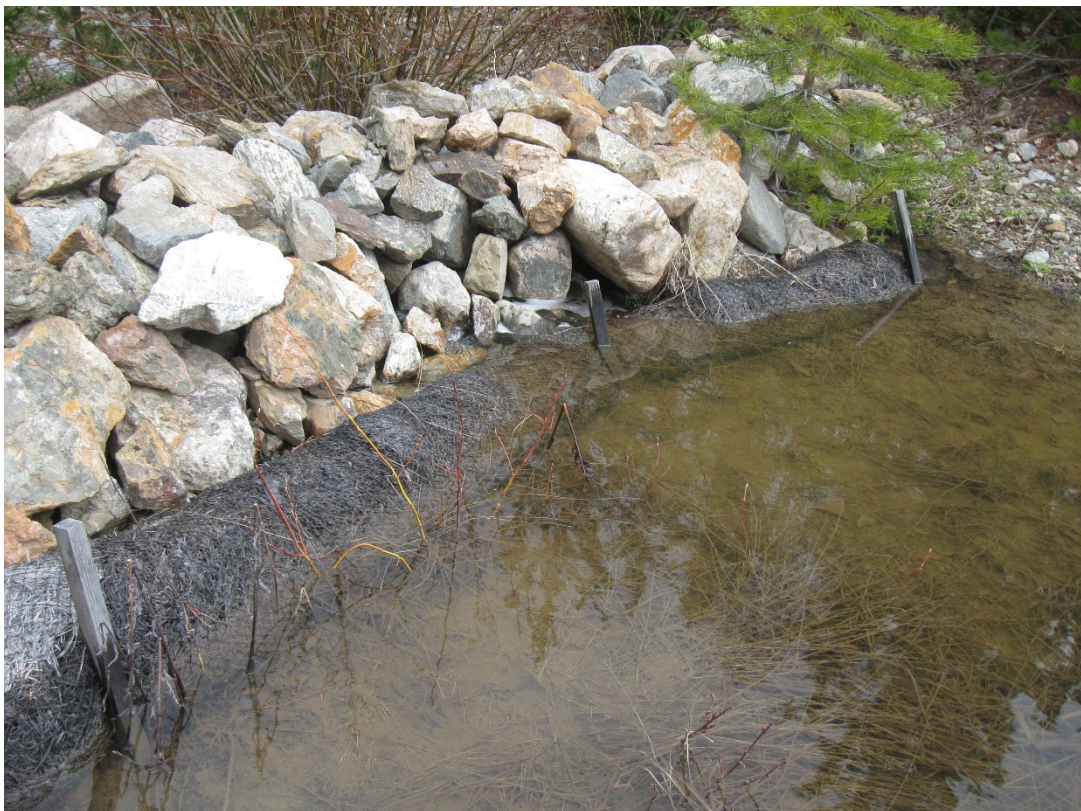
OF-M22: BMP's at this outfall location consist of straw wattles and a rock dam. Water was being discharged through this outfall at the time of the inspection. The Division observed water flowing over the top of the straw wattle. The Operator should replace the existing straw wattle and ensure the replaced straw wattle is at an adequate elevation to capture all discharging stormwater.

2. OF-M22 (Note: water flowing over top of straw wattle)

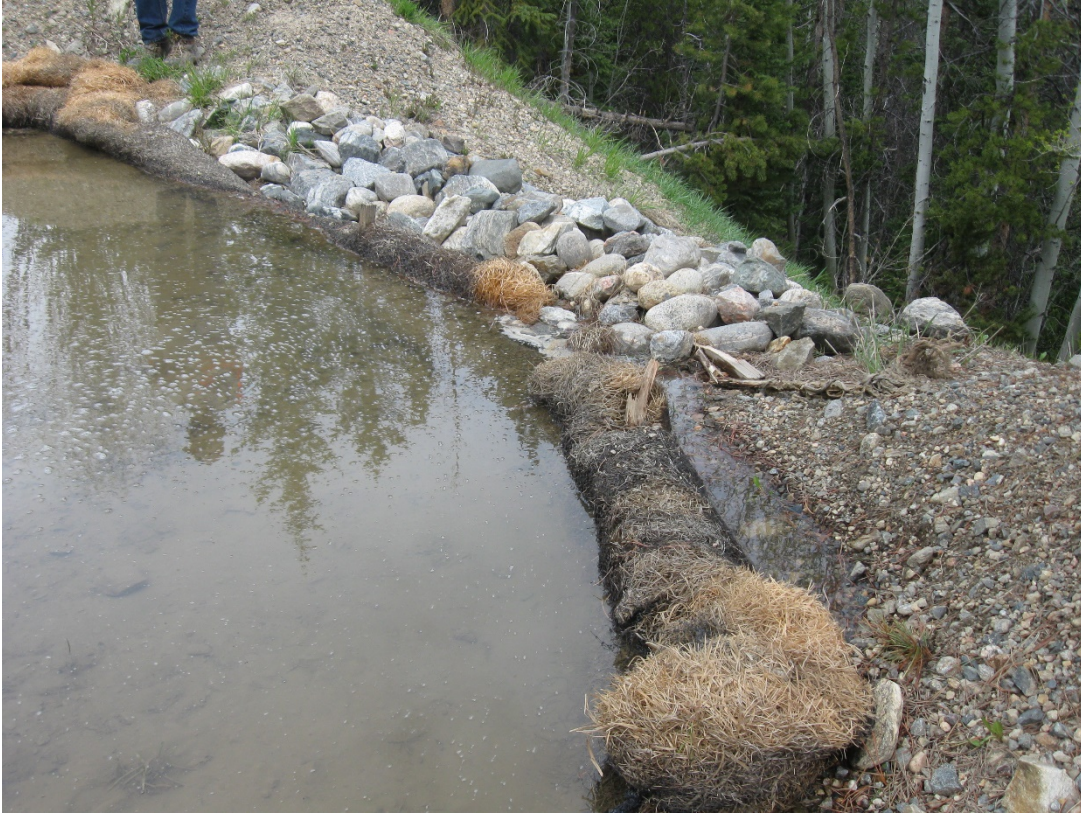
OF-M7: BMP's at this outfall location consist of straw wattles and a rock dam. Water was being discharged through this outfall at the time of the inspection. The Division observed water flowing over the top of the straw wattle. The Operator should replace the existing straw wattle and ensure the replaced straw wattle is at an adequate elevation to capture all discharging stormwater.

3. OF-M7 (Note: water flowing through straw wattle)

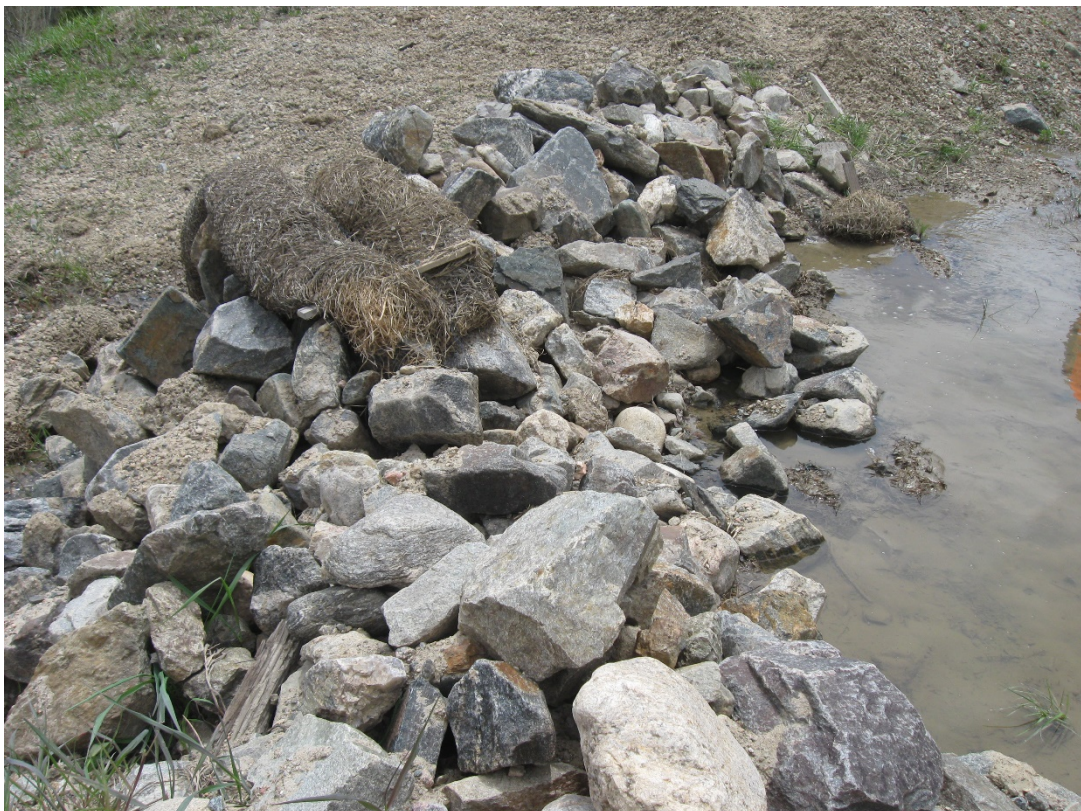
OF-M11: BMP's at this outfall location consist of straw wattles and a rock dam. Water was being discharged through this outfall at the time of the inspection. The Division observed sediment below the rock dam. In

addition, the straw wattle was no longer anchored in place and was located on top of the rock dam. The Operator should replace the existing straw wattle and ensure the replaced straw wattle is at an adequate elevation to capture all discharging stormwater.

4. OF-M11 (Note: straw wattle located on backside of the rock dam)

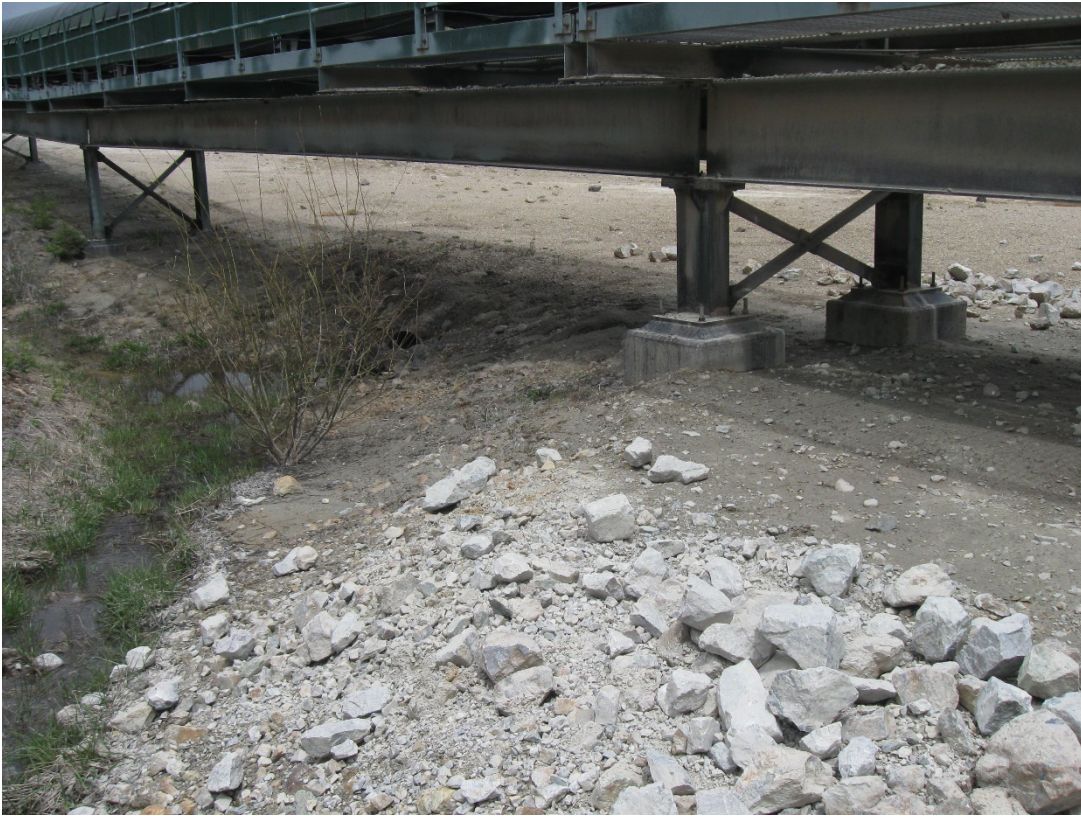
PC2/PC3 Transfer Station: BMP's at the outfall location consist of a straw wattle placed immediately in front of the outfall. The ditch which receives drainage adjacent to the conveyor line should have additional BMP's in place. The Operator should consider installing silt fencing along the portion of the ditch, which is immediately adjacent to the outfall.

5. PC2/PC3 Transfer Station (Note: additional BMP's required along ditch)

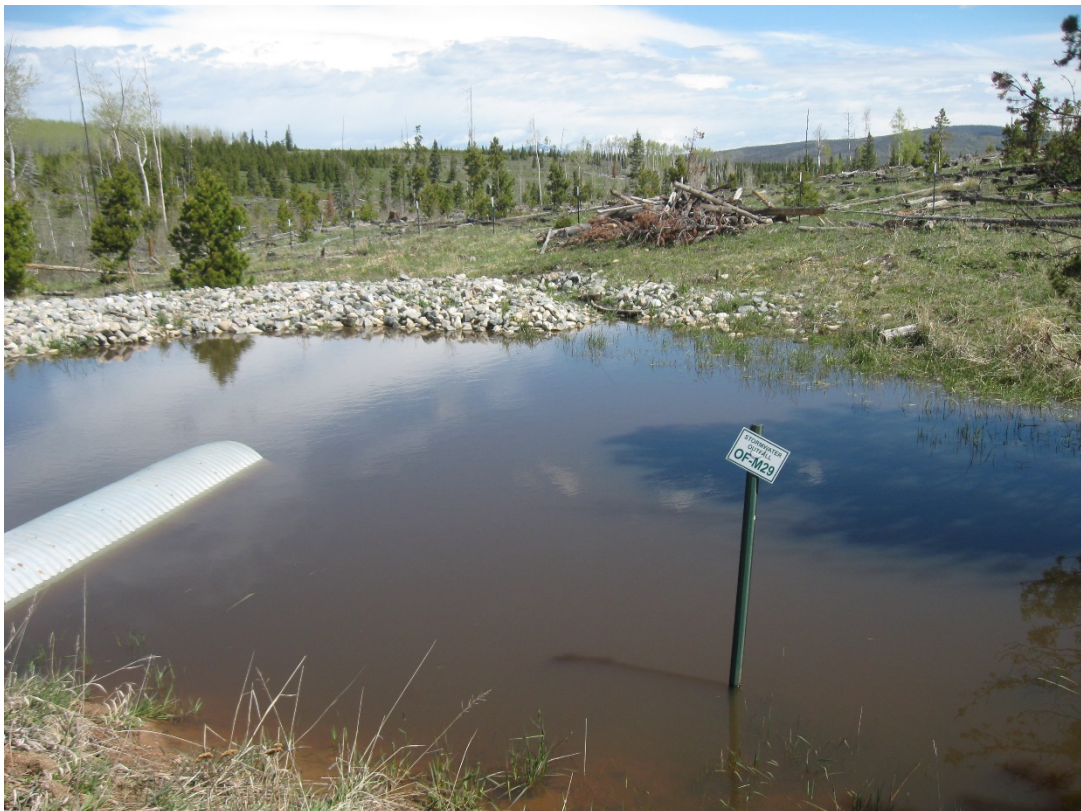
The second topsoil stockpile which was inspected was located on the north side of the tailings impoundment and was the subject of Technical Revision No. 17. The topsoil stockpile is situated within Ranger Gulch and all drainage in this area reports to OF-M29. Water was flowing through Ranger Gulch at the time of the inspection and the Division observed slightly turbid water discharging through the outfall. The topsoil stockpile did not have any BMP's around the perimeter. Under Amendment No. 6, the Operator committed to installing erosion control devices around all future topsoil stockpiles to protect the adjacent water courses. In addition, Hard Rock Rule 3.1.9 requires topsoil stockpiles to be vegetated or otherwise stabilized to protect from wind and water erosion. This matter has been cited as a problem and will require corrective action, please see the first page of this report for additional information.

6. OF-M29 (Note: turbid water discharging through outfall)

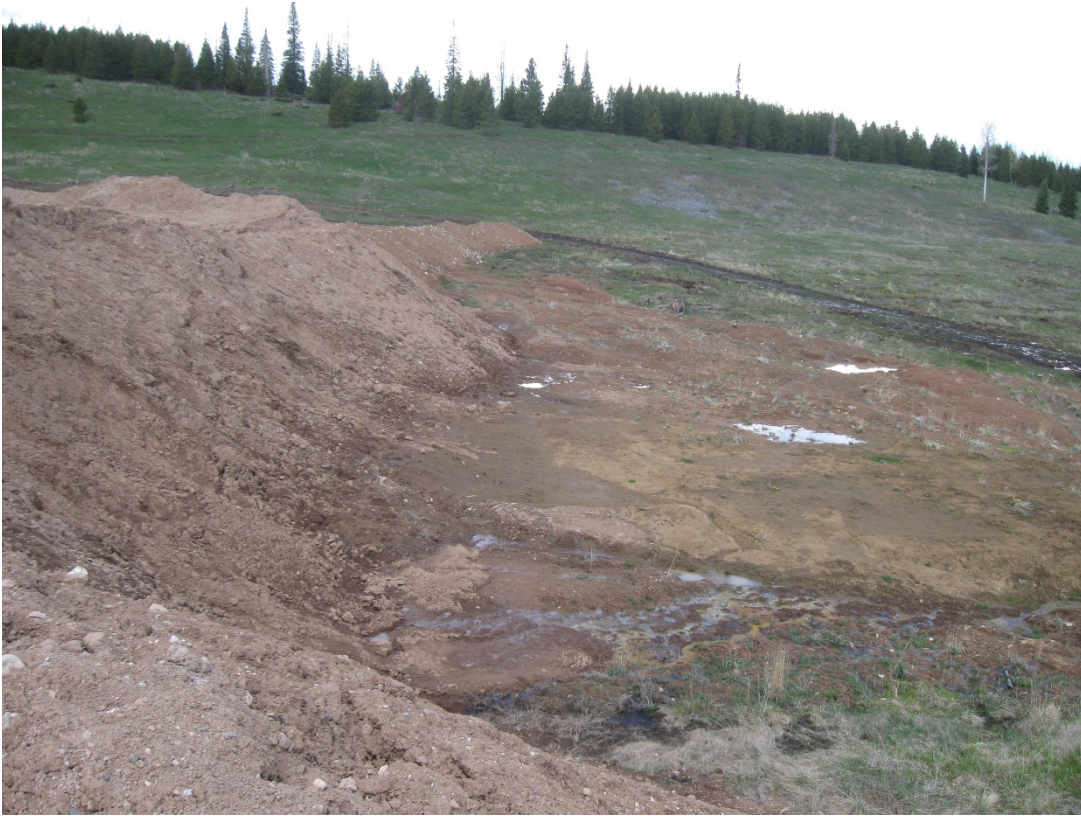
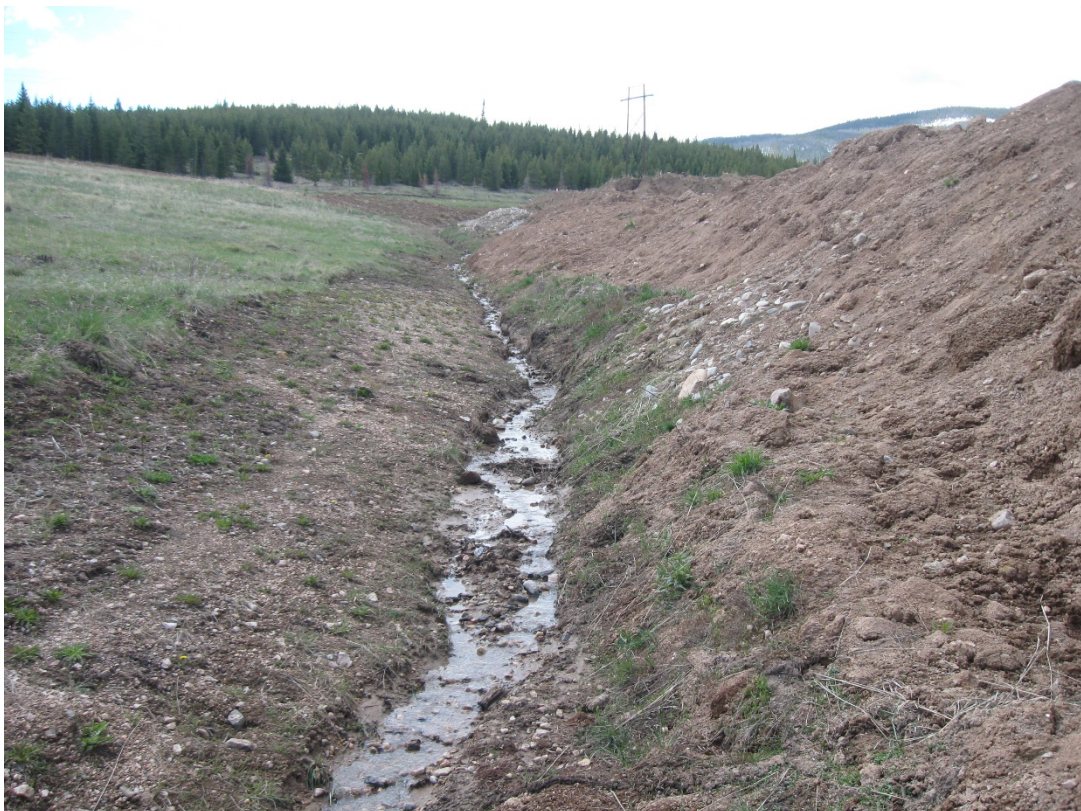
PROBLEM/POSSIBLE VIOLATION: Problem: The topsoil stockpile located north of the tailings impoundment in Ranger Gulch does not have established vegetation or adequate protection for erosion control. This is a problem pursuant to Rule 3.1.9(1) which requires topsoil stockpiles to be vegetated or otherwise stabilized to protect from wind and water erosion.

7. Ranger Gulch Topsoil Stockpile (Note: no BMP's along perimeter)

8. Ranger Gulch Topsoil Stockpile (Note: no BMP's along perimeter)

CORRECTIVE ACTIONS: The Operator shall install appropriate BMP's around the perimeter of the topsoil stockpile by the corrective action date. Proof of compliance may be in the form of photographs.
