MINERALS PROGRAM INSPECTION REPORT
PHONE: (303) 866-3567

| MINE NAME: Henderson Mine | MINE/PROSPECTING ID#: M-1977-342 | MINERAL: Molybdenum | COUNTY: Clear Creek, Grand |
| INSPECTION TYPE: Monitoring | INSPECTOR(S): Peter S. Hays | INSP. DATE: June 22, 2017 | INSP. TIME: 10:00 |

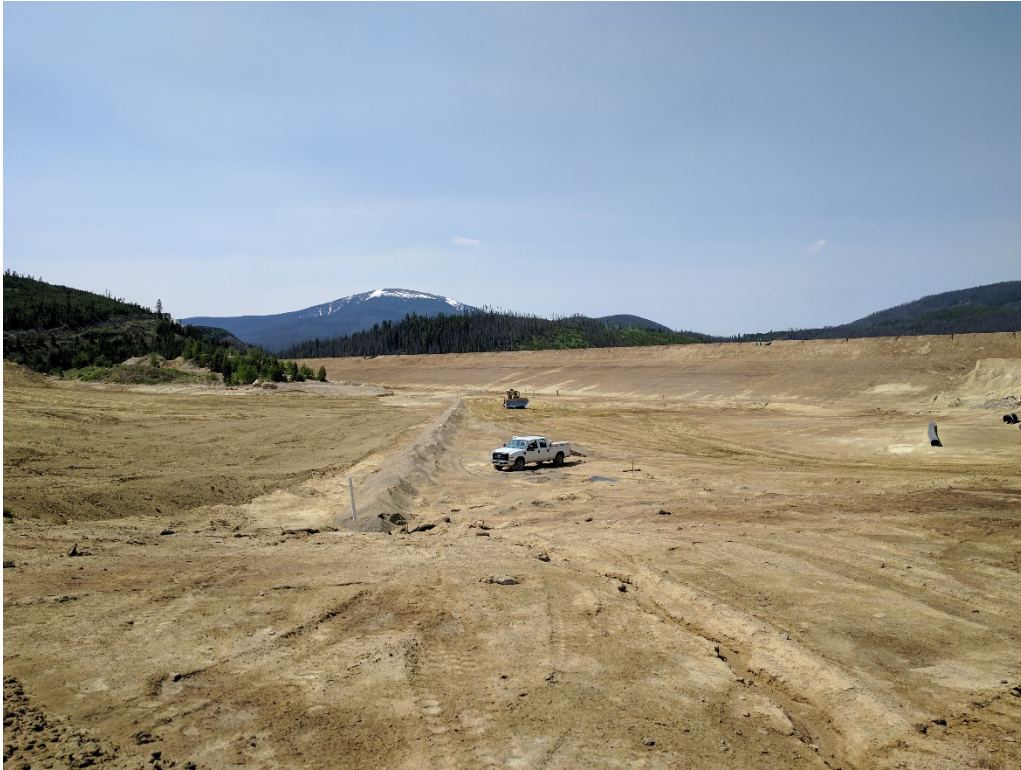
The 3-Dam embankment regrading project was ongoing during the inspection. The project started on June 8, 2017 and is expected to be complete in early July. The slope regrading was progressing from north to south instead of the planned south to north. Approximately one third (1/3) of the embankment regrading was complete at the time of the inspection. Two dozers were working in tandem to regrade the embankment. The first dozer excavated material from the toe of the slope to the crest to rough grade. The second dozer, which was GPS controlled, completed the excavation at the finished grade for the embankment. The excess embankment material was stockpiled above the embankment crest. A front-end loader loaded the excess material into a haul truck. The haul truck transported the material to the setback bench. The material was placed on the bench in eight (8) inch lifts by a D8 dozer. The material was compacted by the dozer using a process method with moisture control to aid in compaction. Henderson stated there have not been changes in the piezometer readings in the embankment with the added ground pressure from the dozers and haul truck. The piezometer elevations will be reset following the completion of the regrading work.

View of the placement of the excess material from the 3 Dam embankment on the setback bench

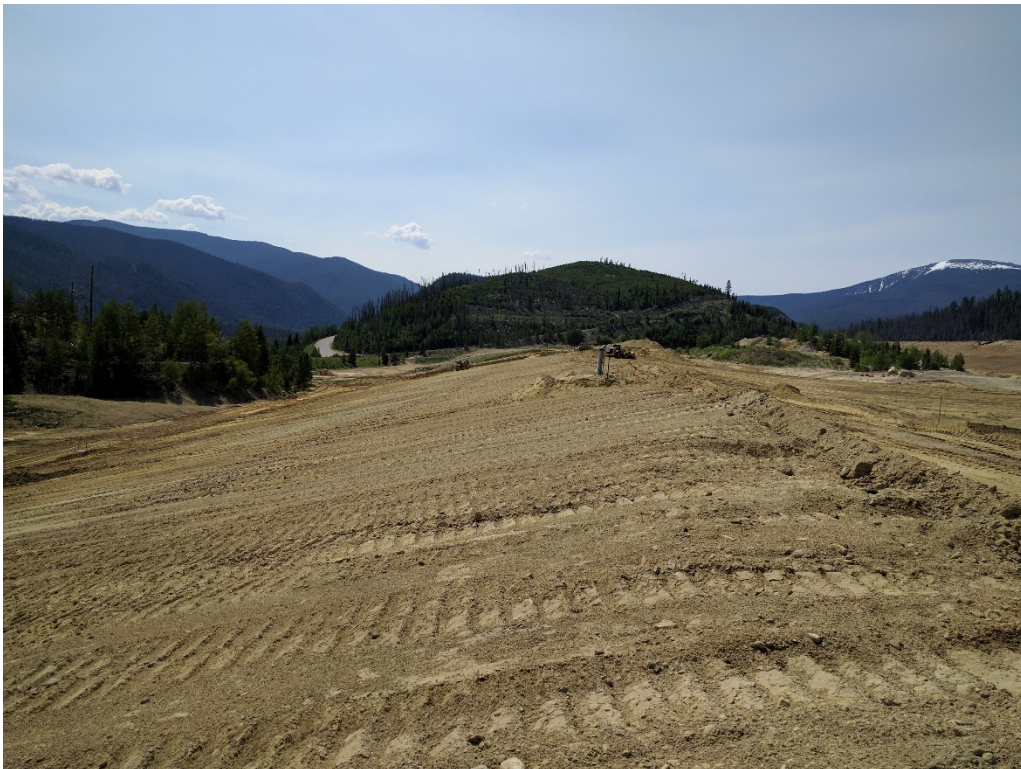
View of the regraded 3 Dam embankment from the north end looking south

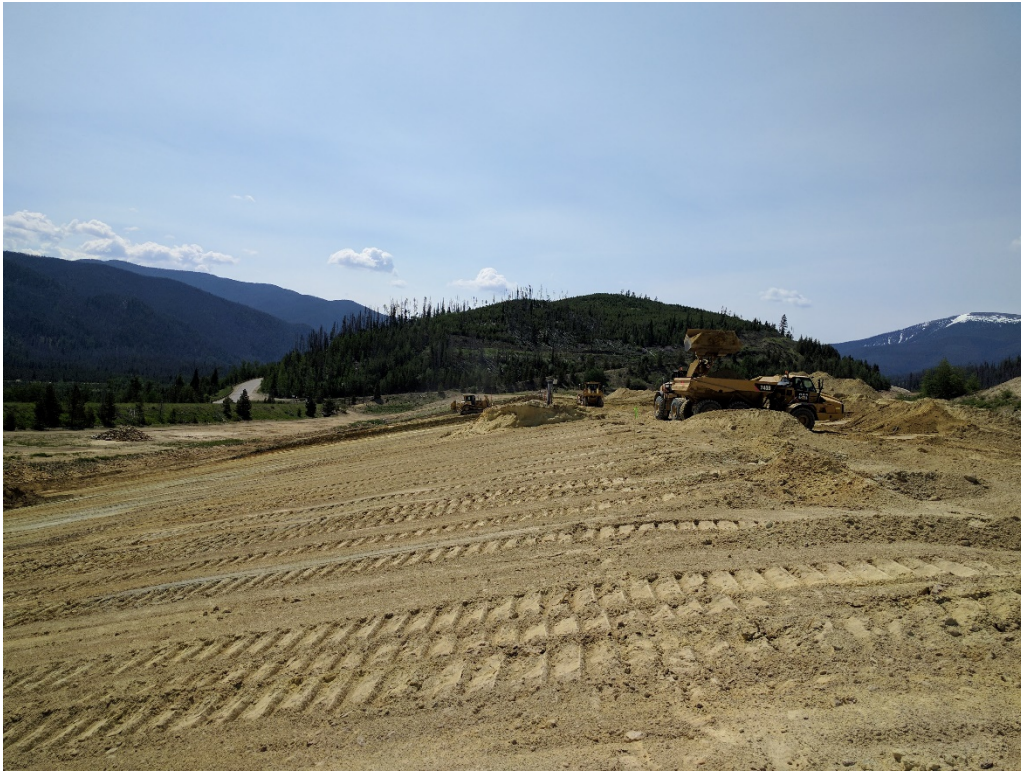
View of the regrading of the 3 Dam embankment looking south

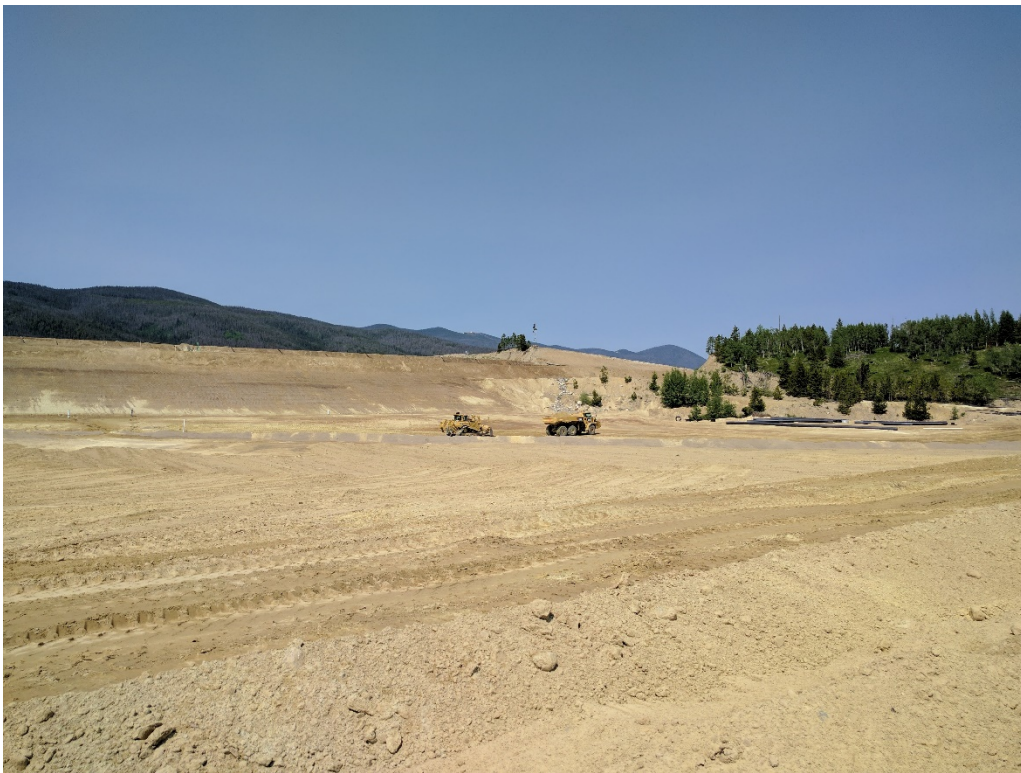
View of the placement of the excess material from the 3 Dam embankment on the setback bench

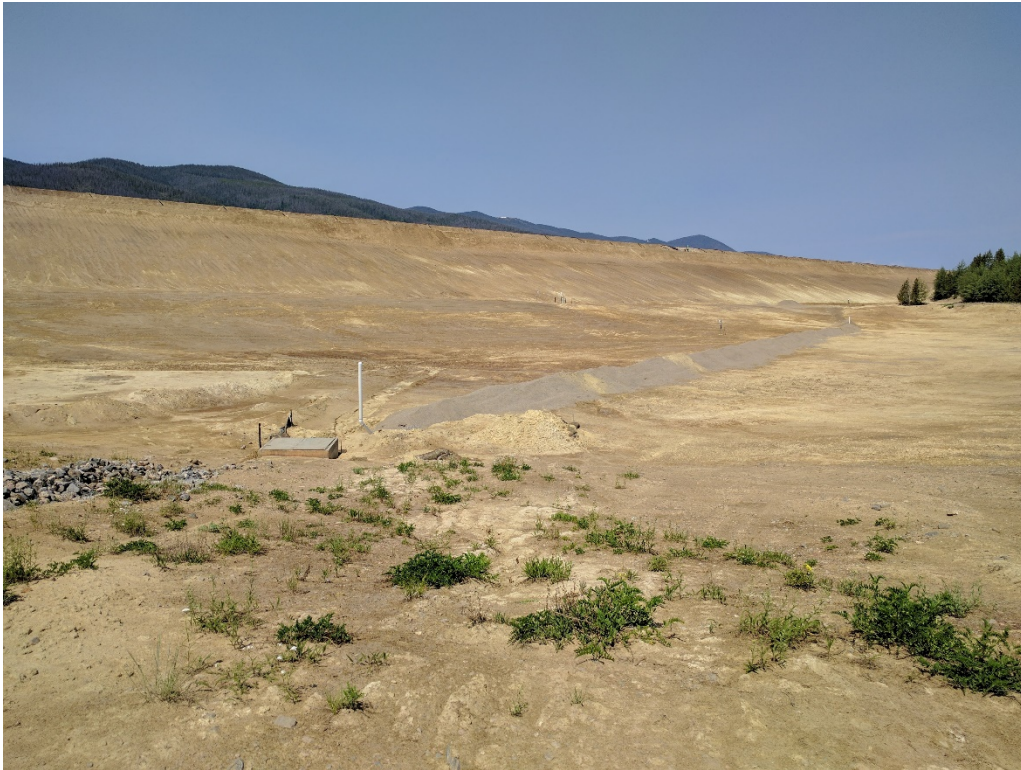
View of the southern portion of the setback bench from the SE corner of the bench

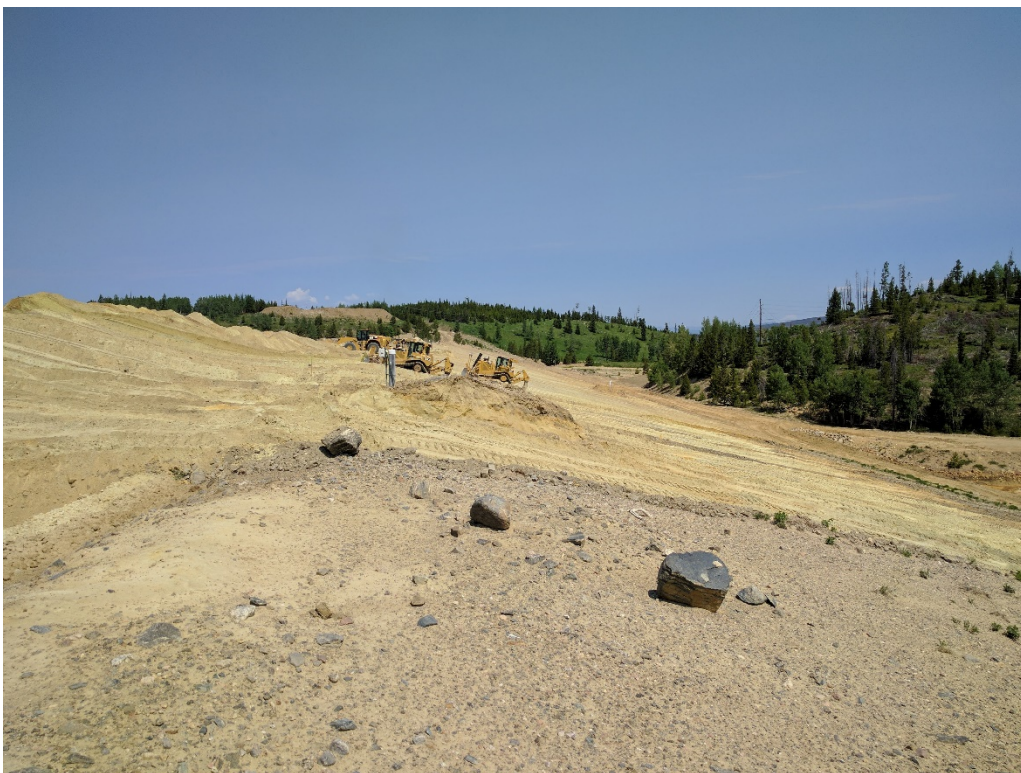
View of the regrading of the 3 Dam embankment looking north

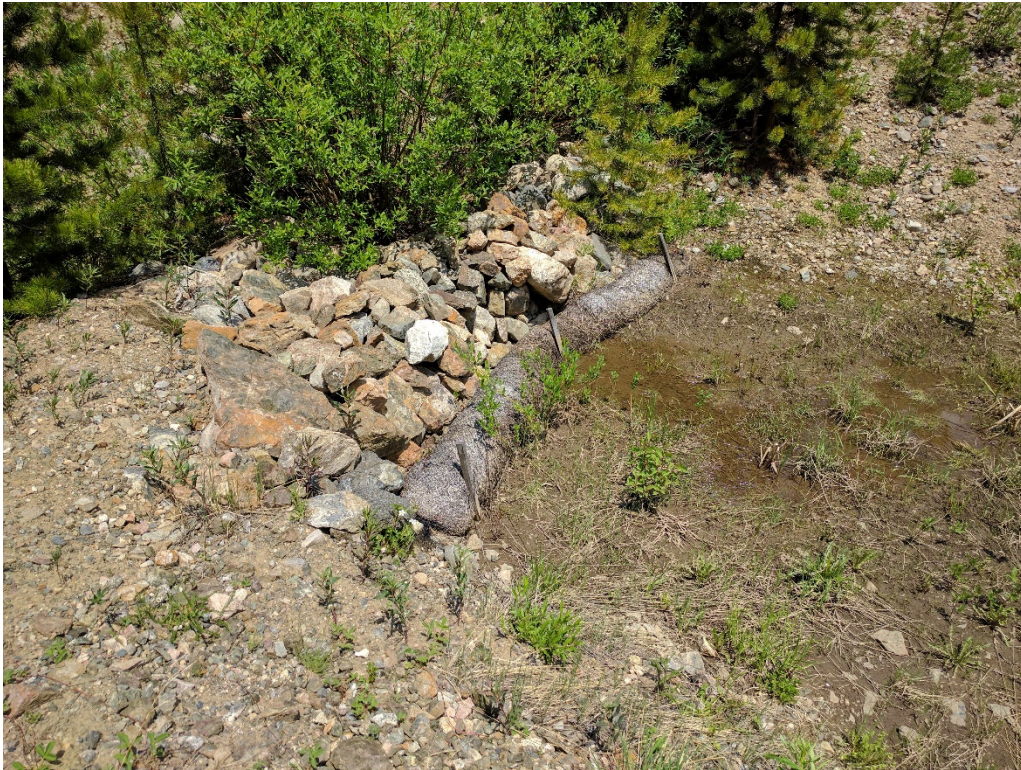
Stormwater Outfall OF-M22

OF-M22: BMP's at this outfall location consist of straw wattles and a rock dam. Water was being discharged through this outfall at the time of the inspection. The Division observed water flowing over the top of the straw wattle. The Operator should replace the existing straw wattle and ensure the replaced straw wattle is at an adequate elevation to capture all discharging stormwater.

Water was being discharged through the outfall at the time of the inspection. The water level had dropped since the May inspection to below the elevation of the straw wattle. Henderson plans to add an additional wattle to this outfall.

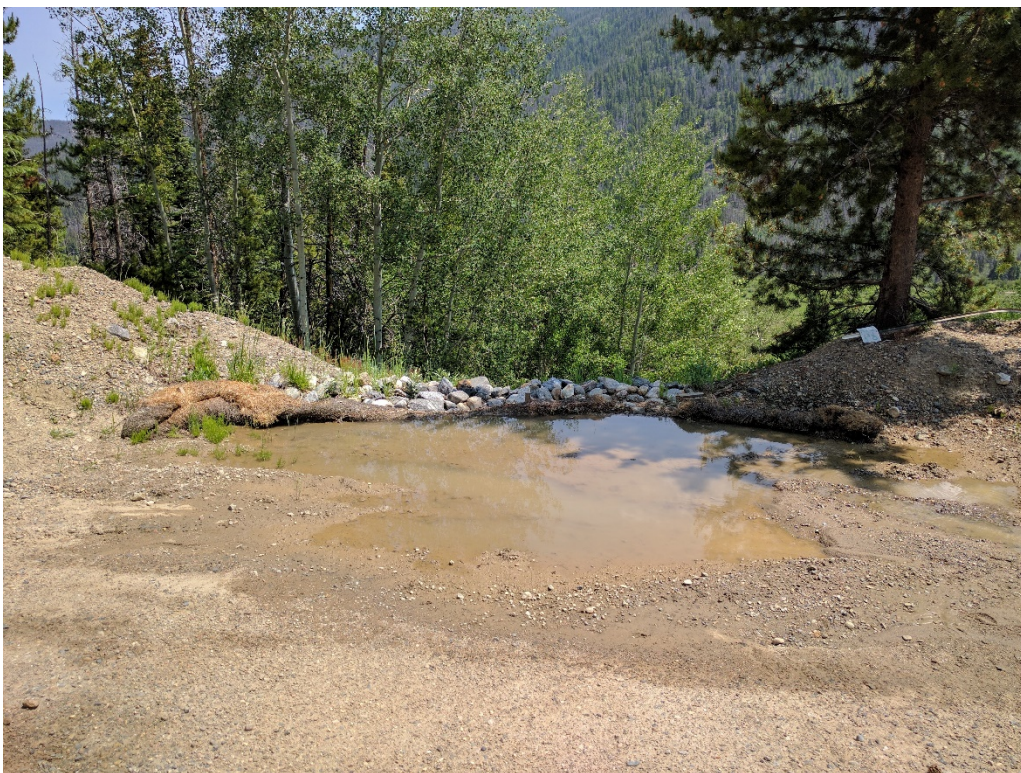
Stormwater Outfall OF-M7

OF-M7: BMP's at this outfall location consist of straw wattles and a rock dam. Water was being discharged through this outfall at the time of the inspection. The Division observed water flowing over the top of the straw wattle. The Operator should replace the existing straw wattle and ensure the replaced straw wattle is at an adequate elevation to capture all discharging stormwater.

Water was being discharged through the outfall at the time of the inspection. The water level had dropped since the May inspection to the elevation of the straw wattle.

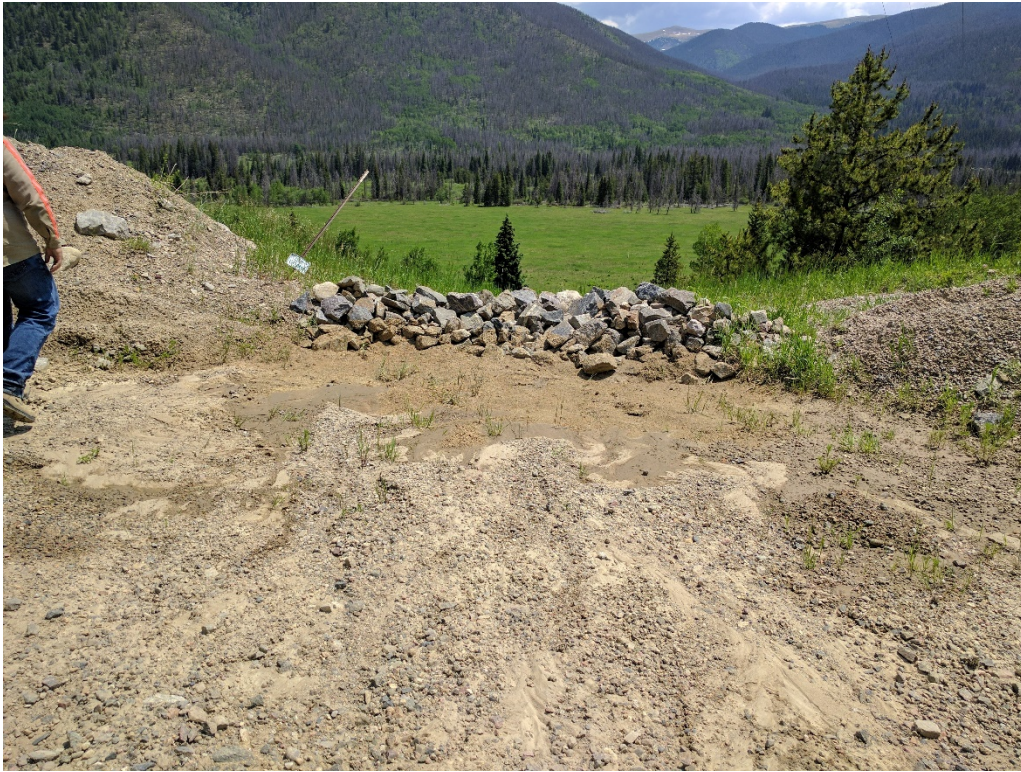
Stormwater Outfall OF-M11

OF-M11: BMP's at this outfall location consist of straw wattles and a rock dam. Water was being discharged through this outfall at the time of the inspection. The Division observed sediment below the rock dam. In addition, the straw wattle was no longer anchored in place and was located on top of the rock dam. The Operator should replace the existing straw wattle and ensure the replaced straw wattle is at an adequate elevation to capture all discharging stormwater.

Water was not being discharged through the outfall at the time of the inspection. The water level had dropped since the May inspection. Sediment captured behind the outfall was observed.

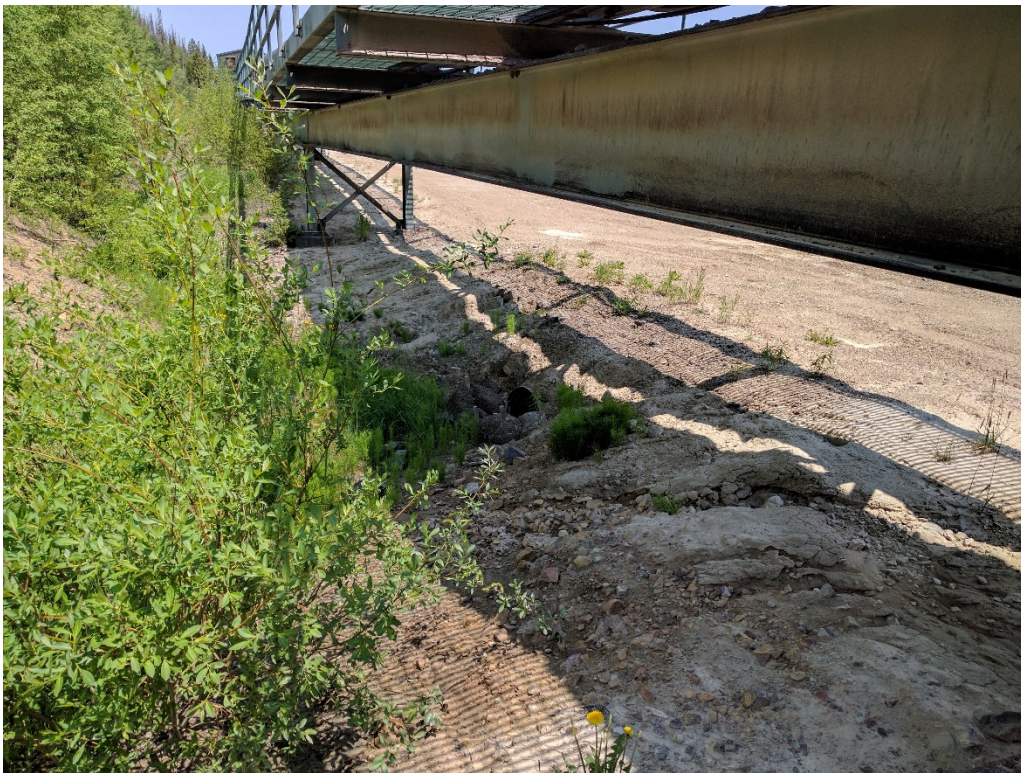
PC2/PC3 Transfer Station Outfall

PC2/PC3 Transfer Station: BMP's at the outfall location consist of a straw wattle placed immediately in front of the outfall. The ditch which receives drainage adjacent to the conveyor line should have additional BMP's in place. The Operator should consider installing silt fencing along the portion of the ditch, which is immediately adjacent to the outfall.

This outfall was unchanged since the May inspection.

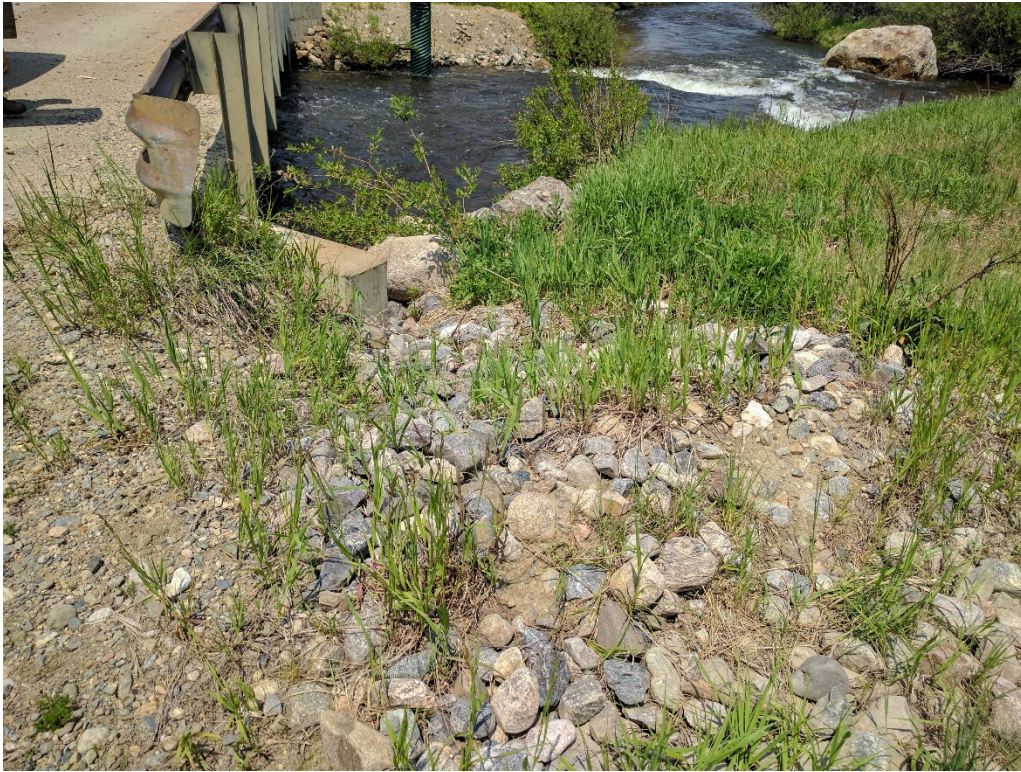
Stormwater Outfall OF-M15

OF-M15 is located by the south gate of the laydown yard. The outfall was dry and appeared to be functioning properly.

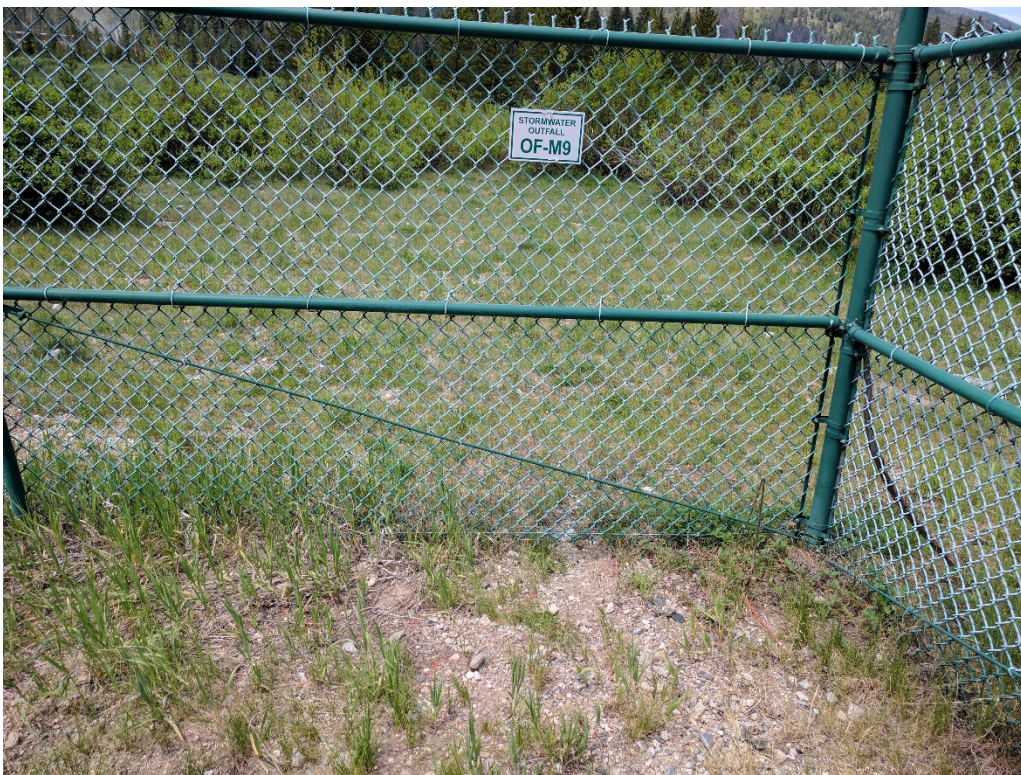
Stormwater Outfall OF-M9

OF-M9 is located in the northwest corner of the laydown yard. The outfall was dry and appeared to be functioning properly.

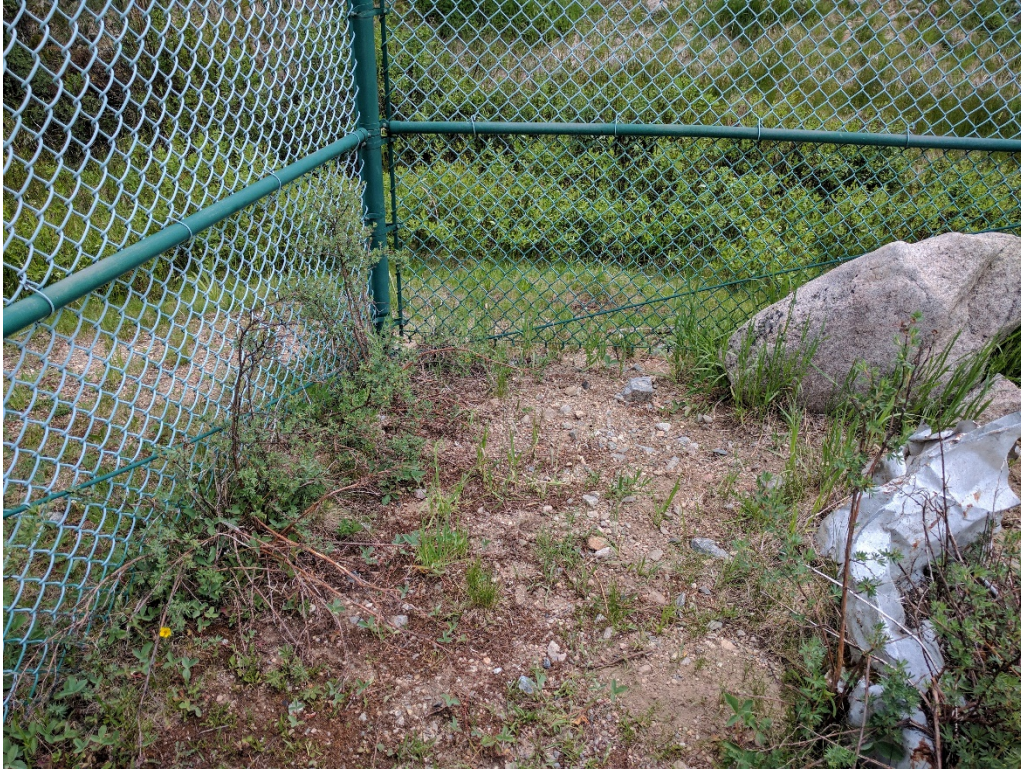
Stormwater Outfall OF-M16

OF-M16 is located in the northeast corner of the laydown yard. The outfall was dry and appeared to be functioning properly.

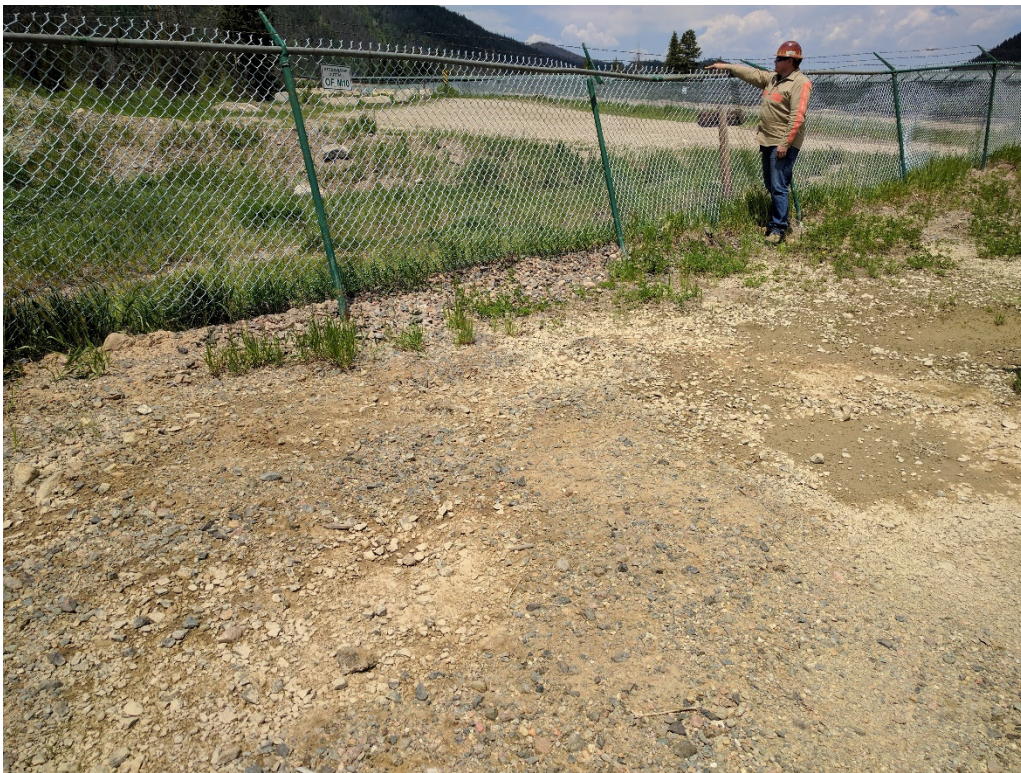
Stormwater Outfall OF-M10

OF-M10 is located along the east fence line in the south portion of the laydown yard. The outfall was dry and appeared to be functioning properly. Areas of damp ground were observed behind the outfall. Henderson stated stormwater evaporates in the yard prior to reaching the outfall.

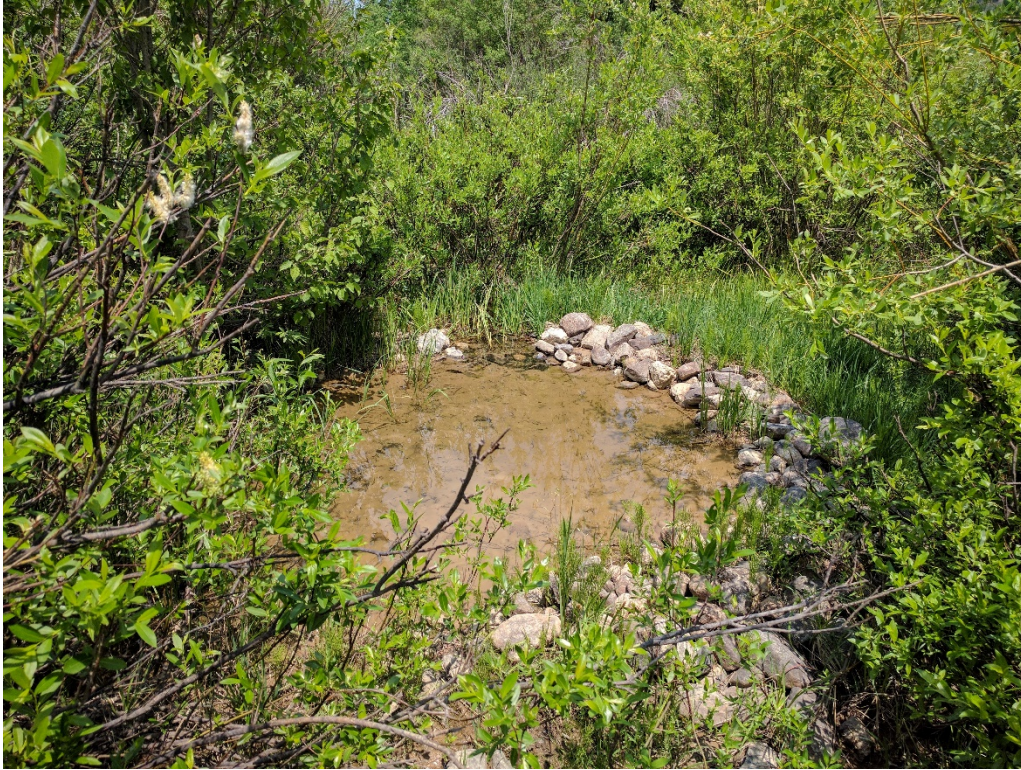
Stormwater Outfall OF-M8

OF-M8 is located below and northeast of the PC1/PC2 transfer station. The BMP's at this outfall location consist of circular rock dam with a notch in the dam serving as the outlet. Water was being discharged through this outfall at the time of the inspection. The outfall was partially filled with sediment and needs to be cleaned out.

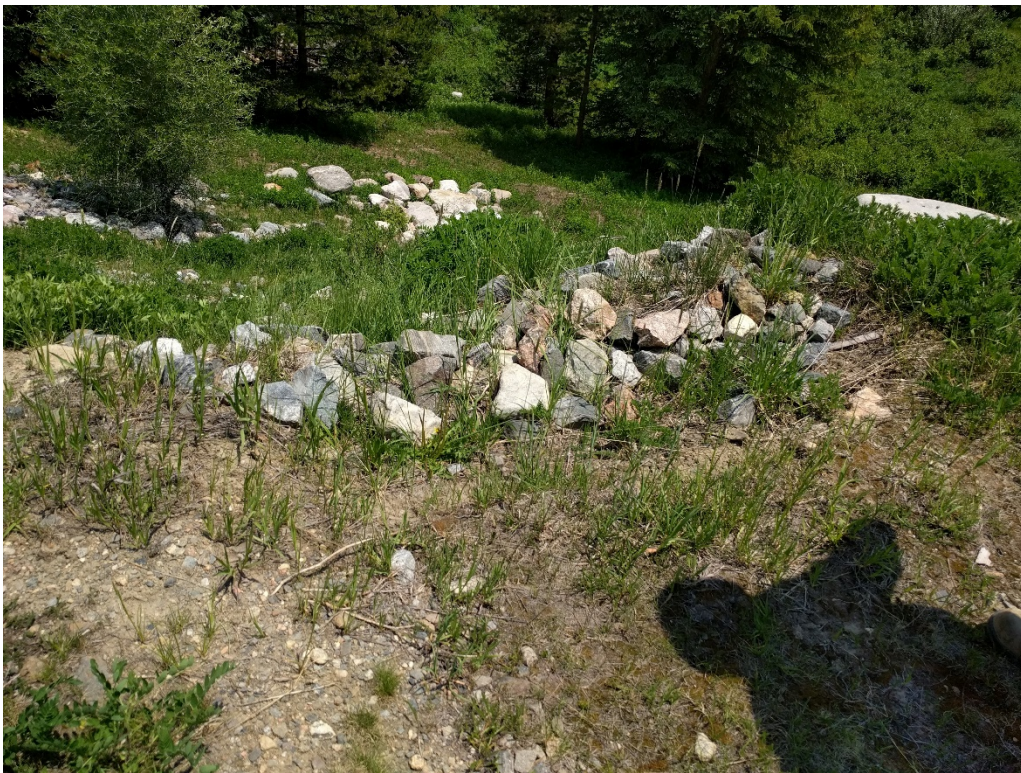
Stormwater Outfall OF-M18

OF-M18 was dry and appeared to be functioning properly.
