COLORADO Division of Reclamation, Mining and Safety Department of Natural Resources

MINERALS PROGRAM INSPECTION REPORT PHONE: (303) 866-3567

MINE NAME:		MINE/PROSPECTING ID#:	MINERAL:	COUNTY:
Henderson Mine		M-1977-342	Molybdenum	Clear Creek, Grand
INSPECTION TYPE:		INSPECTOR(S):	INSP. DATE:	INSP. TIME:
Monitoring		Peter S. Hays	May 25, 2017	09:00
OPERATOR:		OPERATOR REPRESENTATIVE:	TYPE OF OPERATION:	
Climax Molybdenum Company		Miguel Hamarat	112d-3 - Designated Mining Operation	
REASON FOR INSPECTION:		BOND CALCULATION TYPE:	BOND AMOUNT:	
Normal I&E Program		Partial Bond	\$37,993,785.00	
DATE OF COMPLAINT:		POST INSP. CONTACTS:	JOINT INSP. AGENCY:	
NA		None	None	
WEATHER:	INSPECTOR'S SIGNATURE:		SIGNATURE DATE:	
Clear	July 18, 2017

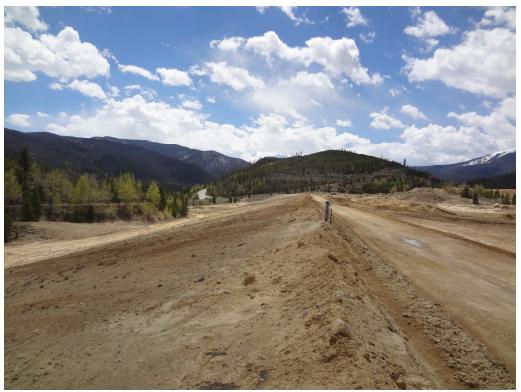
View of lower 3-Dam embankment from north end looking south

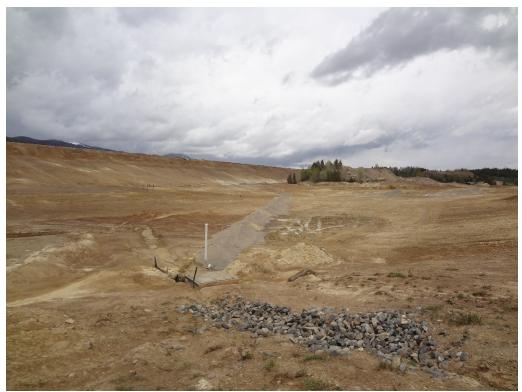
On March 1, 2017, Henderson submitted a technical revision to regrade the original 3 Dam embankment to 4H:1V to increase the long term stability of the tailings impoundment. Technical revision no. 27 (TR-07) was approved by the Division on April 10, 2017. The regrading work is expected to begin on June 6, 2017 and take 2 months to complete. A French drain was installation on both sides of the setback bench in advance of the lower embankment regrading work. The excess material for the embankment regrading will be placed on the bench. The French drains are required to ensure proper drainage on the bench.

View of French drain on the southern portion of the 3-Dam stepback bench

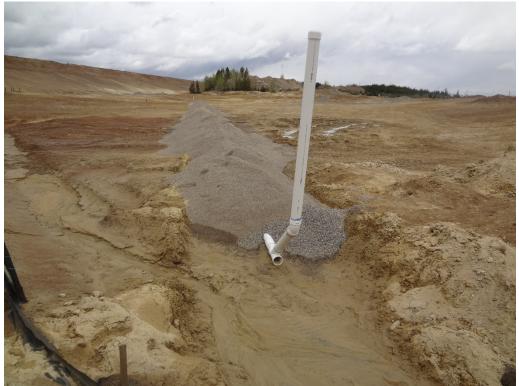
View of French drain on the southern portion of the 3-Dam stepback bench

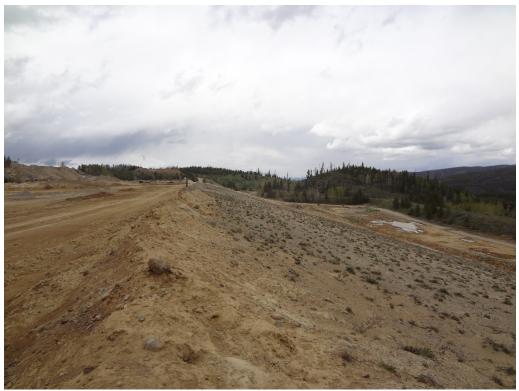
View of lower 3-Dam embankment from south end looking north
