MINERALS PROGRAM INSPECTION REPORT
PHONE: (303) 866-3567

MINE NAME: Mendenhall Pit	MINE/PROSPECTING ID#: M-2004-027	MINERAL: Sand and gravel	COUNTY: Otero
INSPECTION TYPE: Monitoring	INSPECTOR(S): Amy Eschberger	INSP. DATE: June 29, 2017	INSP. TIME: 10:50
OPERATOR: Otero County	OPERATOR REPRESENTATIVE: Lex Nichols	TYPE OF OPERATION: 112c - Construction Regular Operation	
REASON FOR INSPECTION: Normal I&E Program	BOND CALCULATION TYPE: None	BOND AMOUNT: \$0.00	
DATE OF COMPLAINT: NA	POST INSP. CONTACTS: None	JOINT INSP. AGENCY: None	
WEATHER: Clear	INSPECTOR'S SIGNATURE:

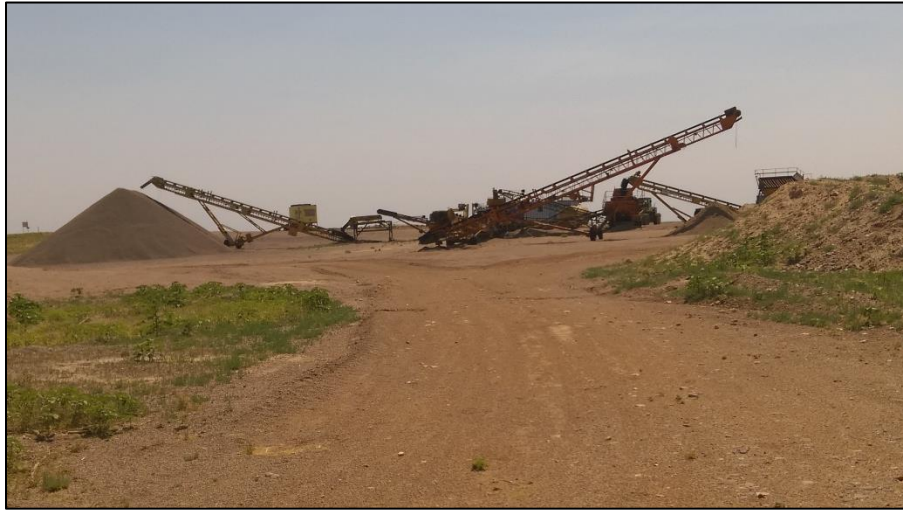
Photo 1. View looking east at mobile processing plant located in north-central portion of permit area.

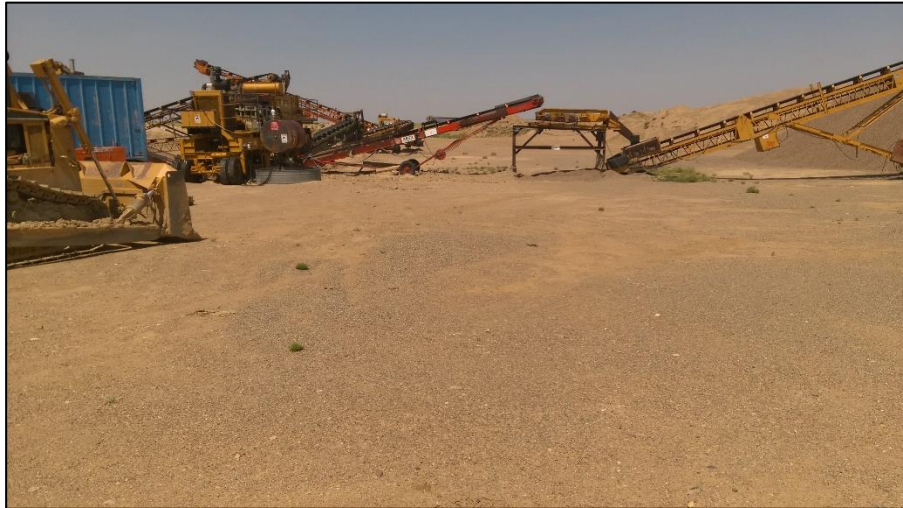
Photo 2. Closer view of mobile processing plant located in north-central portion of permit area.

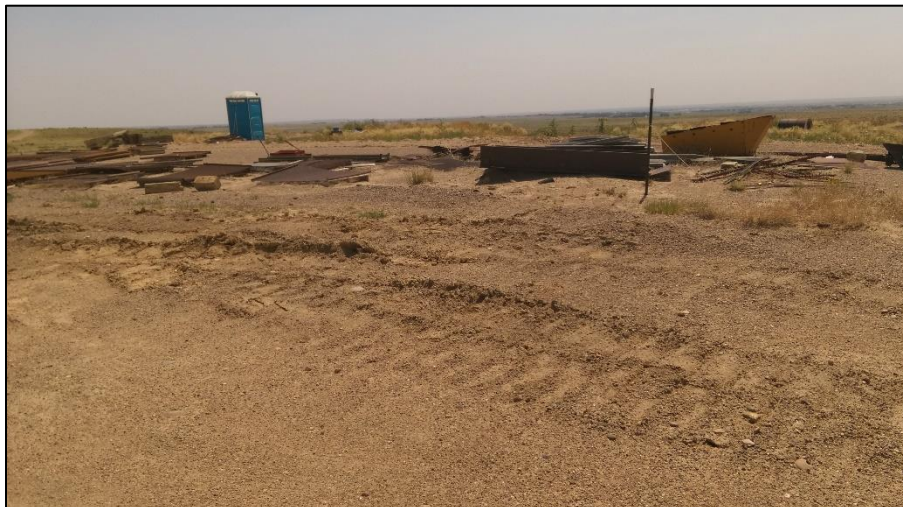
Photo 3. View of small equipment storage area located in northeastern corner of permit area.

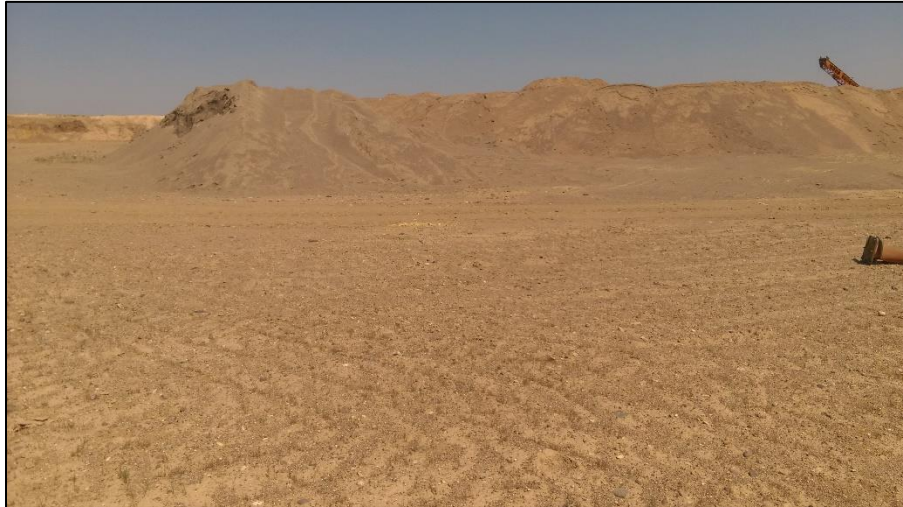
Photo 4. View looking west at material stockpile stored in central portion of permit area.

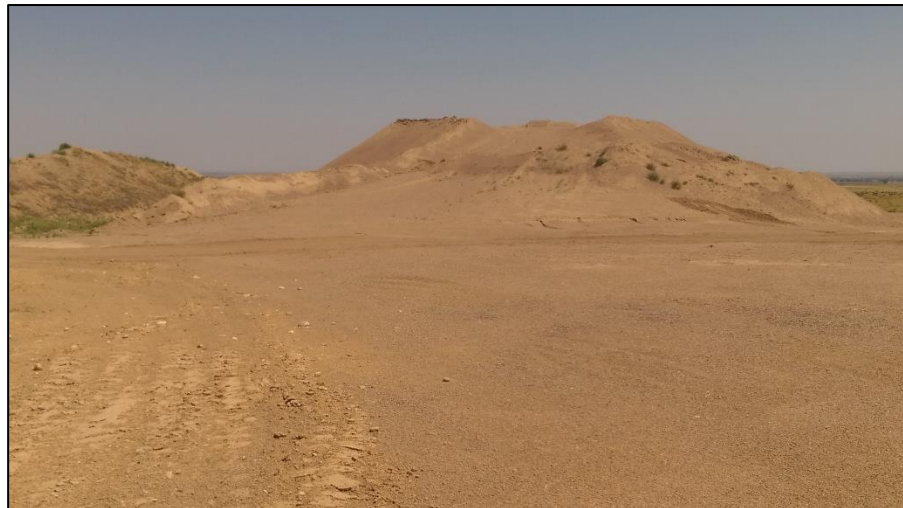
Photo 5. View looking north at material stockpile stored in northwestern portion of permit area.

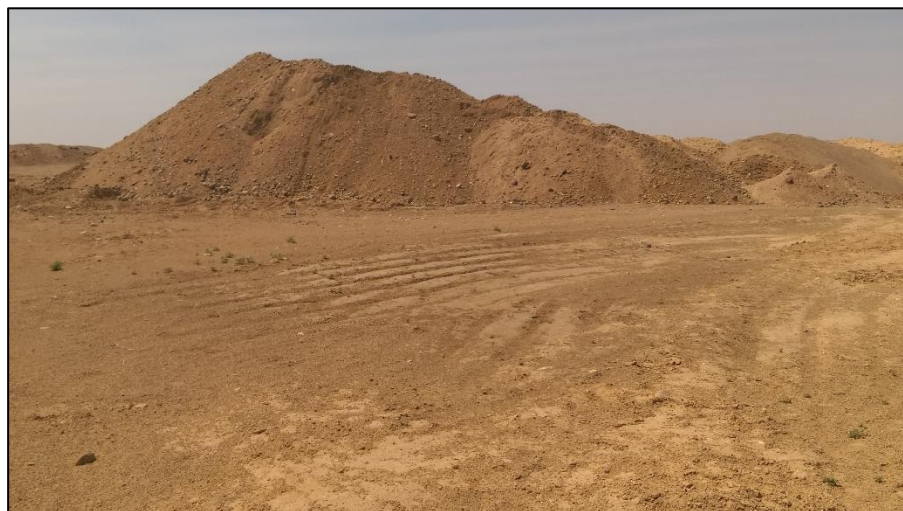
Photo 6. View looking west at material stockpile stored in western portion of permit area.

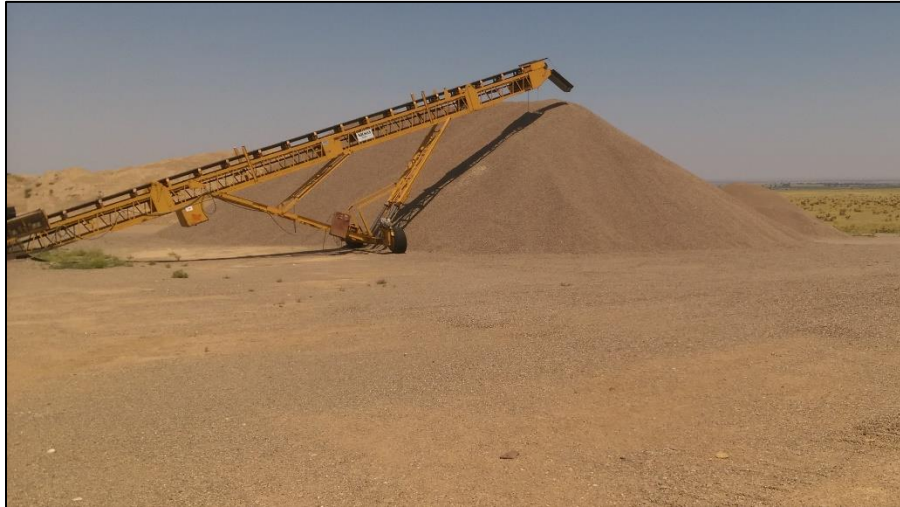
Photo 7. View looking west at material stockpile stored in central portion of permit area.

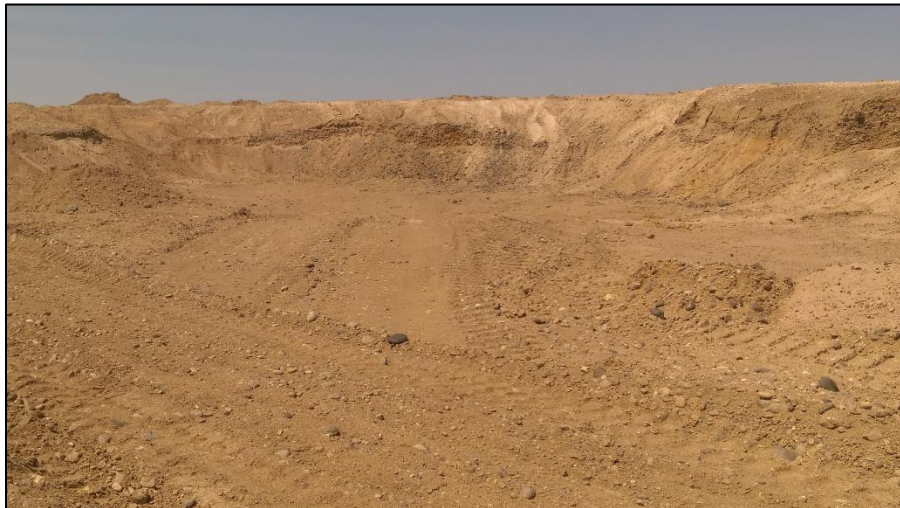
Photo 8. View looking west at southern portion of active mining face along western edge of pit.

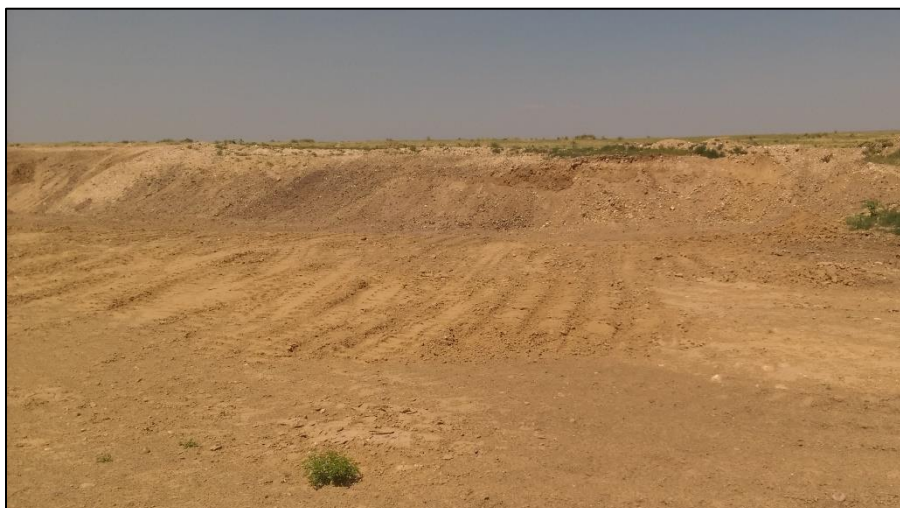
Photo 9. View looking west at northern portion of active mining face along western edge of pit.

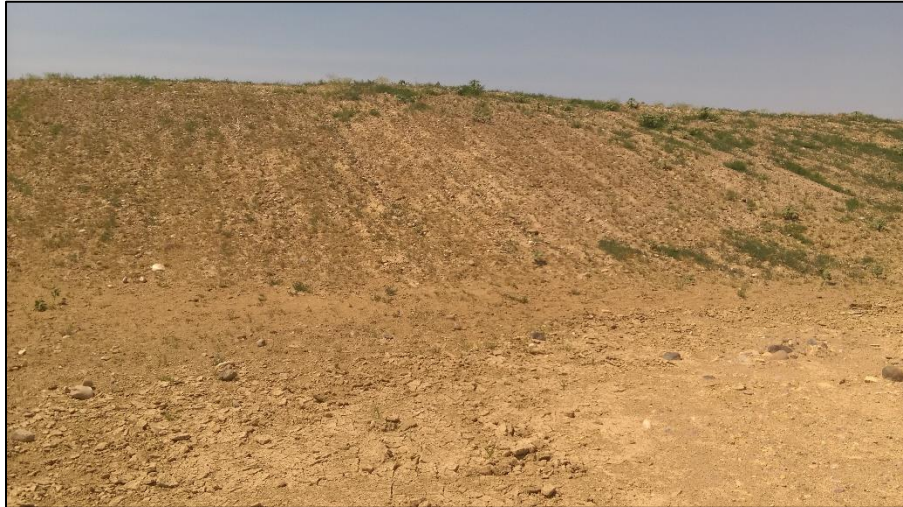
The southern pit wall (**Photos 10 and 11**) was graded to the final approved slope gradient of 3H:1V and seeded in fall of 2016. The eastern portion was graded flatter than 3H:1V. The Division observed some early grass growth along the southern pit wall mixed with annual weeds. It appeared the revegetation of this area was off to a good start. The eastern portion of disturbance (**Photos 12-18**) was graded to slope gradients of 4H:1V or flatter, retopsoiled, and seeded in spring of 2017. The slopes of this area blend well with surrounding topography. The Division observed mainly annual weeds growing in this area at this time. However, since the area was just seeded this spring, it may take a few more growing seasons before grasses are really coming in. The operator should continue to monitor the growth of desired vegetation in areas under reclamation, and implement the weed control plan as necessary so grasses have a chance to establish. The Division estimates approximately 4.8 acres of disturbance is in reclamation, including the eastern portion of the site and the southern pit wall. The Division observed a few topsoil stockpiles stored at the northwestern and western edges of the pit which appeared to be stable (**Photos 19 and 20**). Most likely, the operator will need to import additional topsoil for reclamation of remaining disturbed areas, as allowed by the approved reclamation plan.

Photo 10. View looking south at southern pit wall in reclamation. Slope has been graded to 3H:1V and seeded.

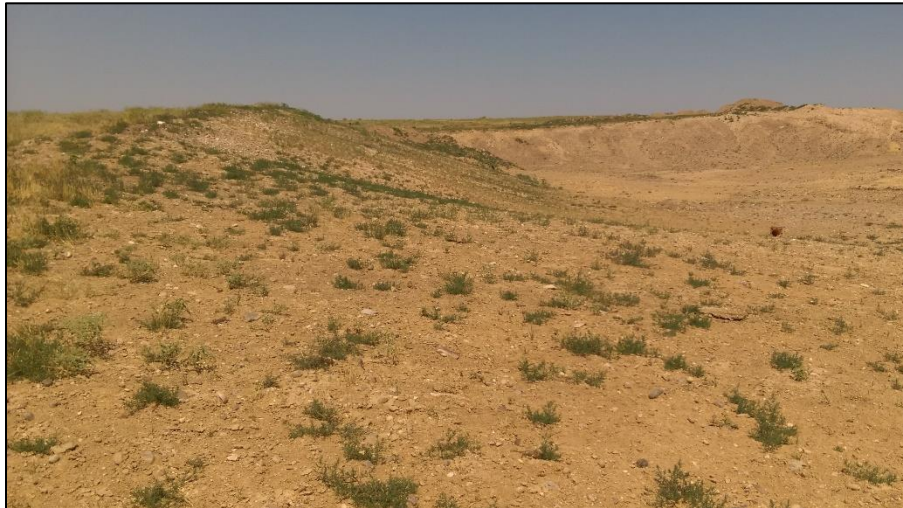
Photo 11. View looking west at southern pit wall in reclamation, showing slope has been graded to 3H:1V (flatter along eastern portion).

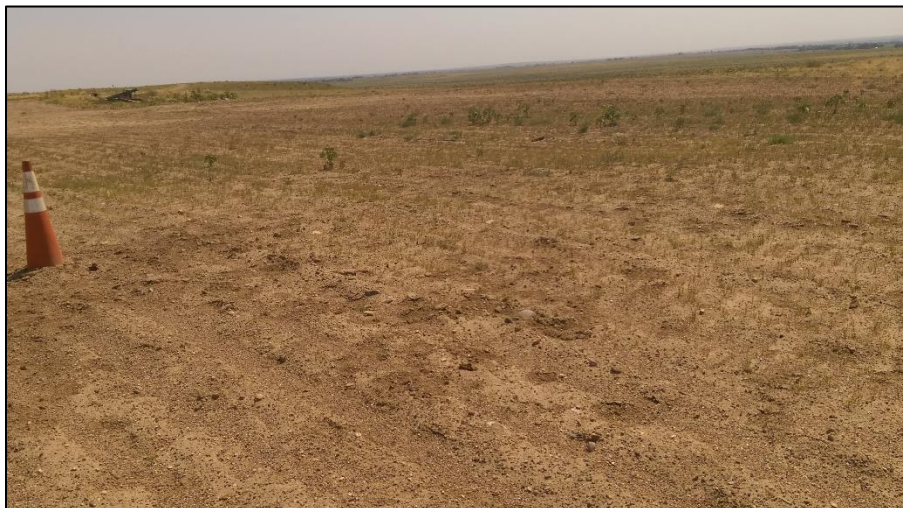
Photo 12. View looking northeast at area in northeastern portion of site in reclamation. Area has been graded to flatter than 3H:1V, retopsoiled, and seeded.

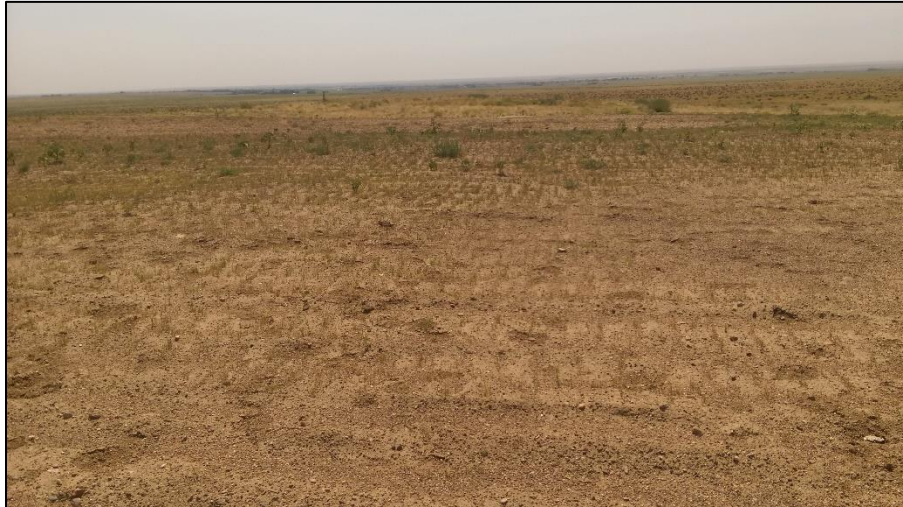
Photo 13. View looking east at area in northeastern portion of site in reclamation. Area has been graded to flatter than 3H:1V, retopsoiled, and seeded.

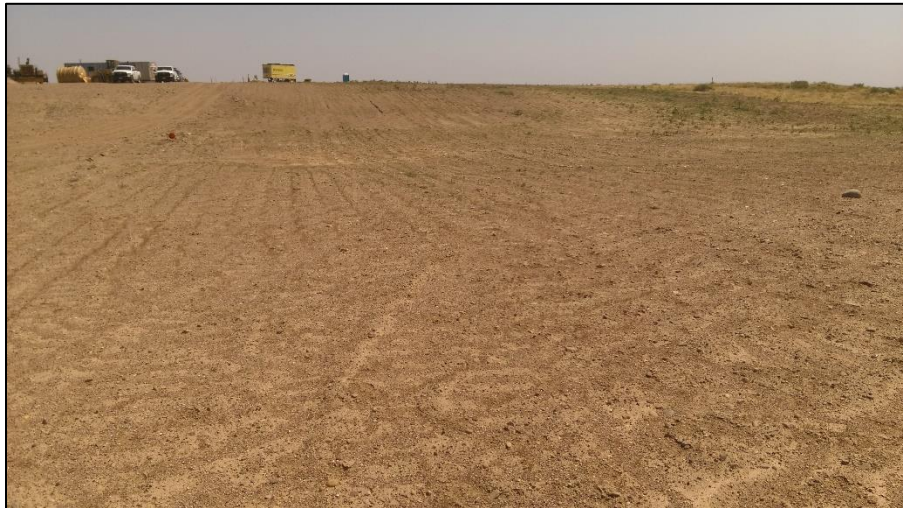
Photo 14. View looking north at area in northeastern portion of site in reclamation. Area has been graded to flatter than 3H:1V, retopsoiled, and seeded.

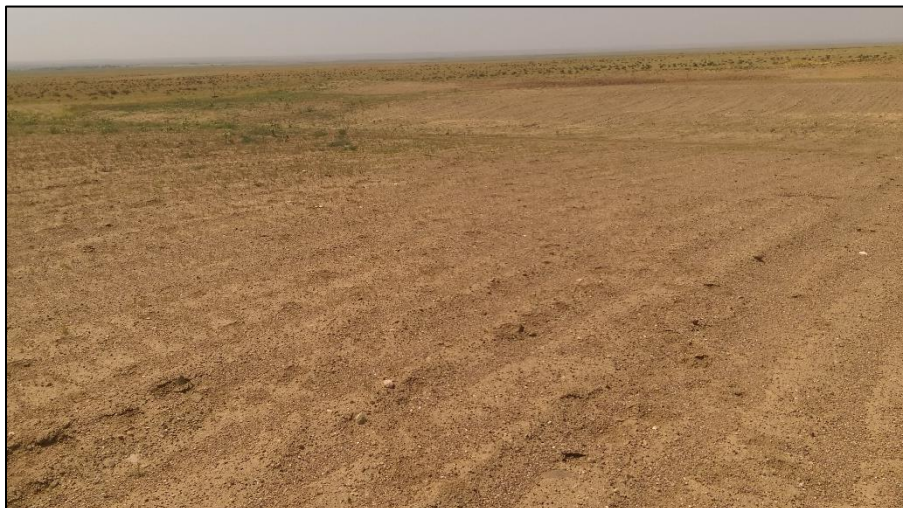
Photo 15. View looking southeast at area in eastern portion of site in reclamation. Area has been graded to flatter than 3H:1V, retopsoiled, and seeded.

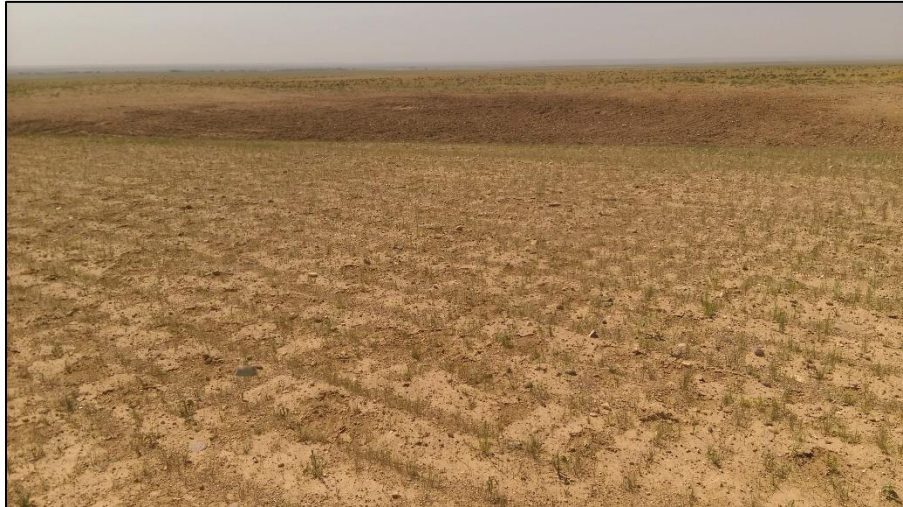
Photo 16. View looking south at area in southeastern portion of site in reclamation. Area has been graded to flatter than 3H:1V, retopsoiled, and seeded.

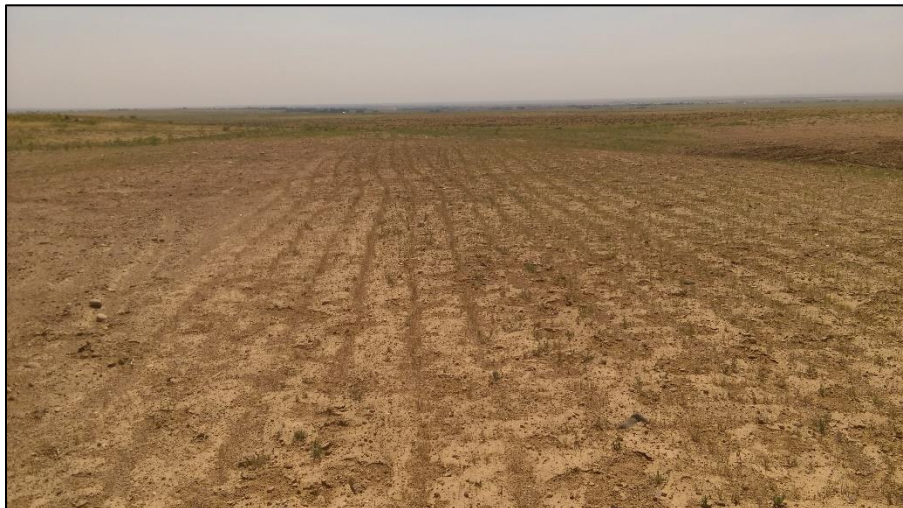
Photo 17. View looking east at area in southeastern portion of site in reclamation. Area has been graded to flatter than 3H:1V, retopsoiled, and seeded.

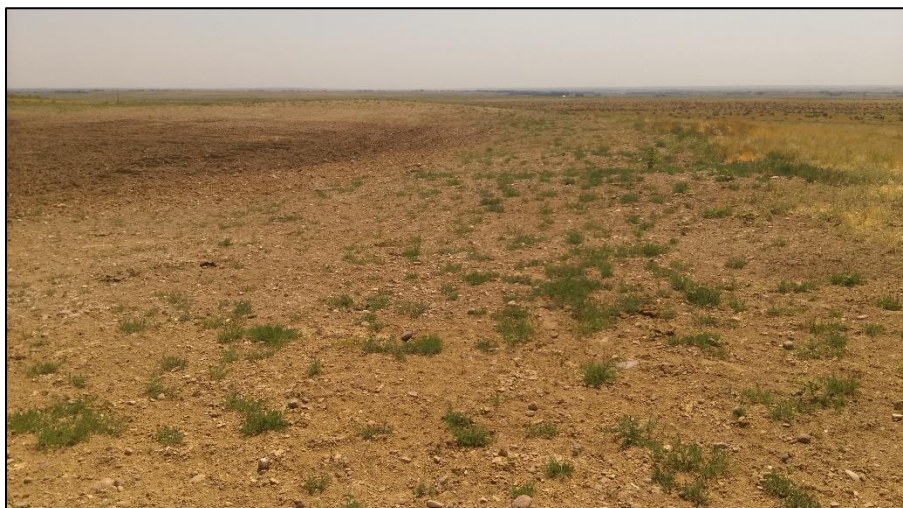
Photo 18. View looking east along southern edge of pit in reclamation. Area has been graded to flatter than 3H:1V, retopsoiled, and seeded.

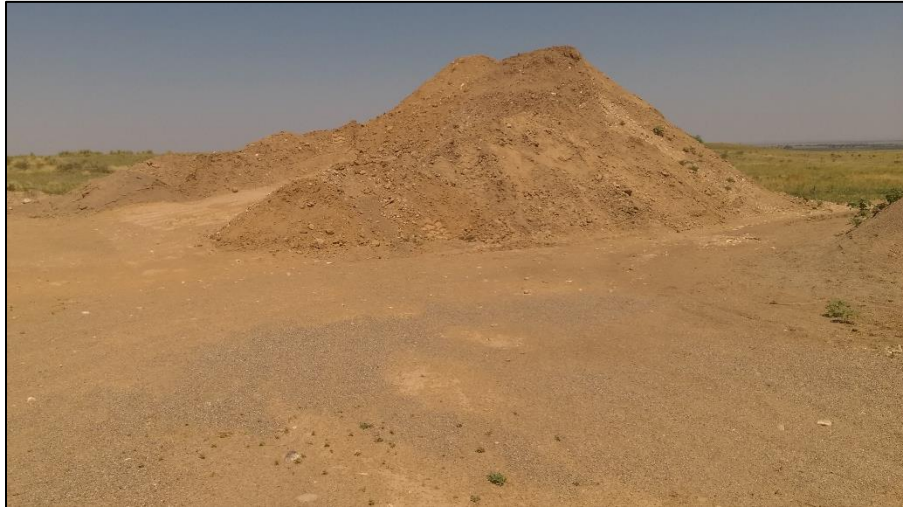
Photo 19. View of topsoil stockpile stored at northwestern corner of site, which was partially used for recent reclamation work.

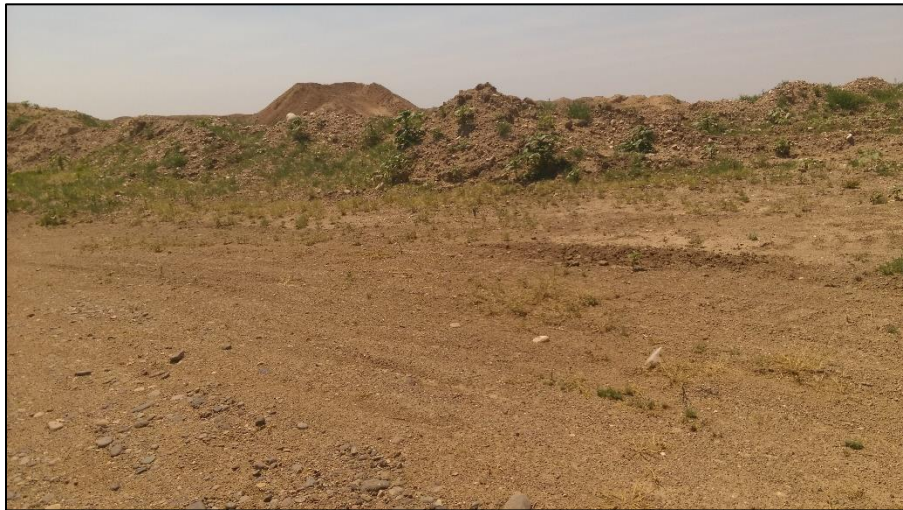
Photo 20. View of topsoil bermed along edge of western pit wall.
