**MINERALS PROGRAM INSPECTION REPORT**  
**PHONE: (303) 866-3567**

| <b>MINE NAME:</b><br>Climax Mine | <b>MINE/PROSPECTING ID#:</b><br>M-1977-493 | <b>MINERAL:</b><br>Molybdenum | <b>COUNTY:</b><br>Summit |
| <b>INSPECTION TYPE:</b><br>Monitoring | <b>INSPECTOR(S):</b><br>Jared L. Ebert | <b>INSP. DATE:</b><br>July 13, 2017 | <b>INSP. TIME:</b><br>08:00 |

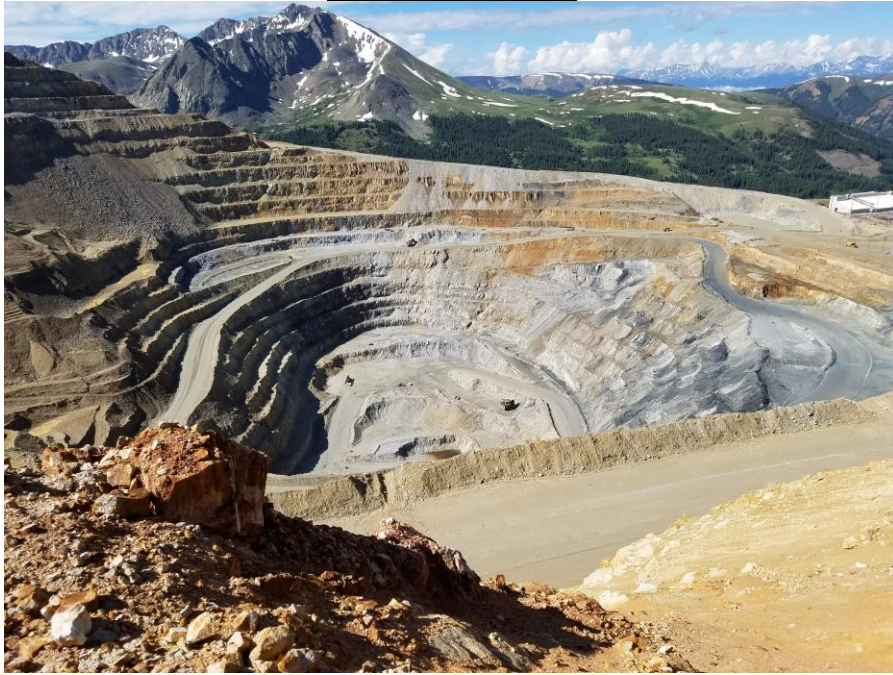
The open pit area was observed. At the time of the inspection, two blast patterns were being developed. Active mining was taking place at the time of the inspection. Two shacks were observed at the site with instrumentation used to monitor and measure the movement of the mine face.

Figure 1. From the northeast side of the open pit looking southwest.

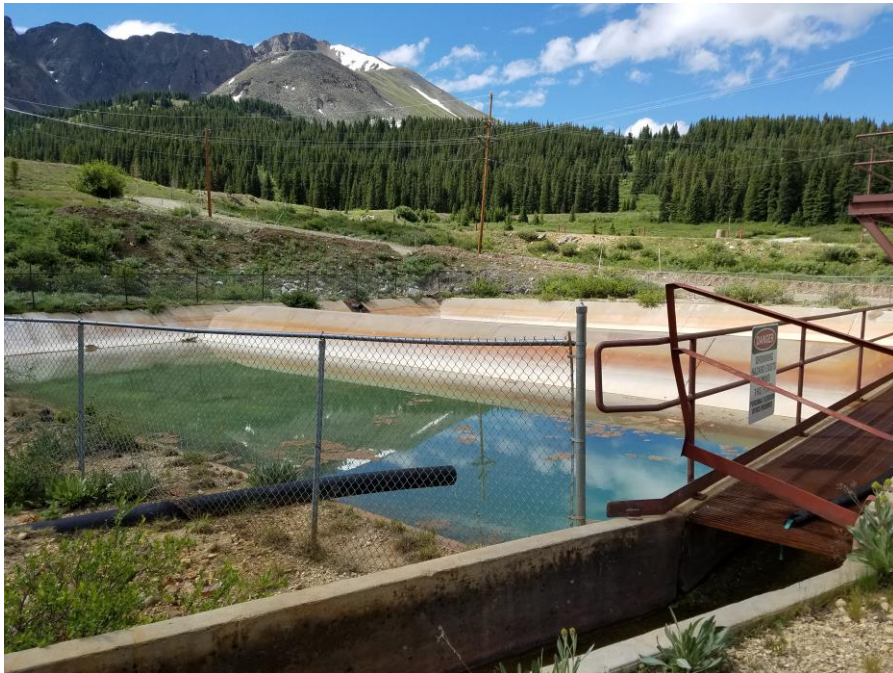
The 5-Shaft Pump Station was observed. Water is pumped to two decant ponds at the Stork Wastewater Pump Station. The two decant ponds were holding water and appeared stable and functional. A drainage ditch catching drainage from the affected lands that drain to the decant ponds was clear and functional.

Figure 2. Decant ponds at Storke Wastewater Pump Station.

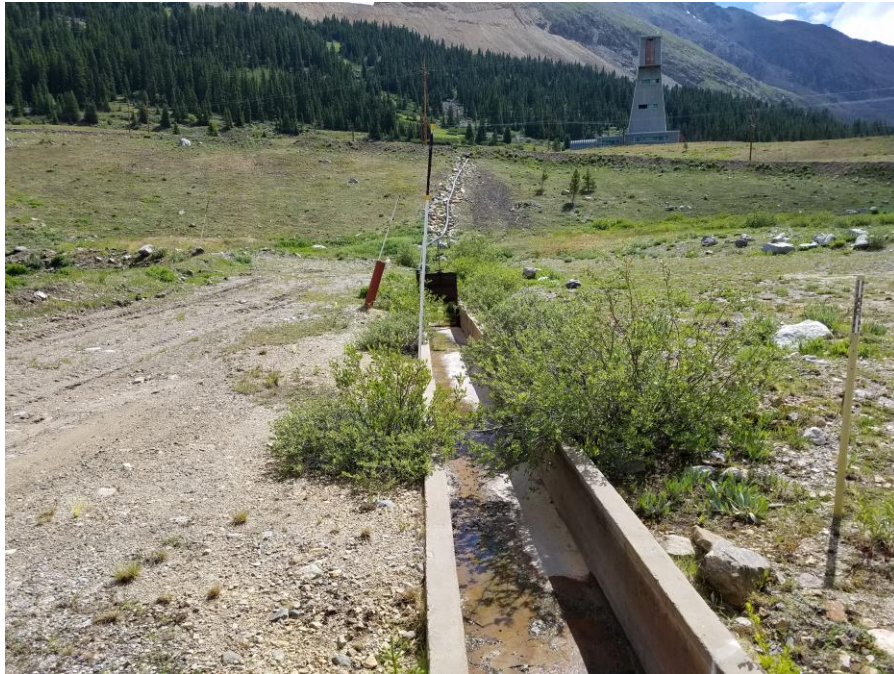
Figure 3. 5-Shaft Pump Station.

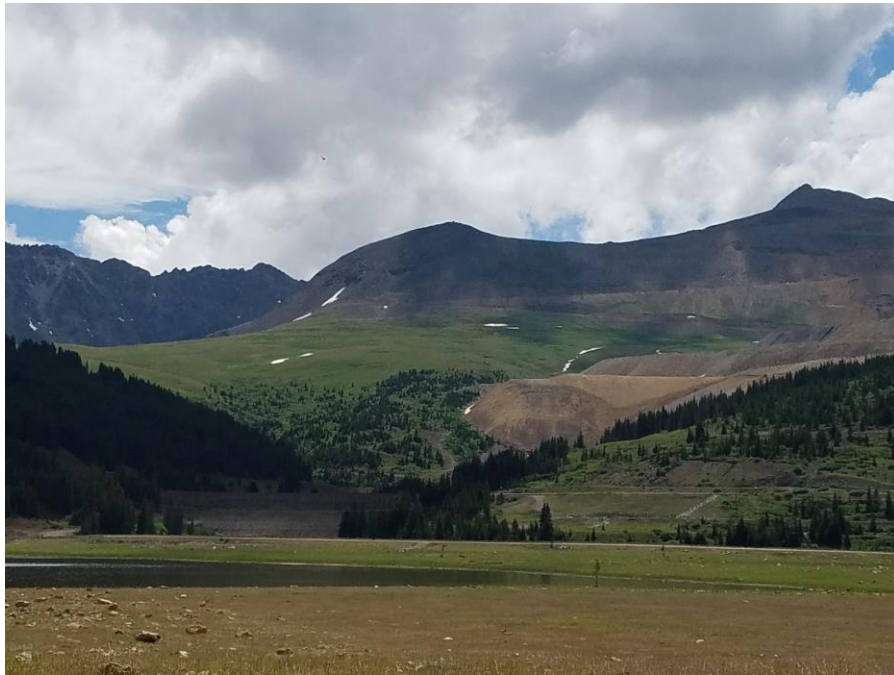
The composting area at the south end of the Robinson Tailings Storage Facility (TSF) was observed. A reclaimed section of the Robinson TSF on the south side was observed. This area was vegetated and stable.

Figure 4. From the south end of the Robinson TSF looking east toward the OSFs.

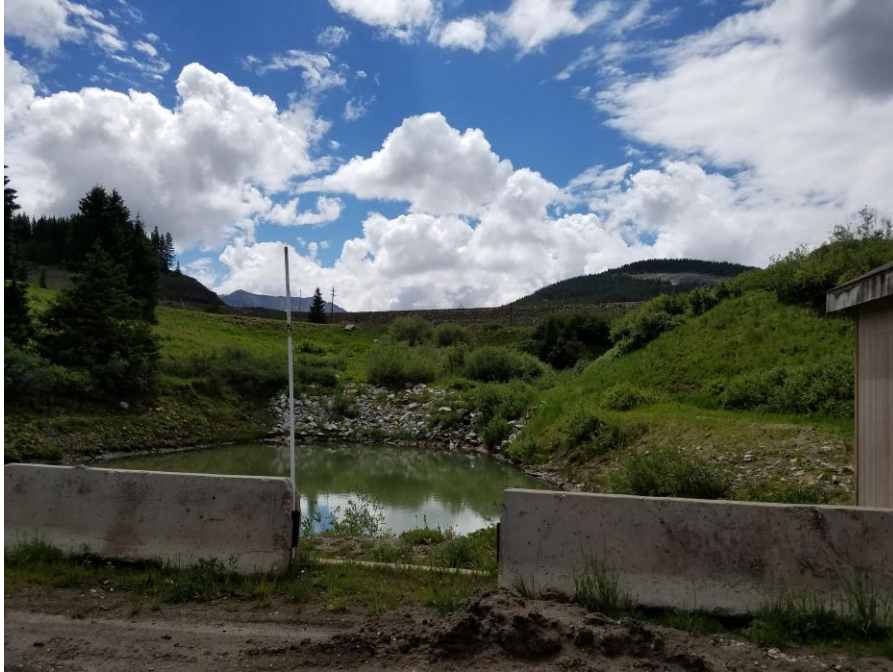
The Robinson Lake Seepwater Pump station and Warren's Pump Station was observed and appeared functional.

Figure 5. Robinson Lake Seepage and Cut-off Wall.

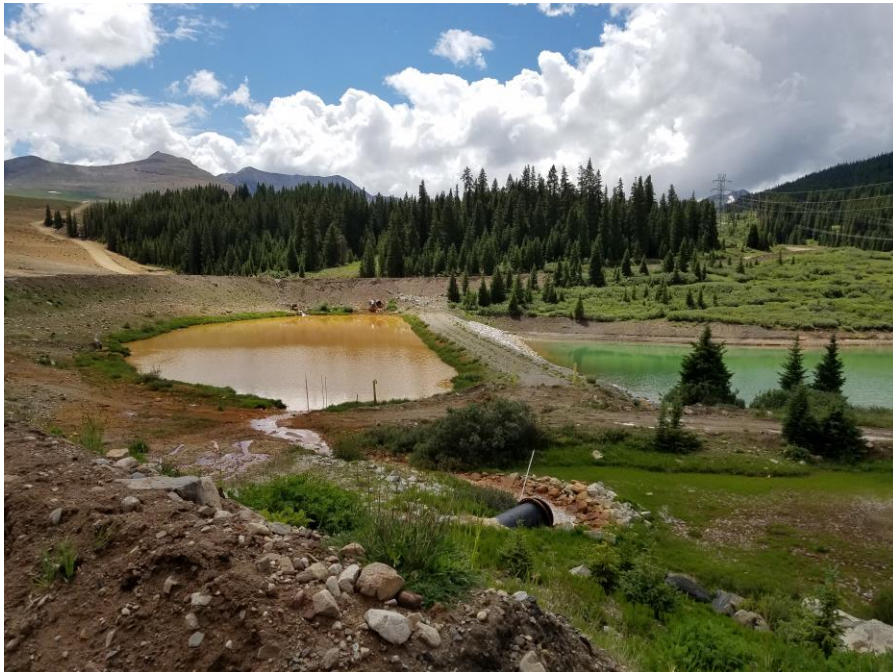
The dam at Tim's Pond was observed. The dam appeared stable.

Figure 6. Tim's Pond.

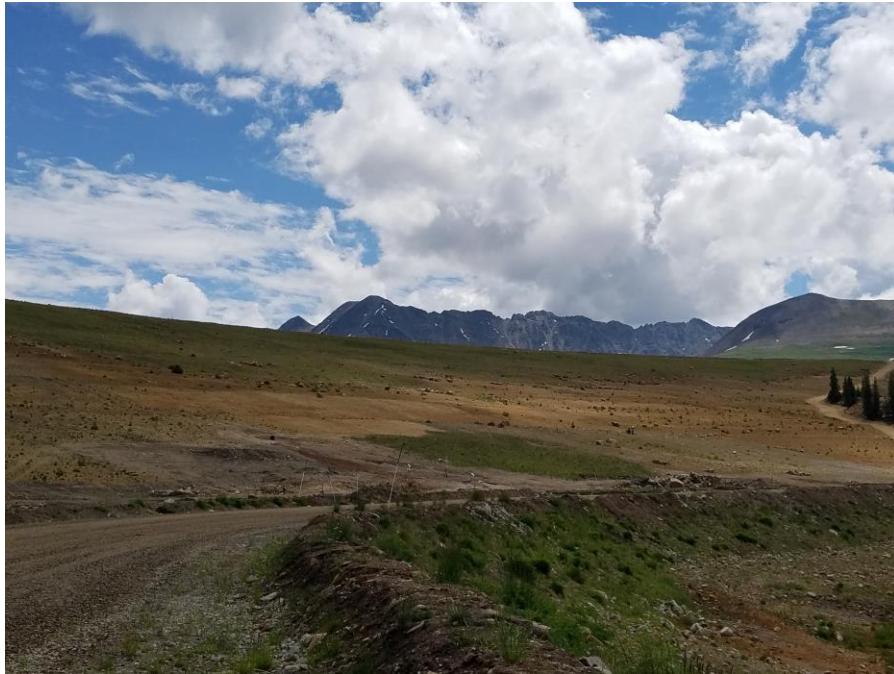
The face of Dam 1 of the Robinson TSF was observed. Overall, the face of the dam appeared stable. Vegetation has established on the upper portions of the dam. Portions of sparse vegetation were observed on the lower benches of the dam.

Figure 7. 1 Dam.

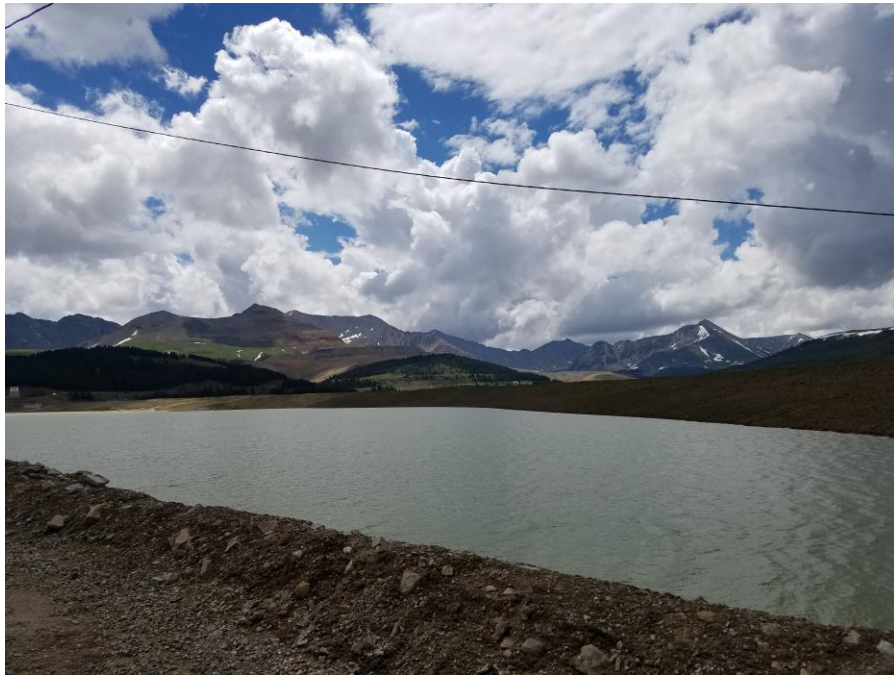
The face of Dam 2 of the Robinson TSF was observed. The face of the dam appeared stable.

Figure 8. Tenmile TSF with 2 Dam in the background.

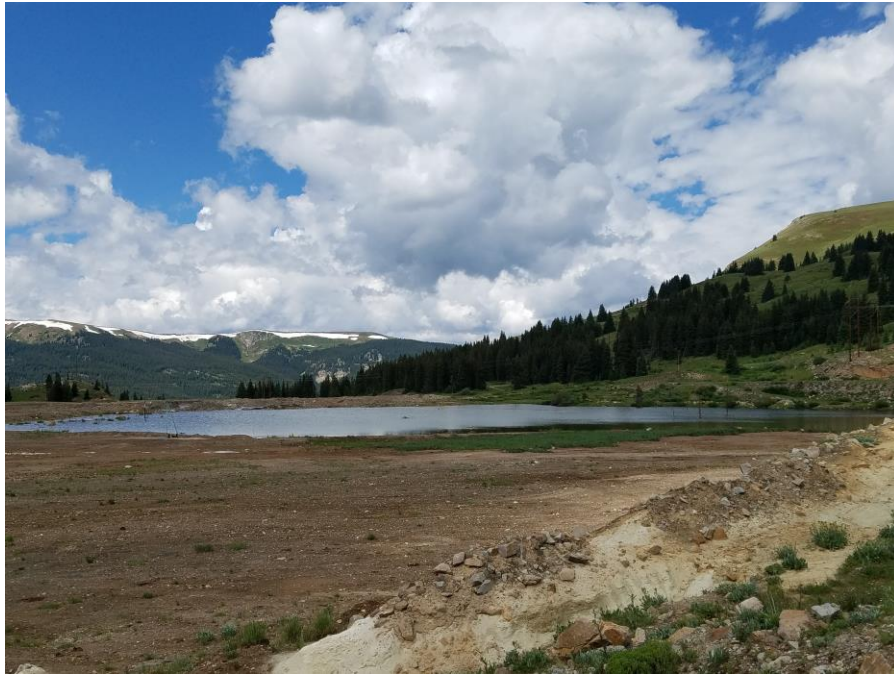
**Figure 9. Lake Irwin**

The Lake Irwin area was observed. According to CMC staff, this area will be reclaimed as a wetland and that a revision to the reclamation plan is forthcoming.

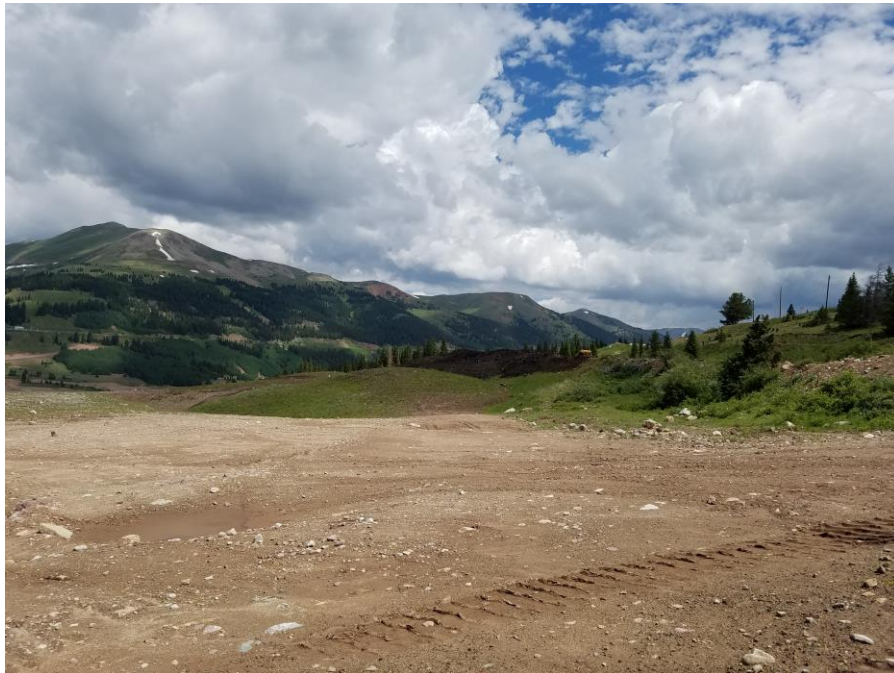
CMC has recently stripped topsoil from an area where future tailings will be placed. The stripped soil has recently been placed in a pile north of the 3 Dam area. A current subsoil pile is also located near this area. The subsoil pile was stable and vegetated.

**Figure 10. Topsoil and subsoil pile north of 3 Dam.**

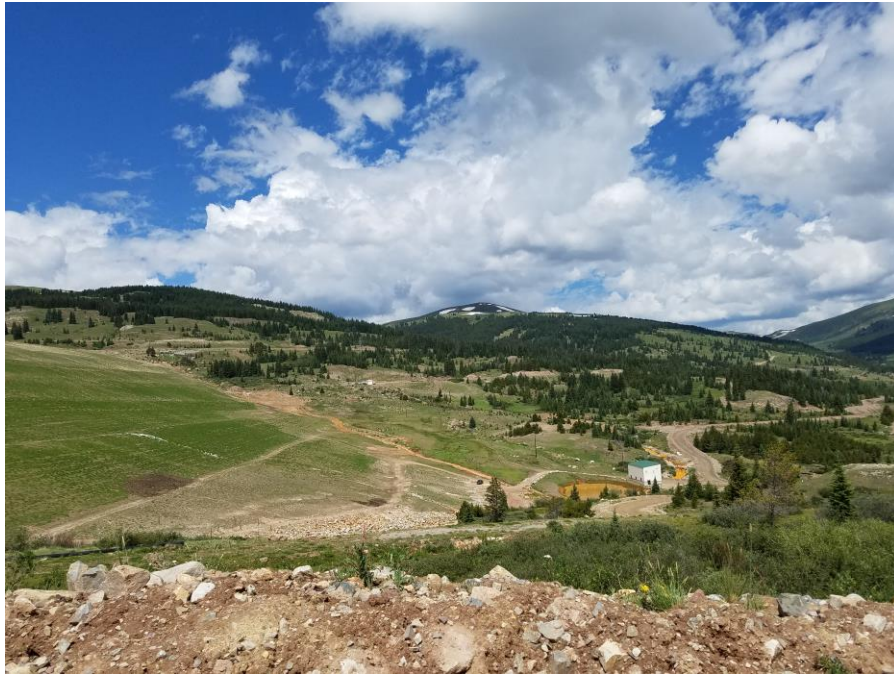
3 Dam of the Tenmile TSF was observed. The dam appeared stable.

**Figure 11. 3 Dam.**
