**MINERALS PROGRAM INSPECTION REPORT****PHONE: (303) 866-3567**

<b>MINE NAME:</b> Chieftain South Mine	<b>MINE/PROSPECTING ID#:</b> M-1981-148	<b>MINERAL:</b> Clay (general)	<b>COUNTY:</b> Jefferson
<b>INSPECTION TYPE:</b> Monitoring	<b>INSPECTOR(S):</b> Michael A. Cunningham	<b>INSP. DATE:</b> May 30, 2017	<b>INSP. TIME:</b> 13:00
<b>OPERATOR:</b> General Shale Brick, Inc.	<b>OPERATOR REPRESENTATIVE:</b> Jason McGraw	<b>TYPE OF OPERATION:</b> 112c - Construction Regular Operation

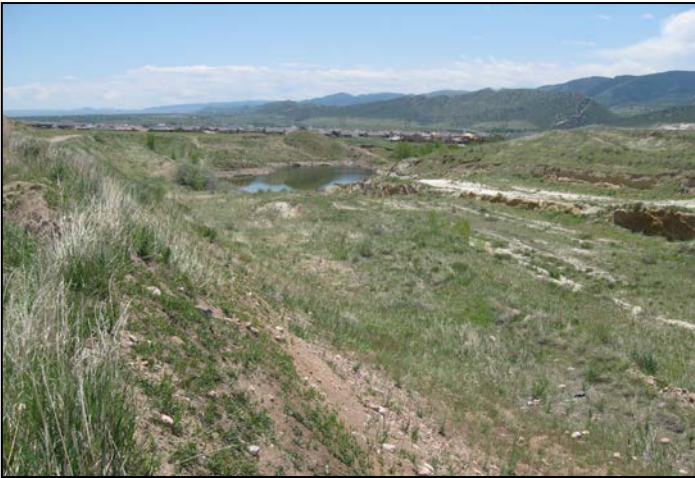
The Operator has salvaged and stockpiled topsoil along the west side of the pit. The topsoil stockpiles are well vegetated and stable. The Division observed an overburden stockpile as well as two product stockpiles located along the east side of the pit. The Operation currently consists of a single pit which is approximately 16 acres in size. Mining operations are progressing to the north.

1. Overview of pit, facing south.

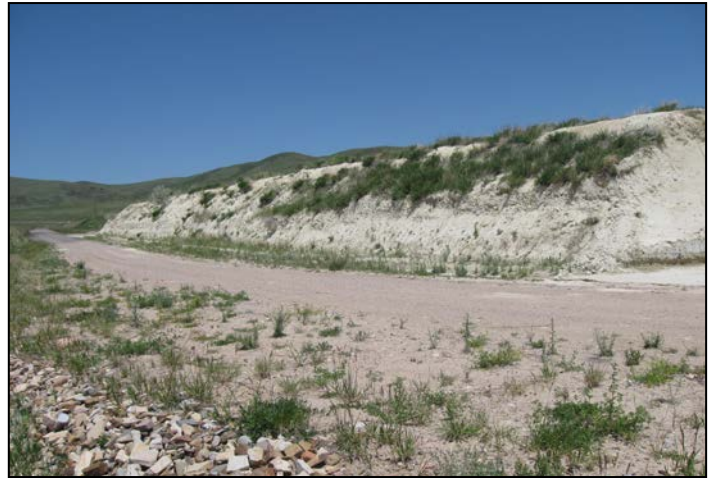
2. Product stockpiles.

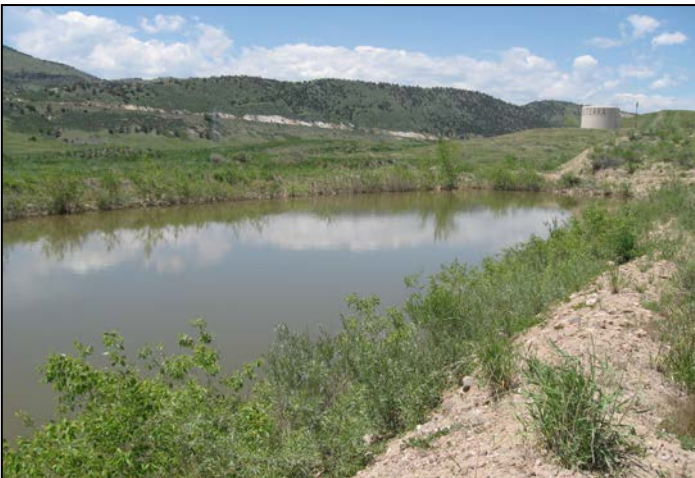
3. Sediment pond.

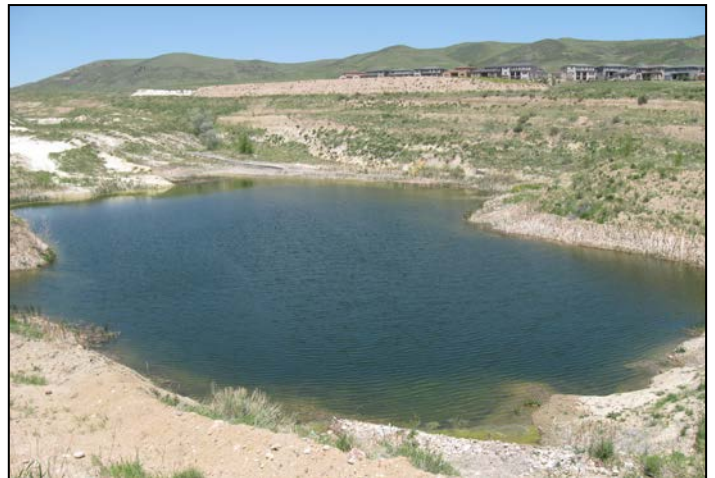
**PROBLEM/POSSIBLE VIOLATION:** Problem: The current reclamation plan needs to be updated and clarified pursuant to C.R.S. 34-32.5-116 (1). The operator must follow approved reclamation plan or provide sufficient information to describe or identify how the operator intends to conduct reclamation.

**PROBLEM/POSSIBLE VIOLATION:** Problem: The Division has no evidence that the operator has a valid well permit for the exposed groundwater at the site. This is a problem related to 34-32.5-116(4)(h) of the Colorado Revised Statutes and 3.1.6(1)(a) of the Construction Materials Rules and Regulations governing injury to existing water rights.

The Division observed exposed groundwater water in the south end of the pit. According to the Operator, the pond is approximately 20 feet deep. The Operator has previously demonstrated compliance with the Office of the State Engineer by providing a copy of the well permit and water decree. The well permit on record expired on March 25, 2012. This matter has been cited as a problem and will require corrective action by the Operator; please see the first page of this report for additional detail.

A file review found the current Reclamation Plan does not account for a 20' deep pond in the mine pit. The Reclamation Plan will need to be updated to describe how the Operator intends to reclaim the pond. This matter has been cited as a problem and will require corrective action by the Operator, please see the first page of this report for additional detail.

4. Pond at south end of pit.

**CORRECTIVE ACTIONS:** The operator shall submit a Technical Revision, with the required \$216 revision fee, to update and clarify the current approved reclamation plan to account for reclamation of the pond within the mine pit. The Technical Revision shall be submitted on or before the corrective action date.

**CORRECTIVE ACTIONS:** The operator shall provide a copy of a valid well permit from the Office of the State Engineer on or before the corrective action date.

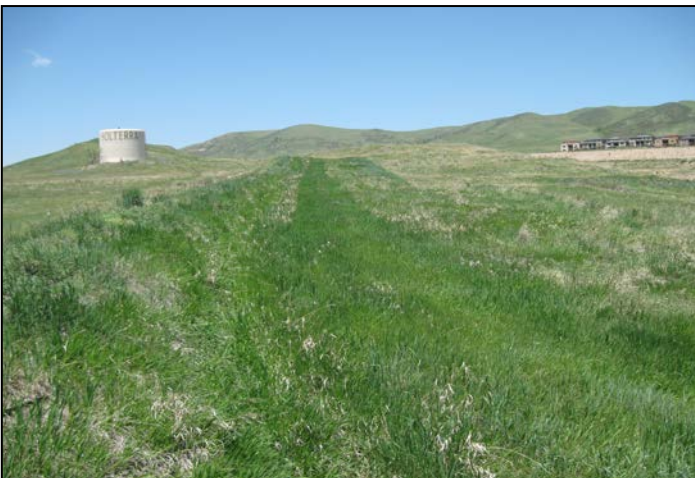
5. South end of topsoil stockpile, facing north.

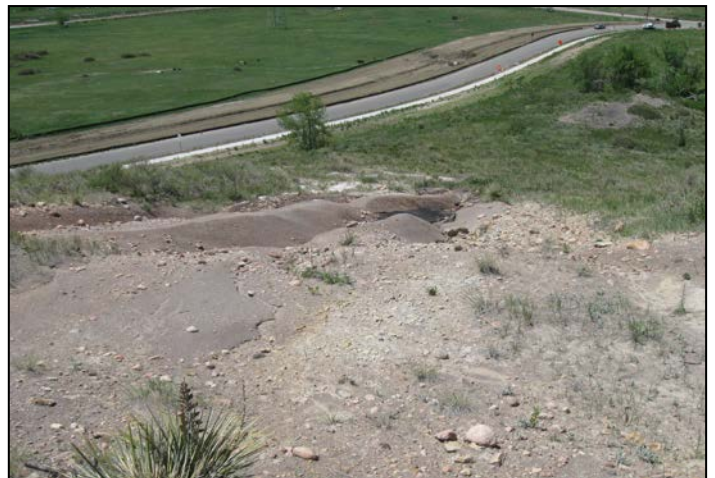
During the inspection, the Division noted minor erosion from the access road at the north end of the pit. The berm adjacent to the access road contained a low spot, which allowed water to flow off the access road and down the north facing slope. No off-site areas were impacted by erosion. Following the inspection, the Operator provided photographs showing the repair of the berm along the access road. This problem is considered to be resolved.

6. Erosion along access road.
