**COLORADO**Division of Reclamation,
Mining and Safety

MINERALS PROGRAM INSPECTION REPORT**PHONE: (303) 866-3567**

MINE NAME: North Chieftain	MINE/PROSPECTING ID#: M-1978-014	MINERAL: Clay (general)	COUNTY: Jefferson
INSPECTION TYPE: Monitoring	INSPECTOR(S): Michael A. Cunningham	INSP. DATE: May 30, 2017	INSP. TIME: 14:15
OPERATOR: General Shale Brick, Inc.	OPERATOR REPRESENTATIVE: Jason McGraw	TYPE OF OPERATION: 112c - Construction Regular Operation	
REASON FOR INSPECTION: Normal I&E Program	BOND CALCULATION TYPE: Complete Bond	BOND AMOUNT: \$73,431.00	
DATE OF COMPLAINT: NA	POST INSP. CONTACTS: None	JOINT INSP. AGENCY: None	
WEATHER: Clear	INSPECTOR'S SIGNATURE:

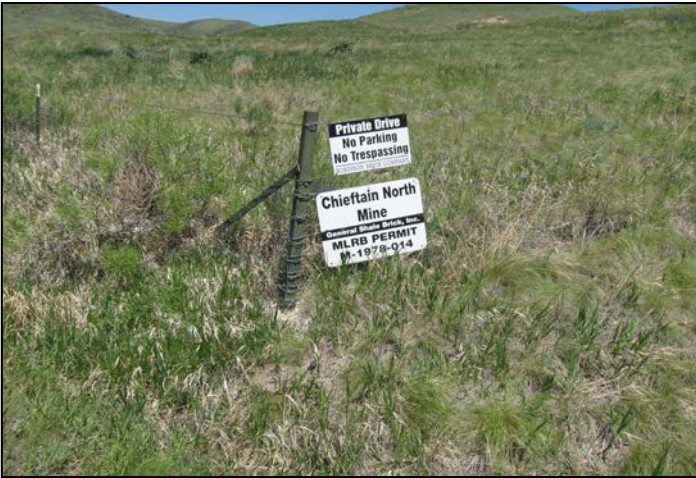
The permit sign was posted at the site entrance and the boundary of the affected area was clearly delineated.

1. Permit sign at site entrance.

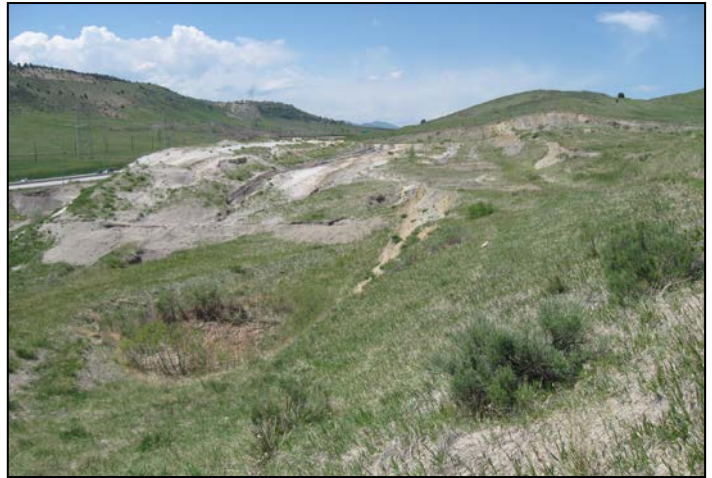
2. North end of pit, facing north.

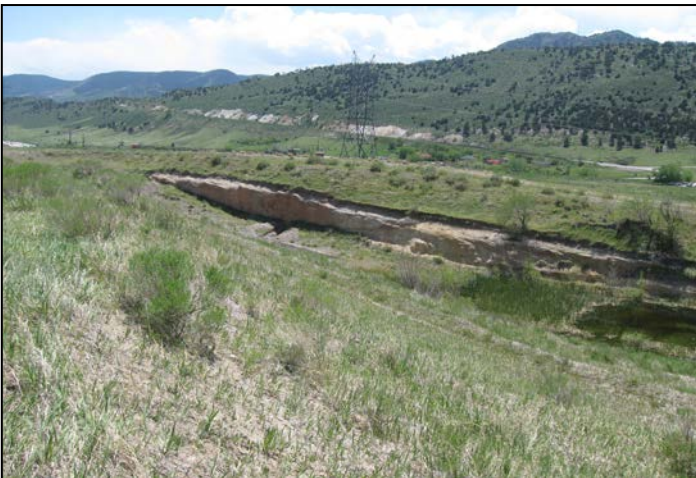
The pit is located on the west side of Phase 1 and is approximately 10 acres in size. The Operator has created a highwall along the western edge of the pit, which is approximately 500 ft. in length and ranges between 3 ft. to 15 ft. in height. Topsoil and overburden have been salvaged and are stockpiled to the east of the pit. The topsoil and overburden stockpiles are vegetated and stable. In addition, there are several product stockpiles located on the level area to the east of the pit. The Operator periodically hauls material from these stockpiles.

3. Pit highwall, facing west.

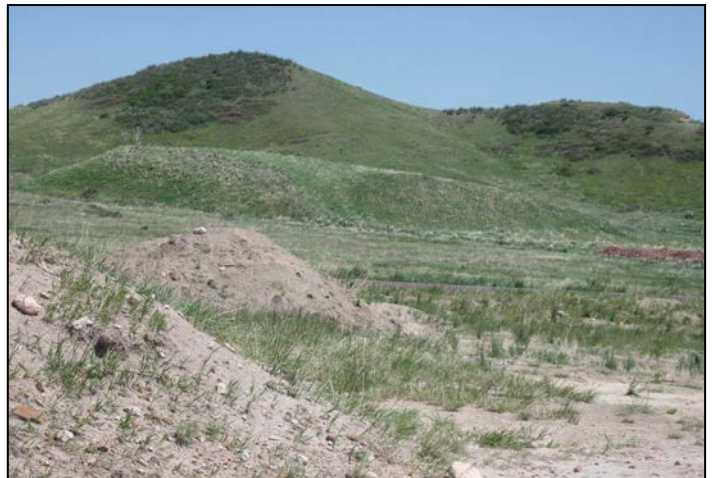
4. Topsoil stockpile.

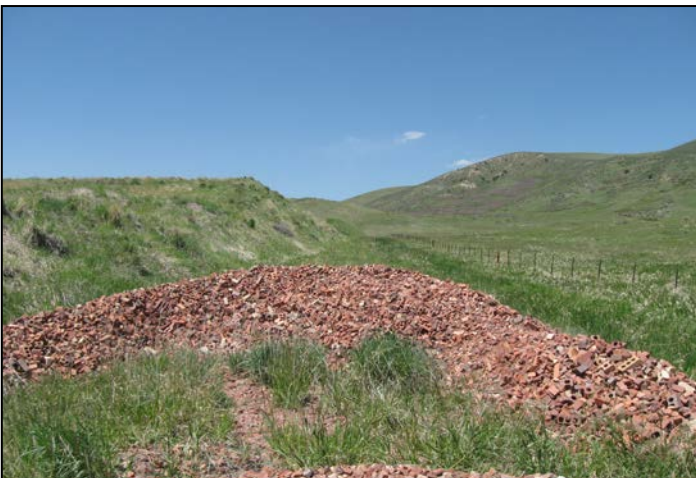
5. Overburden stockpile.
