**MINERALS PROGRAM INSPECTION REPORT**  
**PHONE: (303) 866-3567**

<b>MINE NAME:</b> Klement Pit	<b>MINE/PROSPECTING ID#:</b> M-2007-076	<b>MINERAL:</b> Gravel and sand	<b>COUNTY:</b> Cheyenne
<b>INSPECTION TYPE:</b> Monitoring	<b>INSPECTOR(S):</b> Timothy A. Cazier	<b>INSP. DATE:</b> July 6, 2017	<b>INSP. TIME:</b> 12:30
<b>OPERATOR:</b> Cheyenne County	<b>OPERATOR REPRESENTATIVE:</b> Jim Brown	<b>TYPE OF OPERATION:</b> 110c - Construction Limited Impact	
<b>REASON FOR INSPECTION:</b> Normal I&E Program	<b>BOND CALCULATION TYPE:</b> None	<b>BOND AMOUNT:</b> \$0.00	
<b>DATE OF COMPLAINT:</b> NA	<b>POST INSP. CONTACTS:</b> None	<b>JOINT INSP. AGENCY:</b> None	
<b>WEATHER:</b> Clear	<b>INSPECTOR'S SIGNATURE:</b>

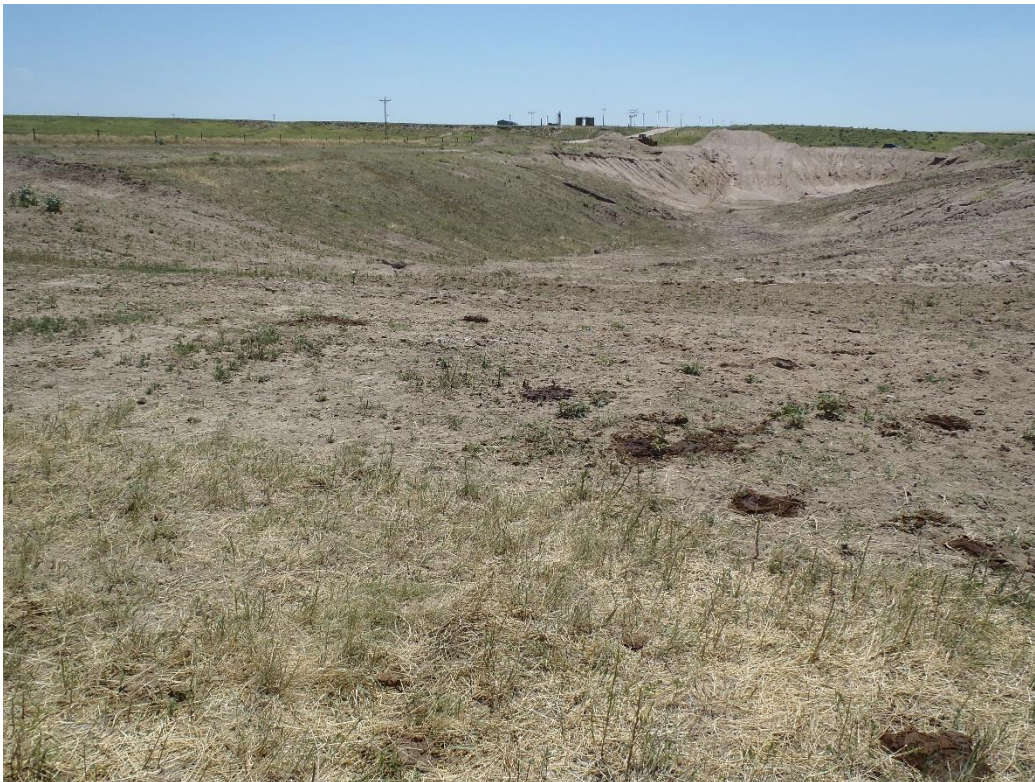
Backfilling and Grading: Mr. Brown pointed out they have backfilled the north end of the pit (see **Photo 1**) and are mining south. Sufficient backfill material appeared to be available (see **Photo 2**).

Photo 1. Backfilled north end of pit (looking South).

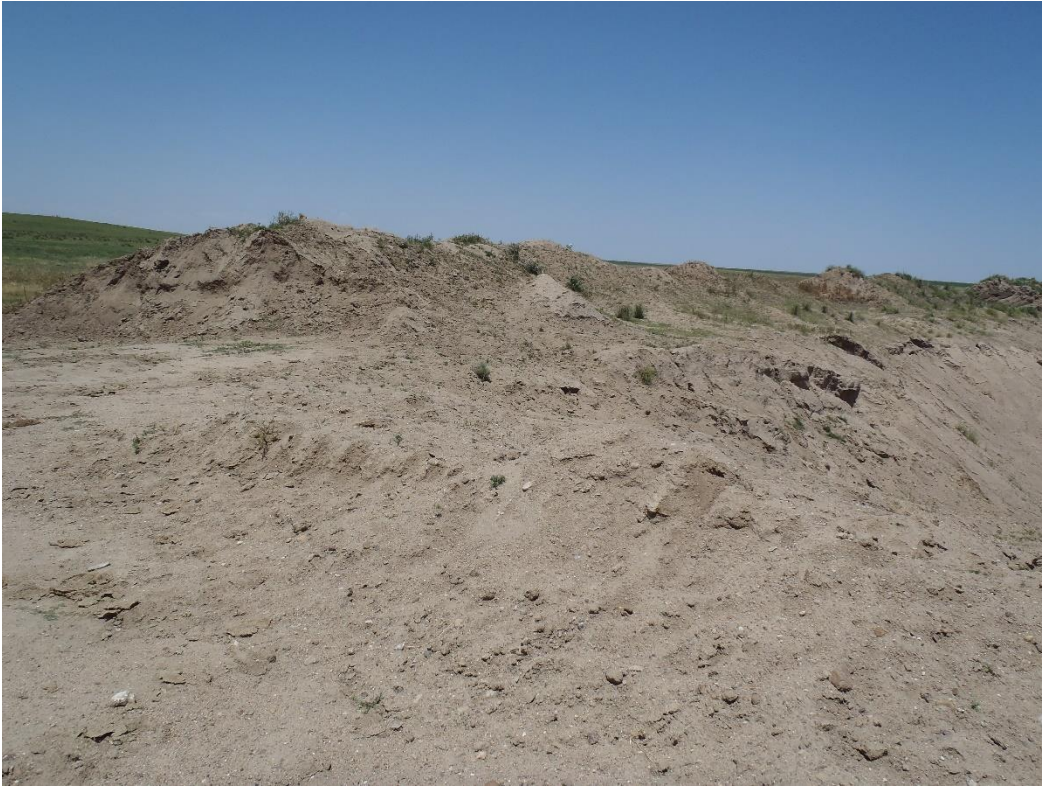
Photo 2. Available backfill material (south end, looking NNW).

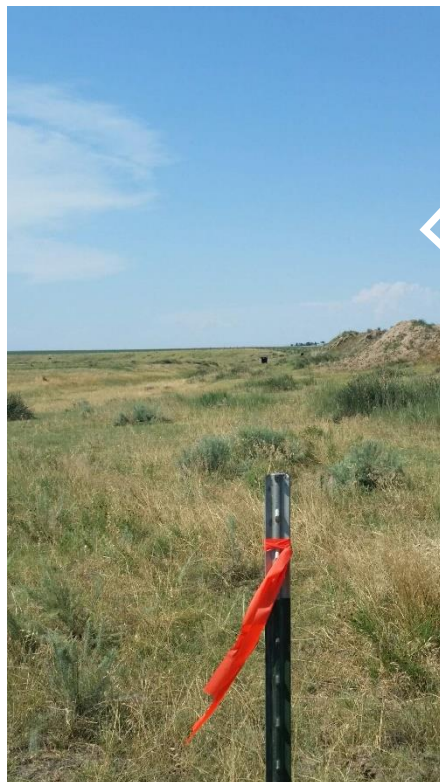
Complete Inspection: The entire permit area was inspected. The southwest boundary marker could not be located during the inspection. Mr. Brown sent a photo to the Division of the missing post having been replaced (see **Photo 3**), as well as having the northwest boundary marker replaced with a more substantive T-post the day following the inspection.

Photo 3. Replaced missing SW corner post (submitted by Permittee, looking north).

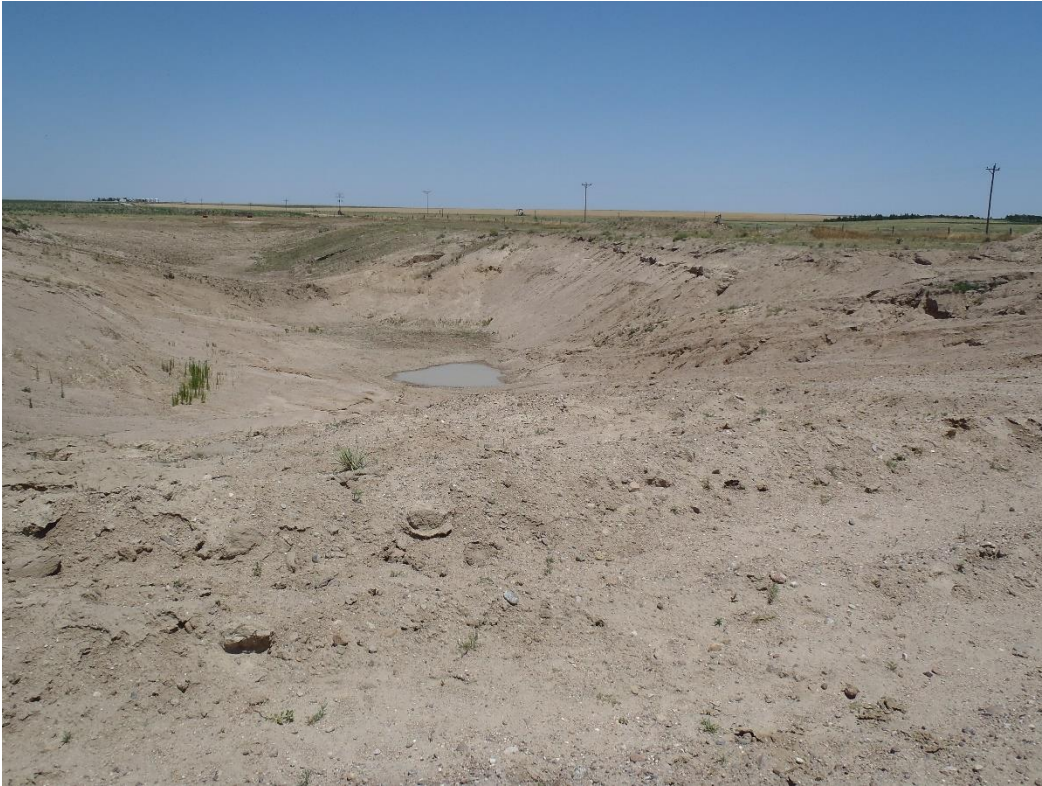
Gen. Compliance with Mine Plan: The operation appeared to be in compliance with the approved mine plan. Google Earth was used to measure the disturbed area, which was estimated to be approximately 6.6 acres based on April 23, 2016 satellite image. High walls were estimated to vary between 15 and 20 feet in high and appeared stable (see **Photo 4**).

Photo 4. High walls appeared stable (looking NNE).

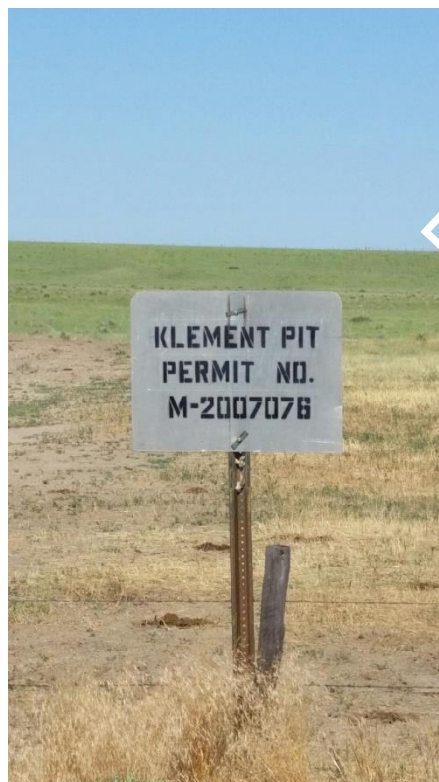
Signs and Markers: The permit sign was posted, but had the wrong permit number. Mr. Brown sent a photo of

the corrected sign to the Division on July 10, 2017 (see **Photo 5**). The missing SW boundary marker was cited as a problem, but corrected prior to completing this report.

Photo 5. Corrected permit sign (submitted by Permittee).
