## MINERALS PROGRAM INSPECTION REPORT

MINE NAME: Stirrup Pit	MINE/PROSPECTING ID#: M-1990-138	MINERAL: Gravel	COUNTY: Fremont
INSPECTION TYPE: Monitoring	INSPECTOR(S): Timothy A. Cazier	INSP. DATE: April 27, 2017	INSP. TIME: 12:40
OPERATOR: Fremont County	OPERATOR REPRESENTATIVE: Sterling Rife	TYPE OF OPERATION: 110c - Construction Limited Impact	
REASON FOR INSPECTION: Normal I&E Program	BOND CALCULATION TYPE: None	BOND AMOUNT: \$0.00	
DATE OF COMPLAINT: NA	POST INSP. CONTACTS: State	JOINT INSP. AGENCY: None	
WEATHER: Windy	INSPECTOR'S SIGNATURE: 	SIGNATURE DATE: July 21, 2017

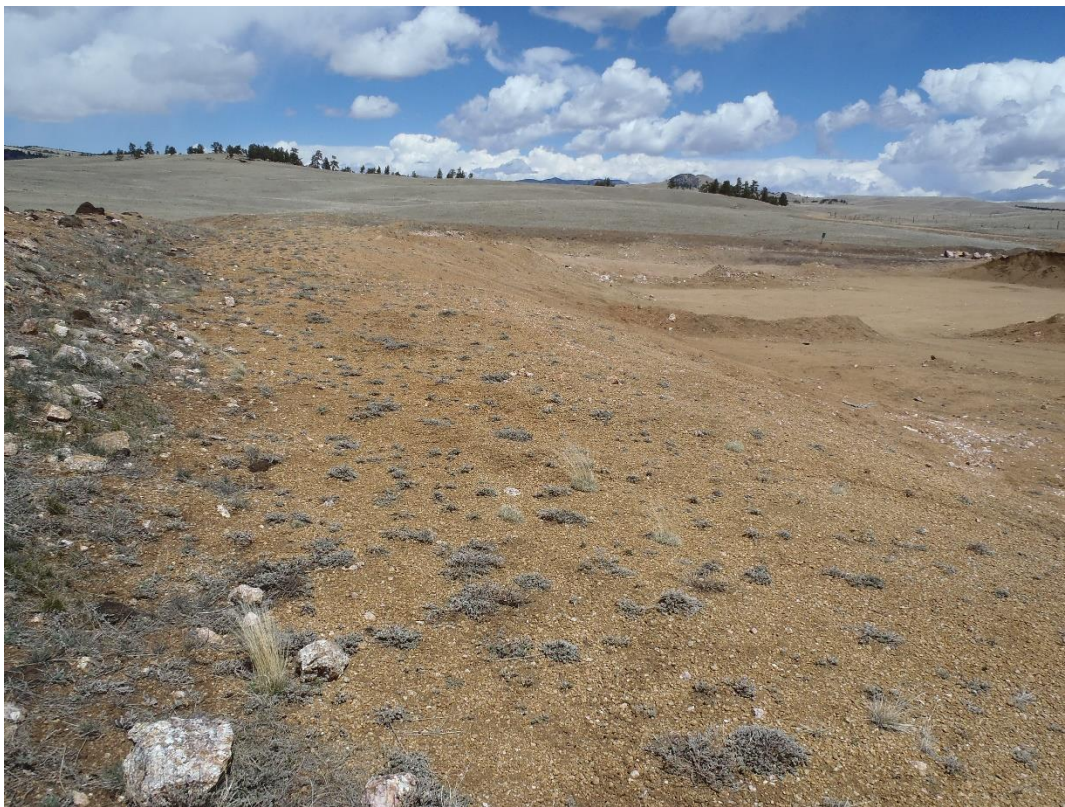
Backfilling and Grading: No backfill material is stockpiled, however highwalls appeared to be near 3H:1V (see **Photo 1**), therefore little to no backfilling is necessary.

Photo 1. Highwalls appeared to be near 3H:1V (looking NNE).

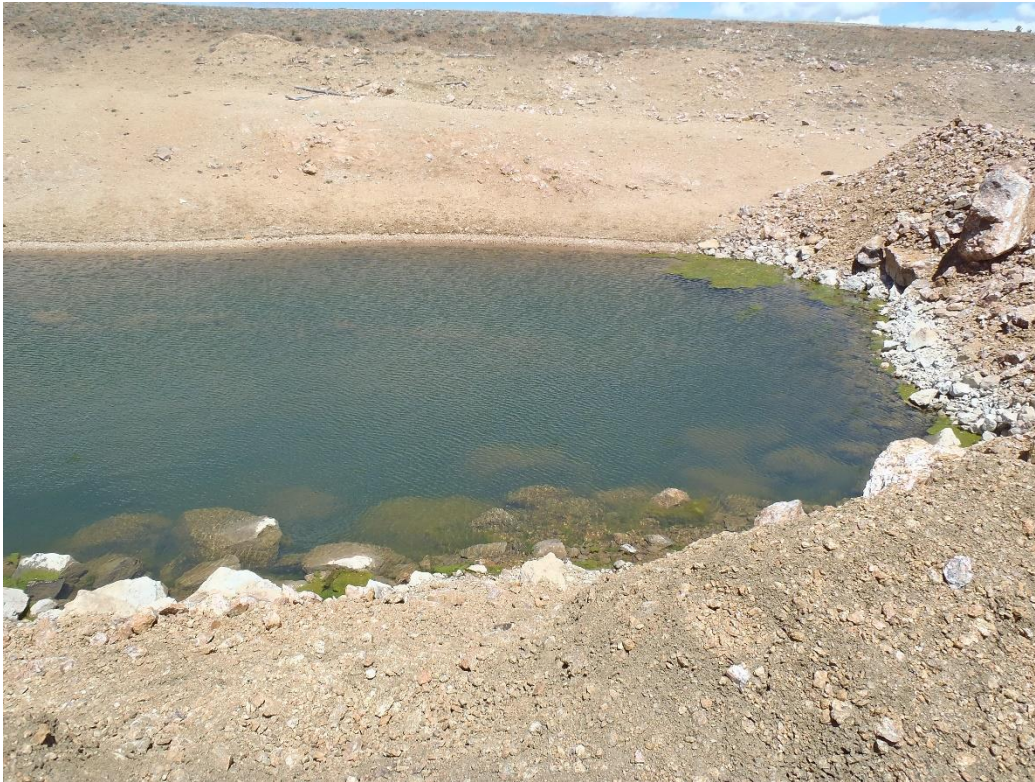
Hydrologic Balance: Exposed groundwater was observed in the northwest corner of the pit (see **Photo 2**). Mr. Rife stated he would have it backfilled to two feet above the observed water level. The Division received a photo of the northwest corner being backfilled on May 2, 2017 (see **Photo 3**).

Photo 2. Exposed groundwater pool (looking north from edge of pool).

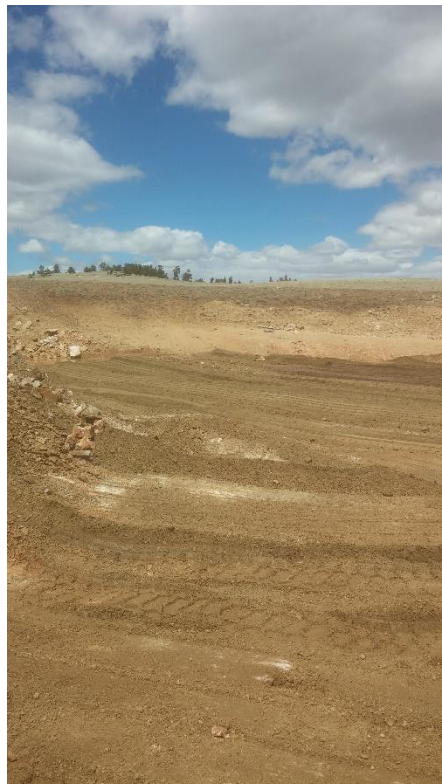
Photo 3. Backfilled northwest corner (photo submitted by permittee, looking north).

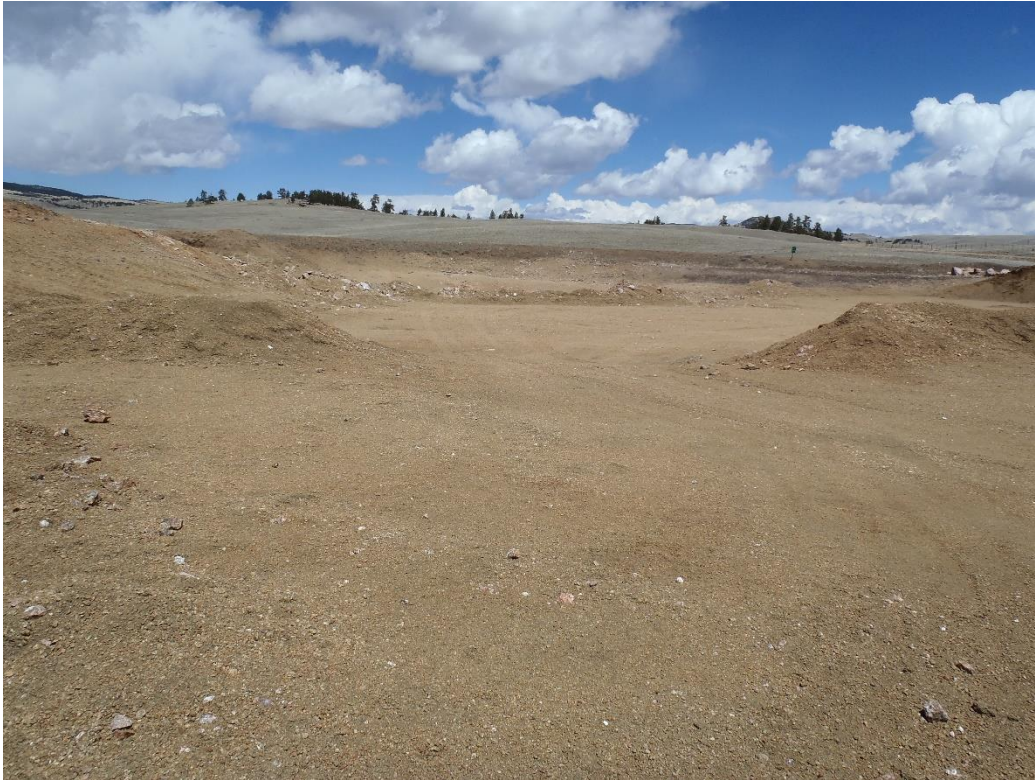
Gen. Compliance With Mine Plan: The operation appeared to be in compliance with the approved mine plan (with exception of the exposed groundwater). Google Earth was used to measure the disturbed area, which was estimated to be approximately 2.9 acres. Highwalls were estimated to be on average 10 feet in height and appeared stable (see **Photo 4**).

Photo 4. Highwalls, on average ~10 feet in height appeared stable (looking NNE).

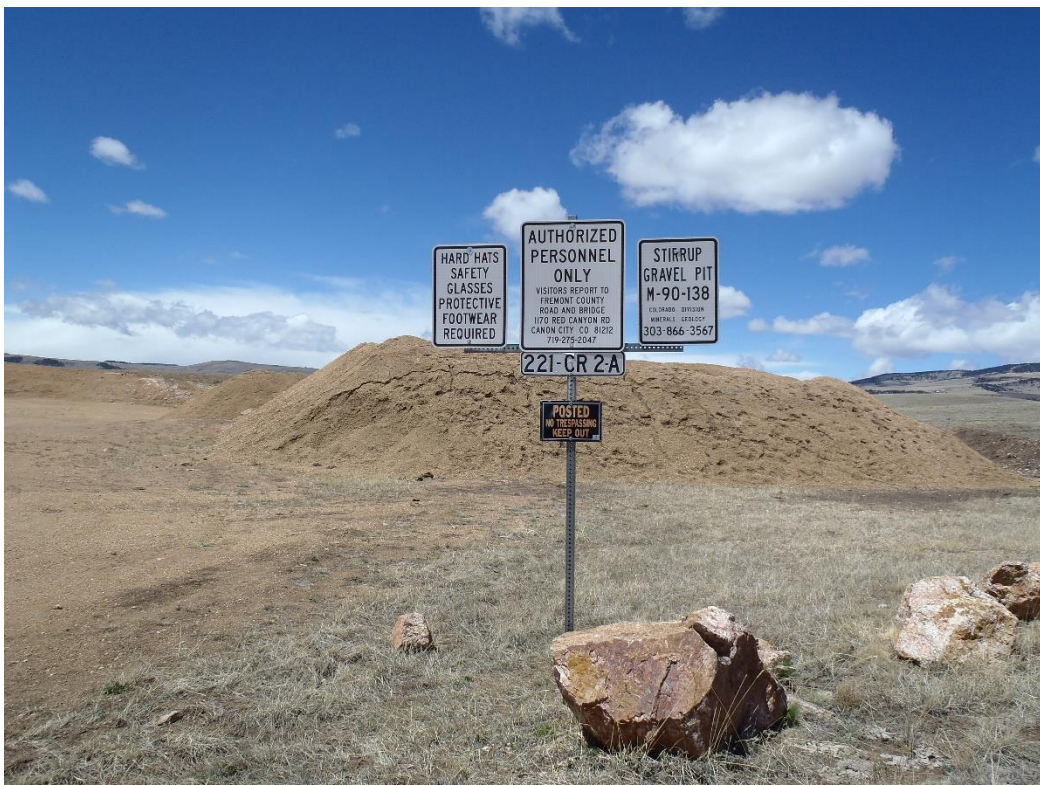
Signs and Markers: The permit sign was properly posted (see **Photo 5**) and boundary markers were observed

Photo 5. Permit sign.
