**COLORADO**Division of Reclamation,  
Mining and Safety

**MINERALS PROGRAM INSPECTION REPORT****PHONE: (303) 866-3567**

| <b>MINE NAME:</b><br>Byzantine Quarry | <b>MINE/PROSPECTING ID#:</b><br>M-2007-014 | <b>MINERAL:</b><br>Limestone (general),<br>granite, granite gneiss and<br>(silica, stone, quartzite) | <b>COUNTY:</b><br>Fremont |
| <b>INSPECTION TYPE:</b><br>Monitoring | <b>INSPECTOR(S):</b><br>Timothy A. Cazier | <b>INSP. DATE:</b><br>May 3, 2017 | <b>INSP. TIME:</b><br>07:25 |

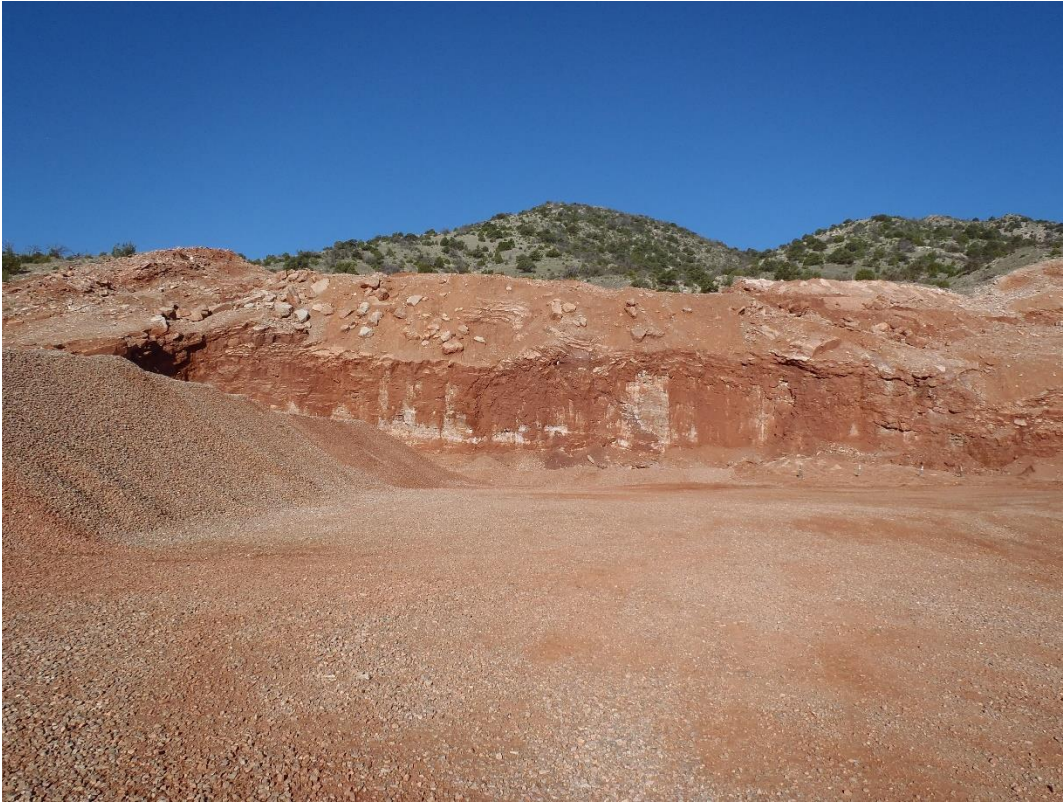
Gen. Compliance with Mine Plan: The operation appeared to be in compliance with the approved mine plan. Google Earth was used to measure the disturbed area, which was estimated to be on the order of 15 acres (June 15, 2016 satellite imagery). High walls were estimated to be 40 feet in height (see **Photo 1**) and appeared to be sufficiently stable as the "clean up" progresses. Mr. Tezak pointed out the drill rig mast where blast holes were being drilled for an upcoming blast (see **Photo 2**).

Photo 1. Approx. 40 feet Highwalls, south end (looking west).

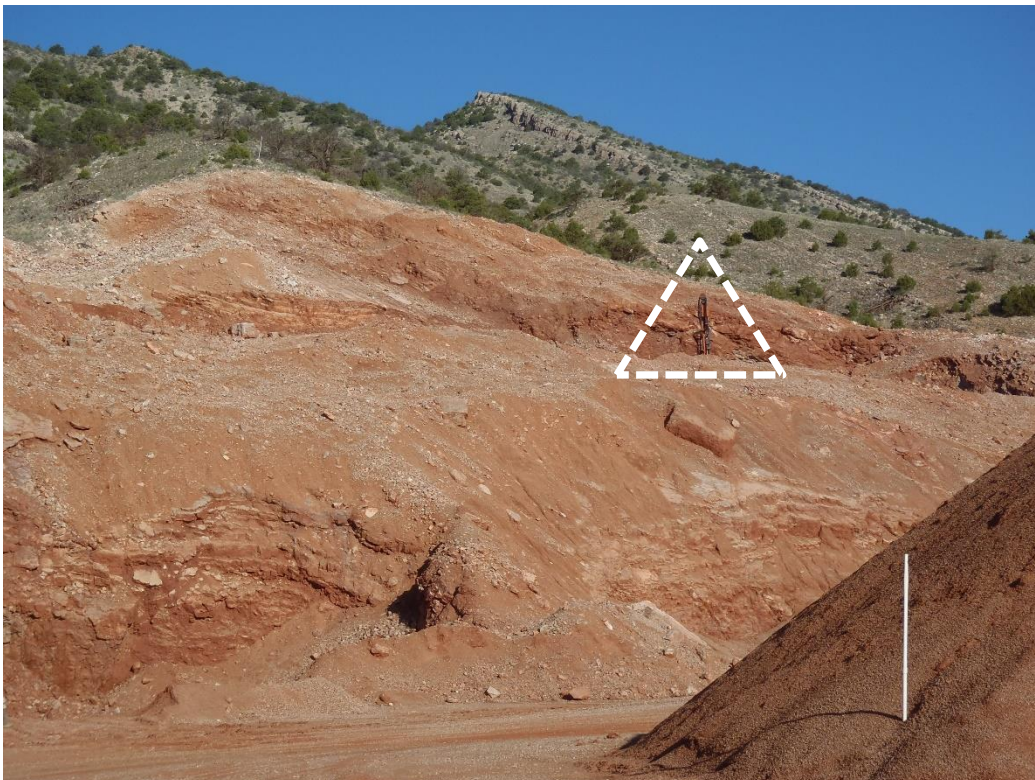
Photo 2. Drill rig mast where blast holes were being drilled south end (looking NW).

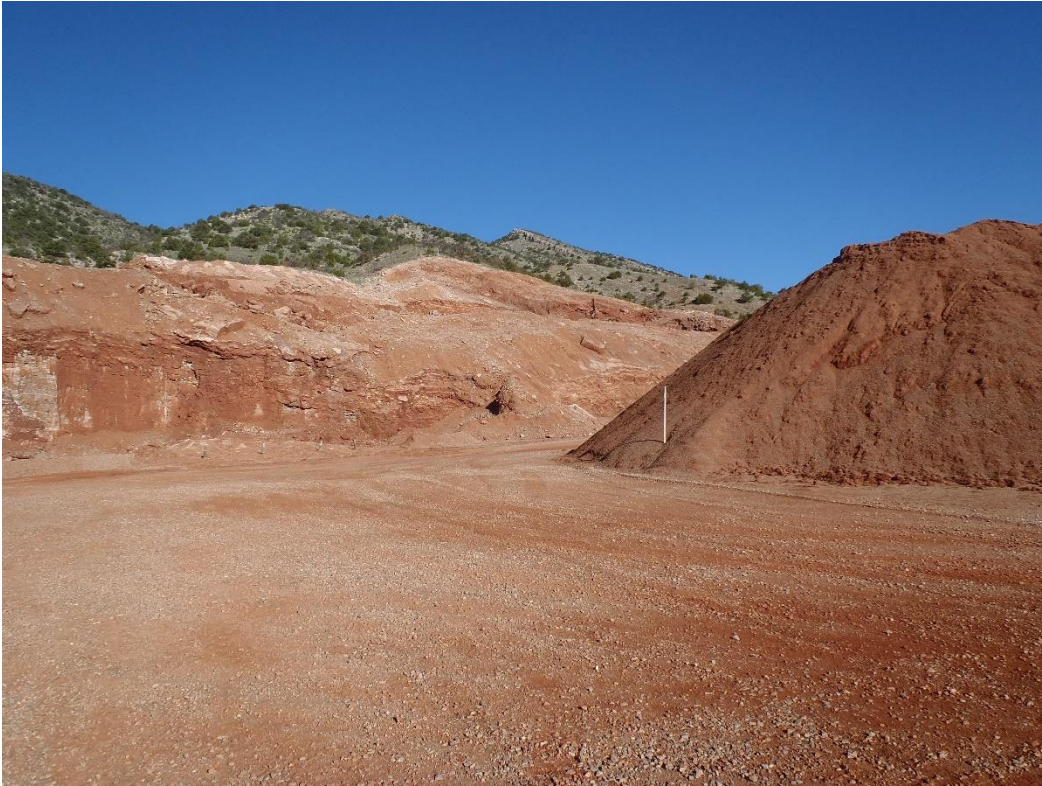
Processing Waste: Two medium fines stockpiles were observed on the pit floor (see **Photo 3**).

Photo 3. Typical fines stockpile (south end).

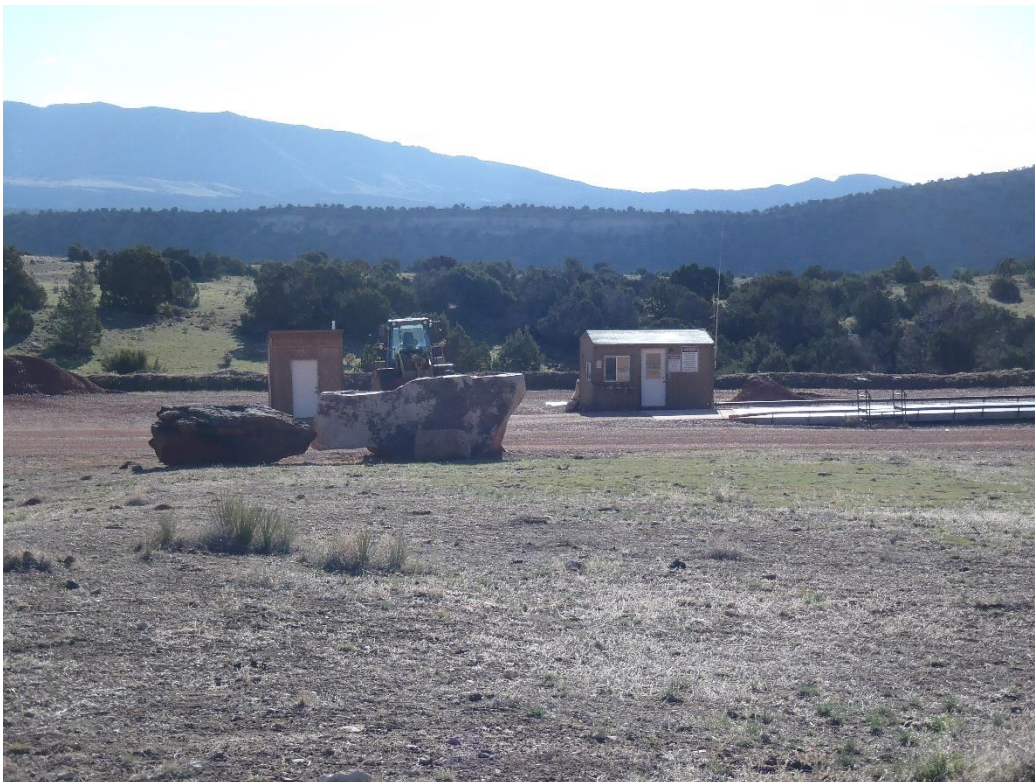
Support Facilities On-site: A scale, bull dozer and loader were observed on site (see **Photos 4 and 5**).

Photo 4. Loader & scale (north end).

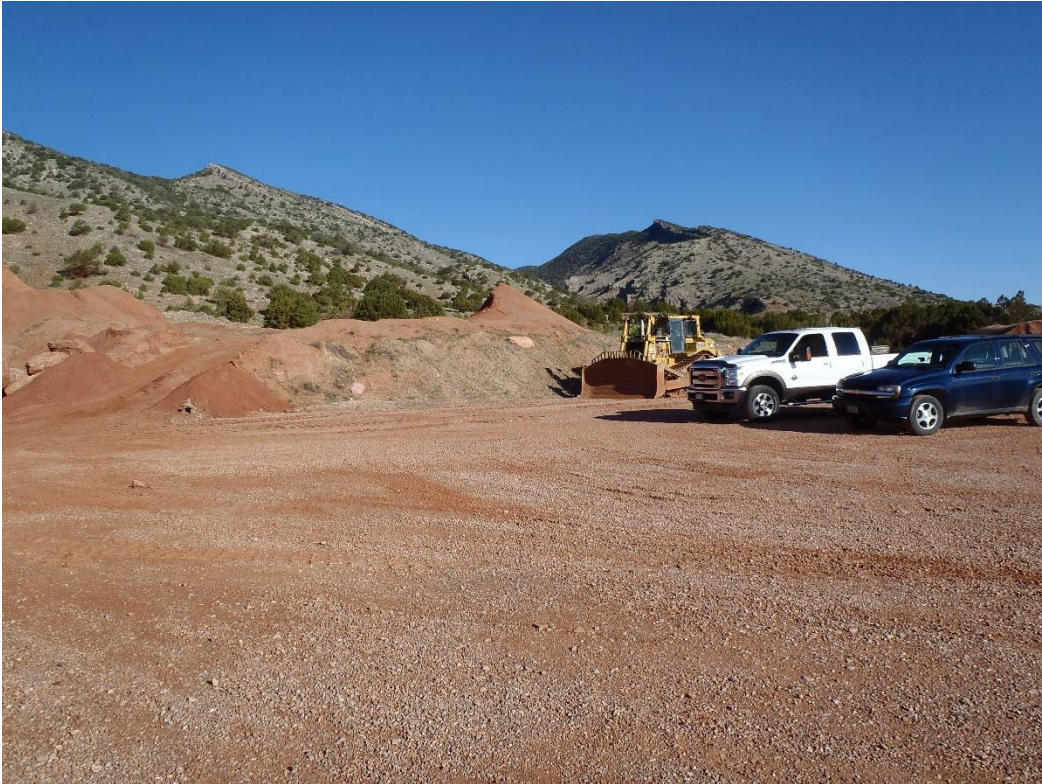
Photo 5. Dozer and access ramp (west side, central area).

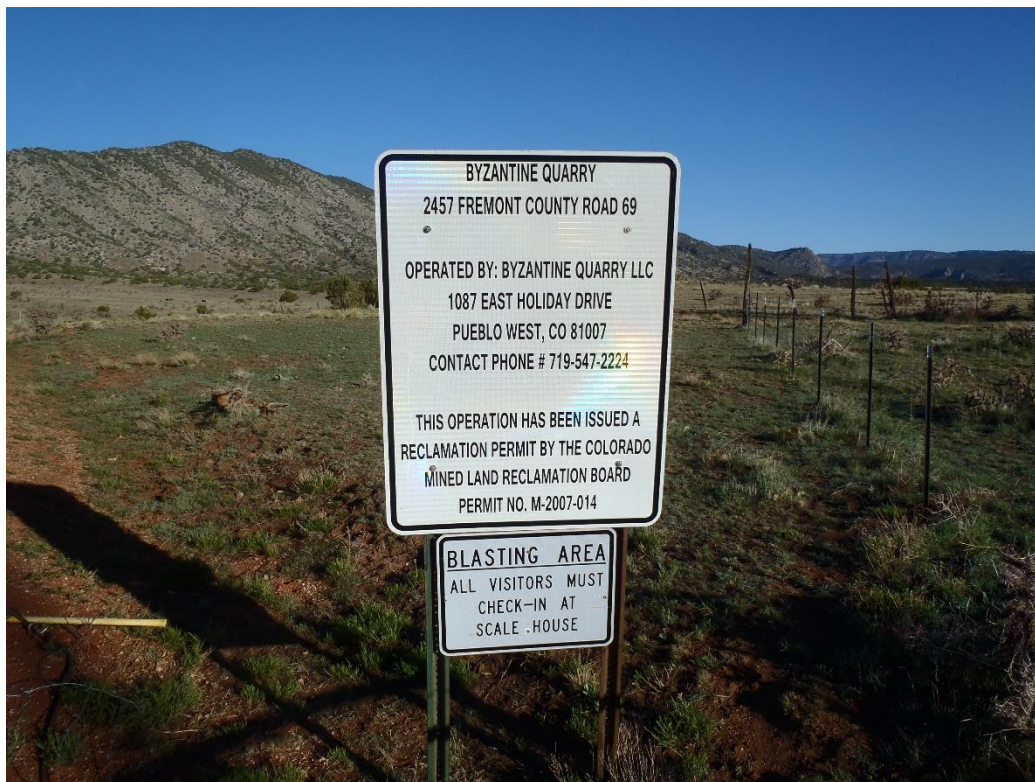
Signs and Markers: The permit sign was properly posted (see **Photo 6**). Permanent boundary markers are planned, but not currently critical as mining activity is well within the permit boundary.

Photo 6. Permit sign, near Fremont County Road 69.
