**MINERALS PROGRAM INSPECTION REPORT**  
**PHONE: (303) 866-3567**

| <b>MINE NAME:</b><br>Weis Pit | <b>MINE/PROSPECTING ID#:</b><br>M-2009-069 | <b>MINERAL:</b><br>Borrow and Gravel | <b>COUNTY:</b><br>Phillips |
| <b>INSPECTION TYPE:</b><br>Monitoring | <b>INSPECTOR(S):</b><br>Elliott R. Russell | <b>INSP. DATE:</b><br>March 28, 2017 | <b>INSP. TIME:</b><br>10:00 |

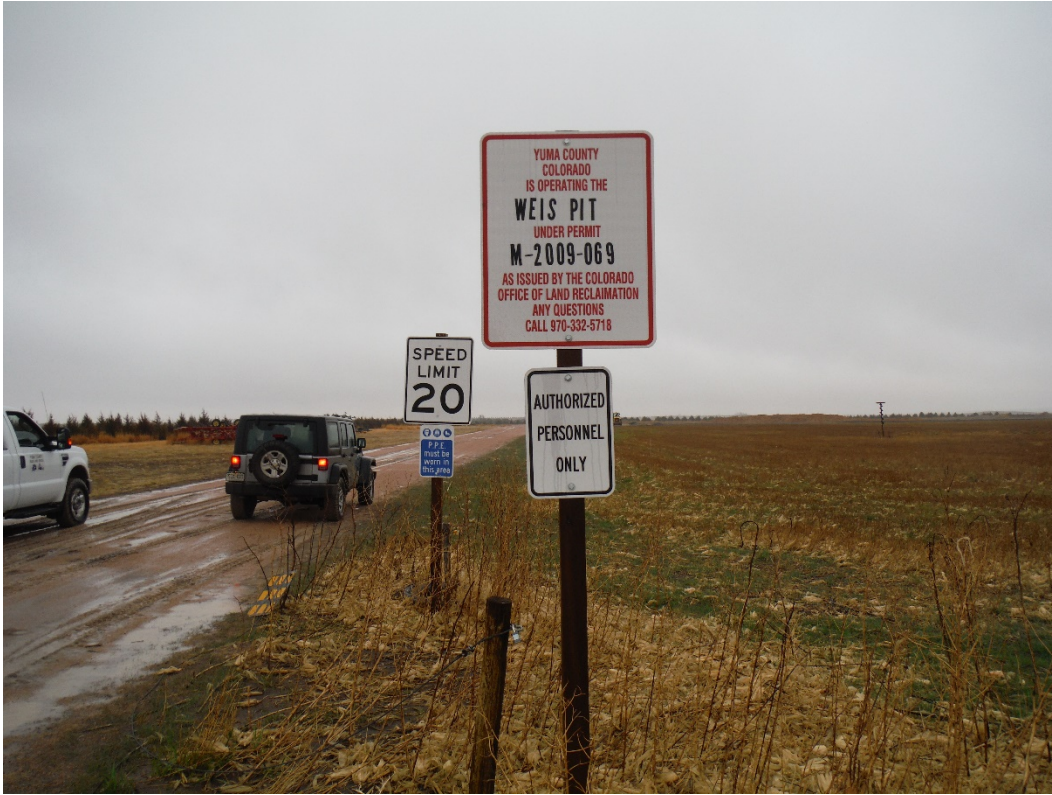
The Division met Don Marr and Mitch Witte at the mine site entrance on the east side of County Road 61, approximately one mile south of County Road 18. The mine site identification sign was posted at the entrance and was in compliance with Rule 3.1.12(1). The permit boundary was delineated by a metal t-posts and augers. The site was not active at the time of the inspection, however, the Division observed evidence of recent activity.

**Photo 1.** Mine identification sign; looking east.

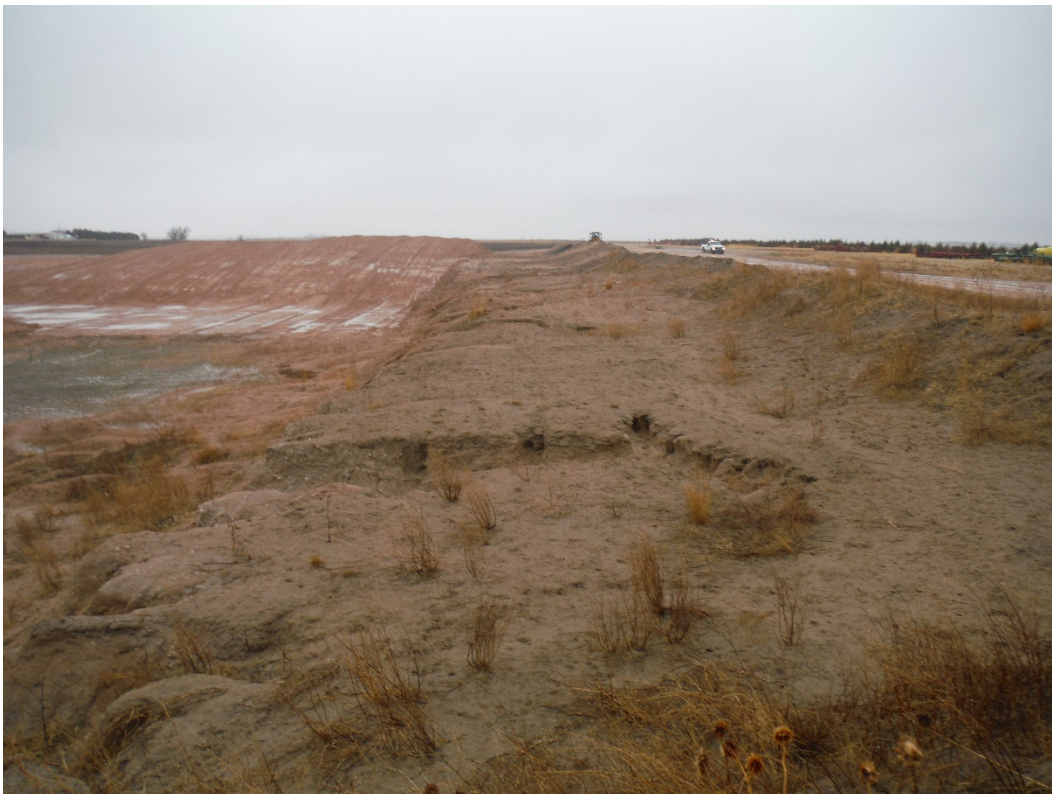
The site consists of a single pit which is advancing to the west. A large overburden stockpile and topsoil stockpile are located in the southeast portion of the site. The Division observed some minor erosion occurring on the pit slopes, but this is not cited as a problem because the sediment reports to the pit and the erosion is not affected undisturbed areas outside of the pit. The Division recommends the operator monitor the gullies and repair them if they start to head cut further.

**Photo 2.** Northern pit slope; looking west.

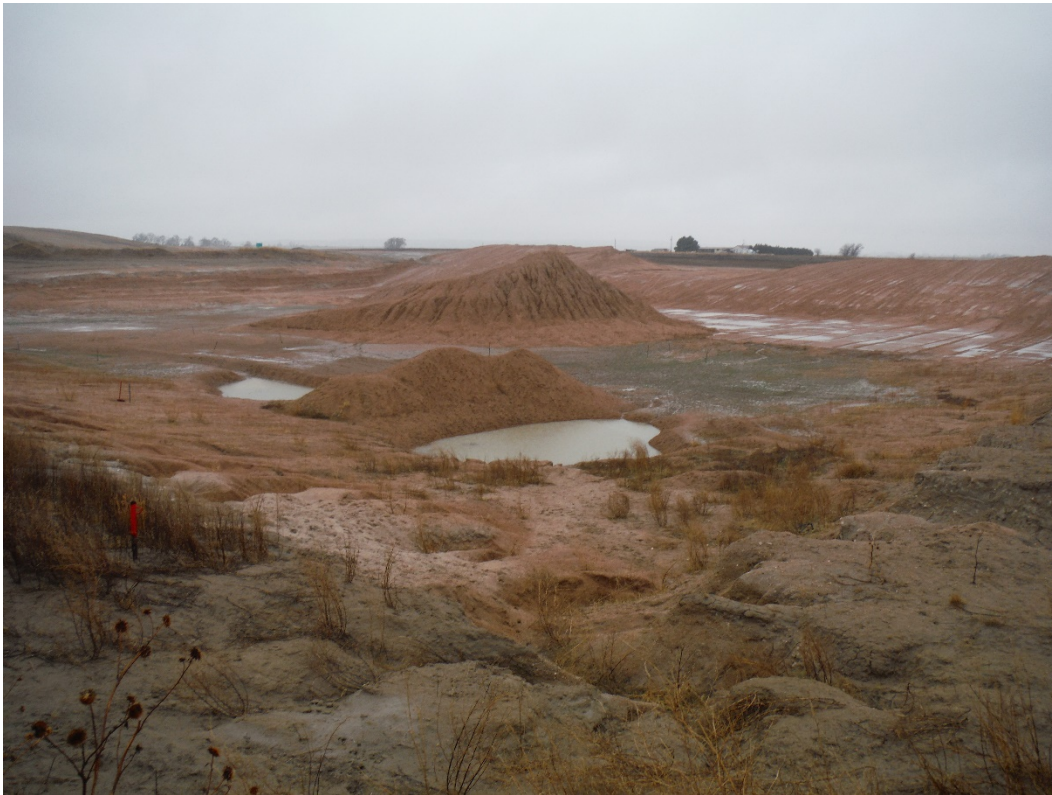
Some standing water was observed during the inspection, likely from recent rain events as well as the rainstorm during the inspection. Mr. Marr stated Yuma County has dealt with storm water and standing water on the pit floor since the operation commenced due to off-site areas draining to their operation. The Division and Mr. Marr discussed the possibility of redesigning the reclamation plan to help control off-site storm water. Utilizing a permanent berm like feature with appropriate up-gradient drainage around the pit could be an option if Yuma County chooses to do so in the future. These plans will need to be submitted for Division review and approval through the Technical Revision process. .

**Photo 3.** Pit overview; looking southwest.

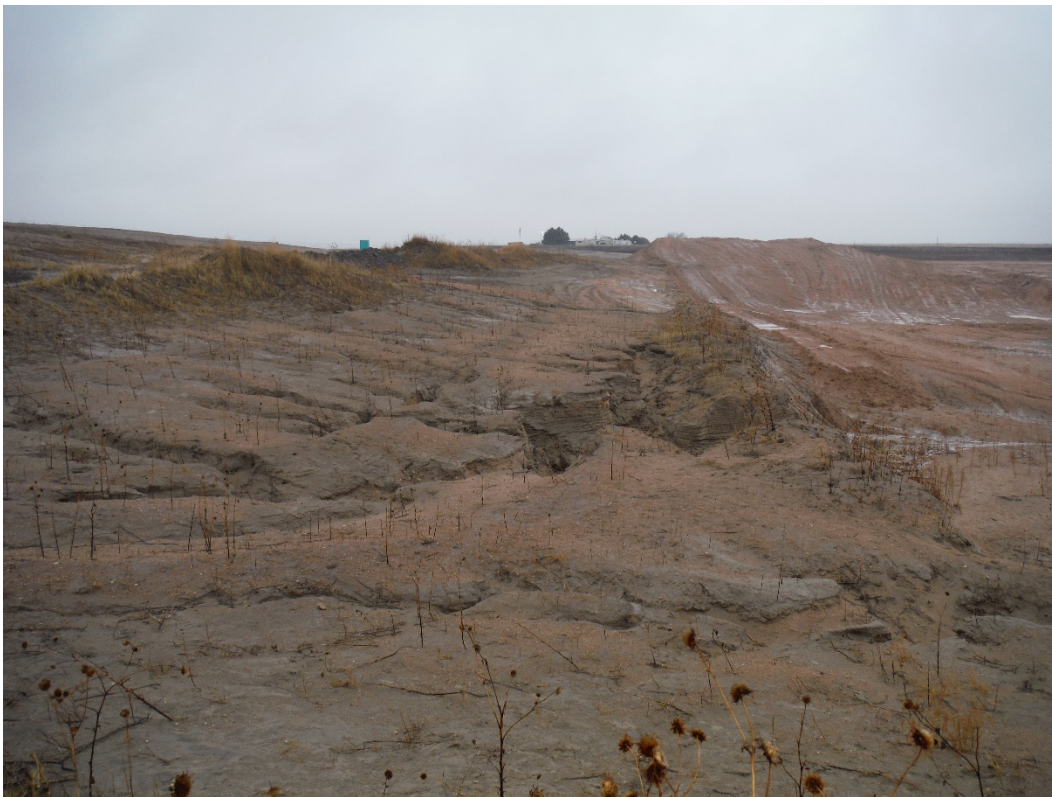
**Photo 4.** Southern pit slope; looking west.

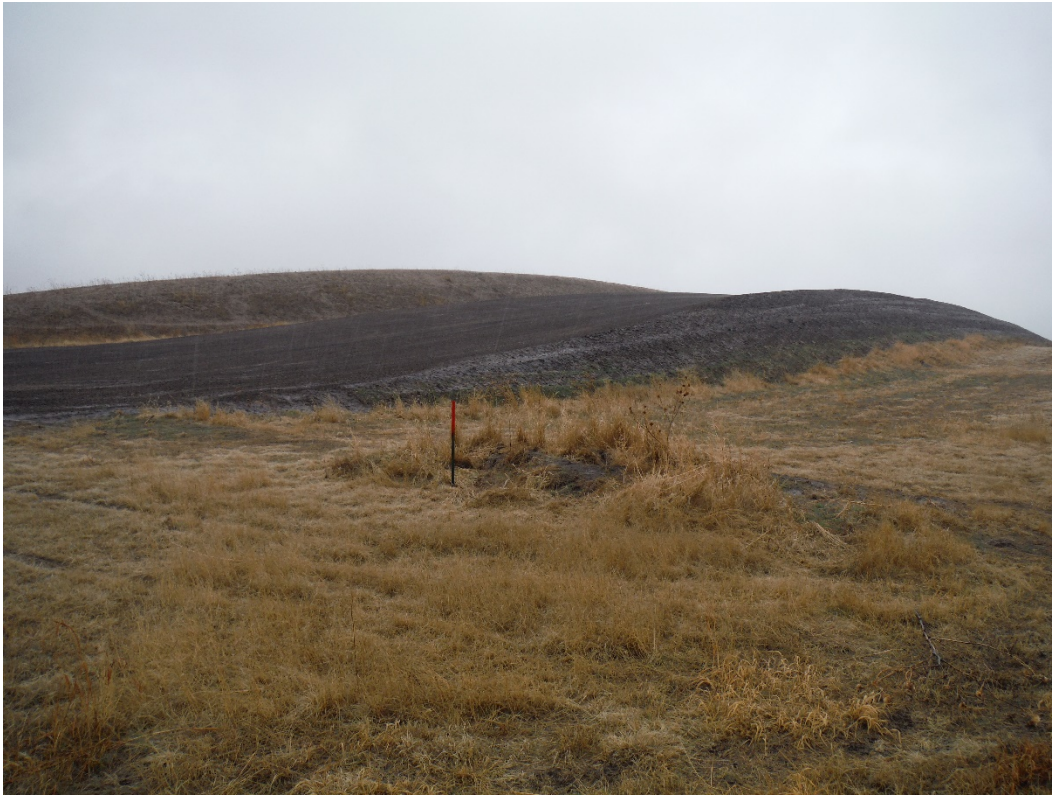
**Photo 5.** Topsoil stockpile (darker soil and in foreground) and overburden stockpile (lighter soil and in background); looking northwest.

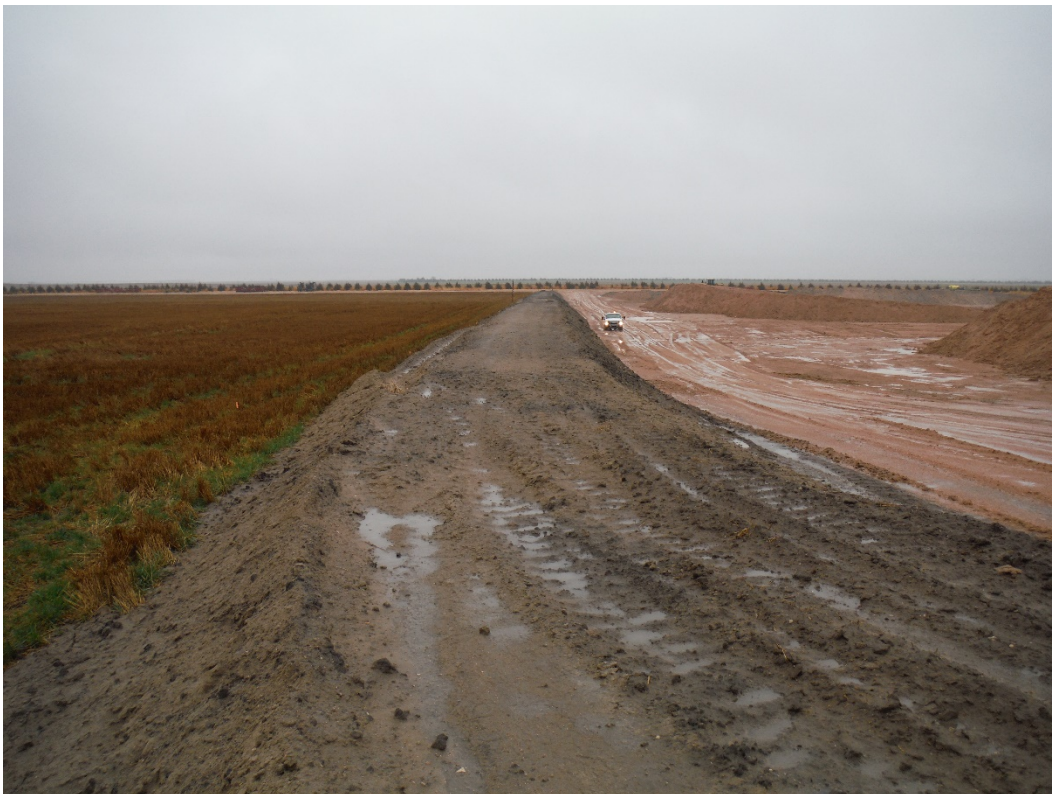
**Photo 6.** Active overburden face and product stockpiles, mine advancing to the west (left); looking north.
