MINERALS PROGRAM INSPECTION REPORT
PHONE: (303) 866-3567

MINE NAME: Pheasant Run Gravel Pit	MINE/PROSPECTING ID#: M-2007-069	MINERAL: Gravel, sand, borrow	COUNTY: Pueblo
INSPECTION TYPE: Monitoring	INSPECTOR(S): Elliott R. Russell	INSP. DATE: March 1, 2017	INSP. TIME: 11:00
OPERATOR: Tony J. Beltramo and Sons, Inc.	OPERATOR REPRESENTATIVE: Alan Thorson	TYPE OF OPERATION: 112c - Construction Regular Operation

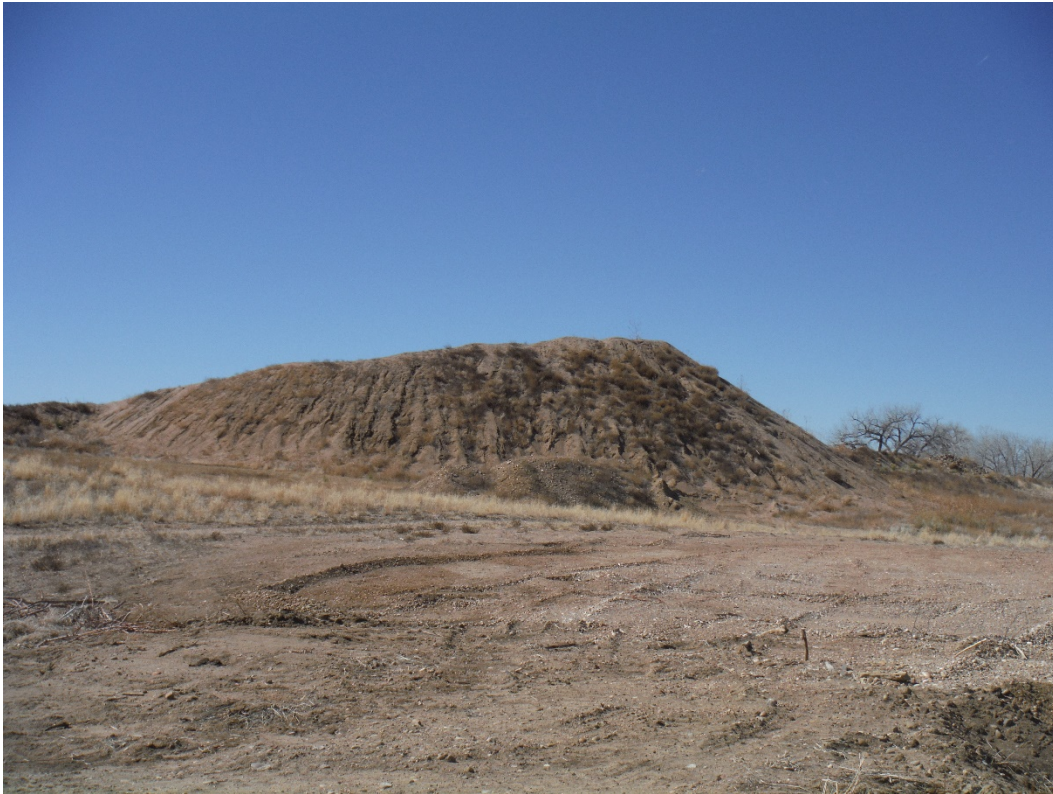
The Division met Mr. Thorson at the mine site entrance on the west side of Nepesta Road, 700 feet north of US Highway 50. The site consists of two areas on either side of the Highline Canal. Older mining areas (see **Photos 1 & 2**), which could be best described as terrace excavations, are along the north/east side of the canal and the newer, more active, pit (see **Photos 3 & 4**) on the south/west side of the canal. A small temporary bridge spans the canal to access the active pit (see **Photo 5**). The site was not active at the time of the inspection, however, there was evidence of recent activity. Equipment on the site consisted of a front-end loader.

Photo 1. Older portion of site; looking northwest.

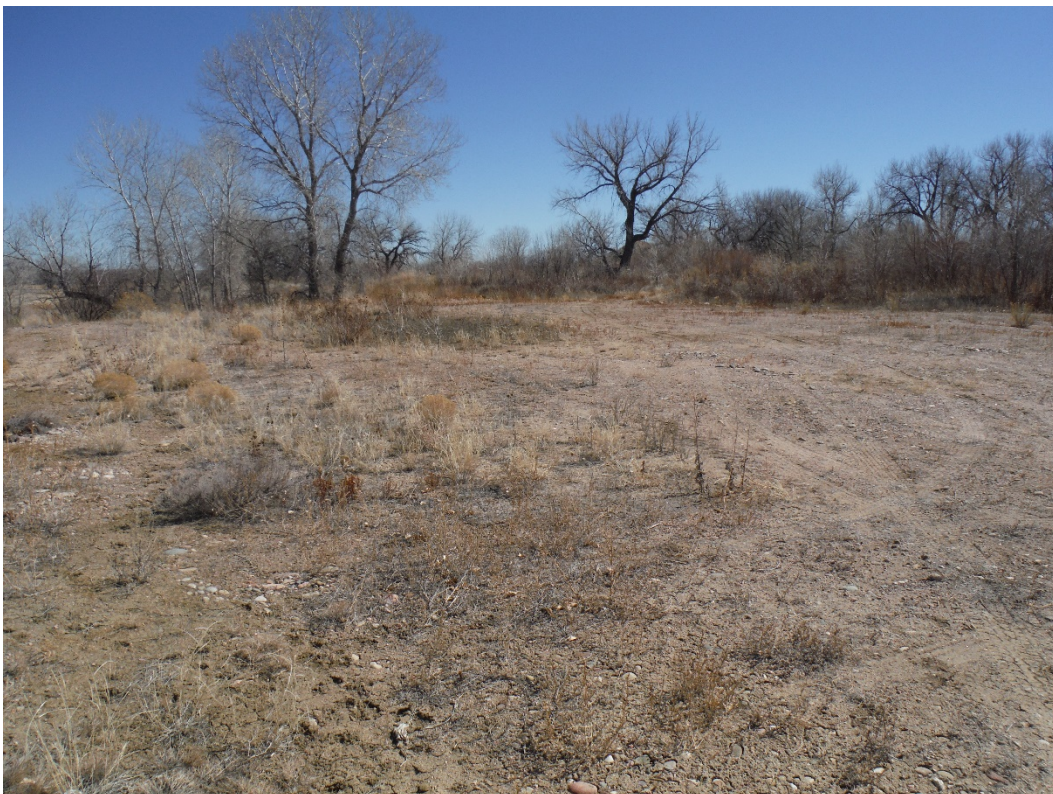
Photo 2. Older portion of site; looking south.

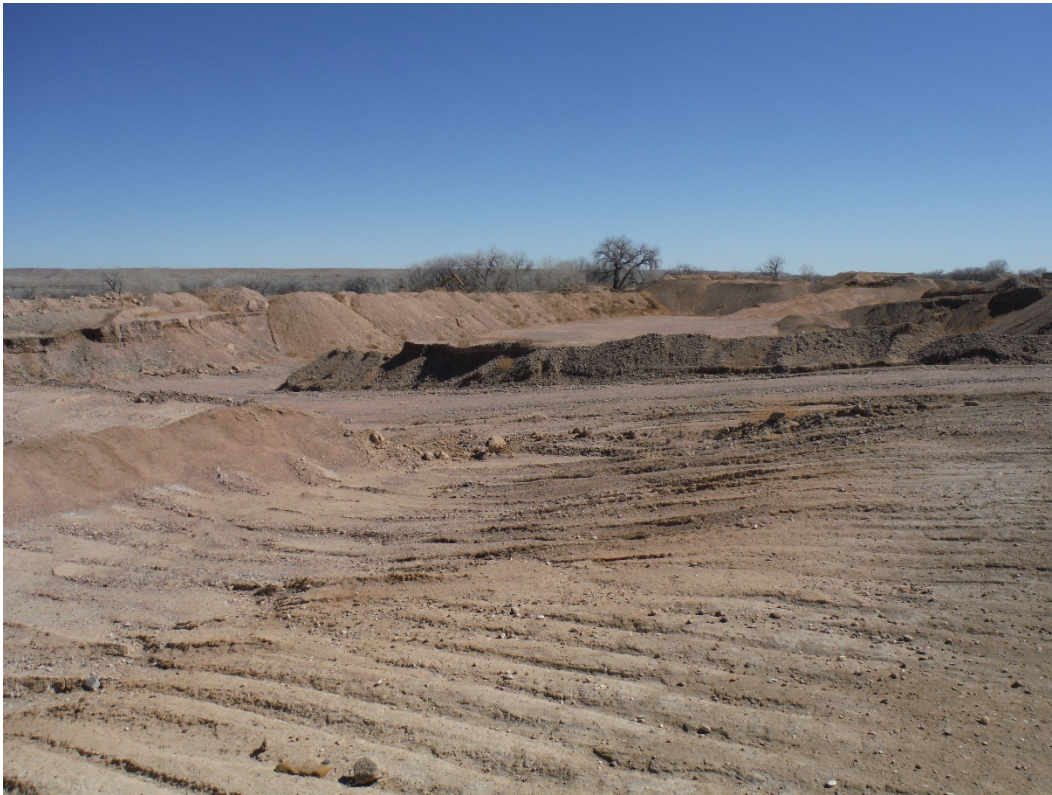
Photo 3. Newer portion of site; looking east.

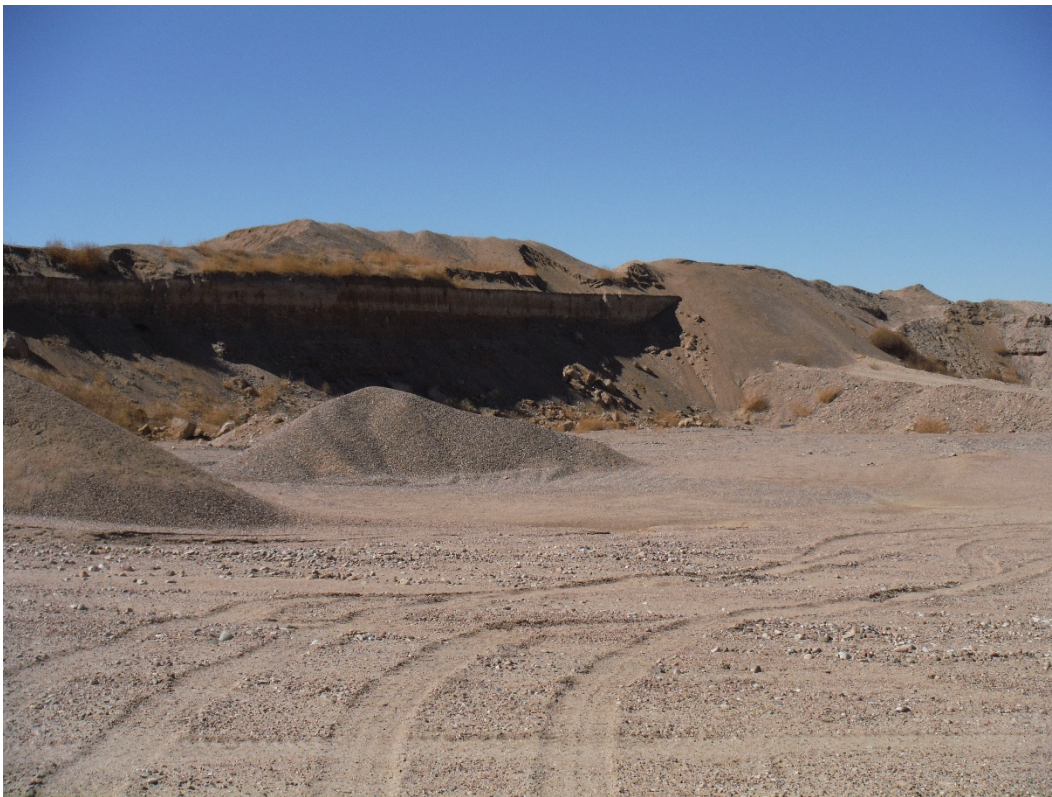
Photo 4. Pit highwall within newer portion of site; looking northwest.

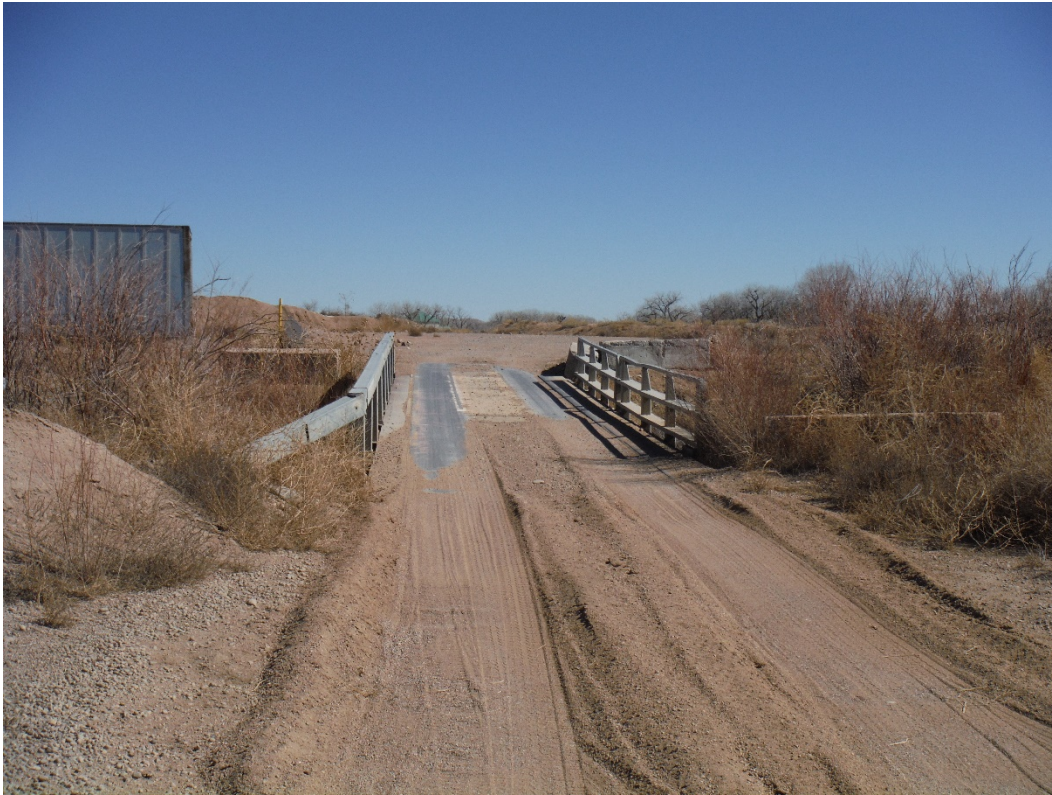
Photo 5. Bridge crossing the Highline Canal; looking east.

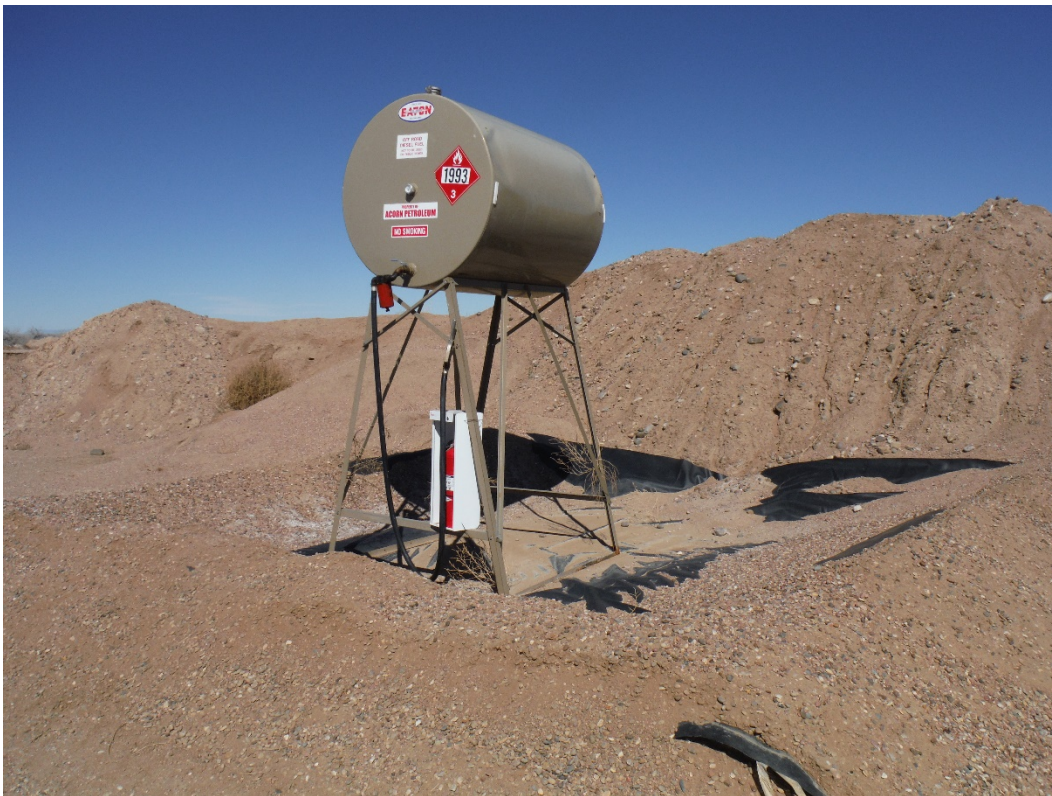
Acid Or Toxic Materials: A diesel fuel storage tank was located on-site over a lined and bermed secondary containment (see **Photo 6**). Two 55 gallon drum of hydraulic fluid were located on-site, but not stored within a secondary containment structure nor appeared to be double walled (see **Photo 7**). This is cited as Compliance Problem #1 on page two of this report. On March 17, 2017, the Division received photo documentation and a statement from the Operator that the drums were removed from the site, resolving the compliance problem.

Photo 6. Diesel fuel storage and secondary containment; looking north.

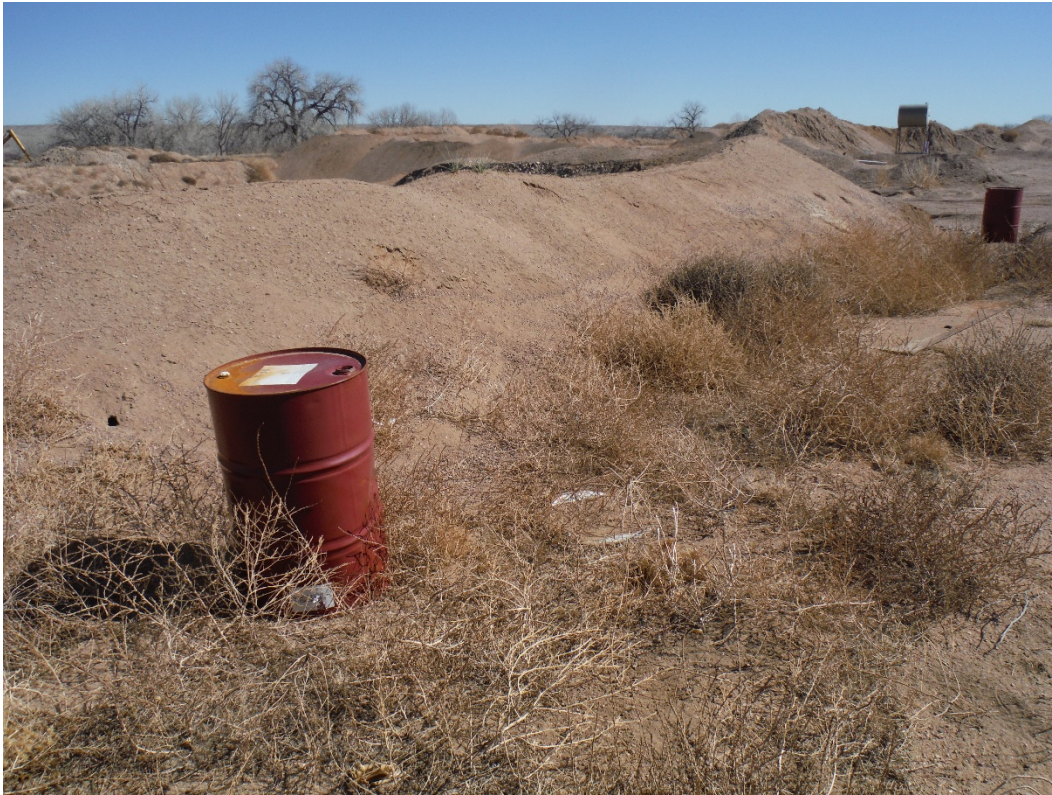
COMPLIANCE PROBLEM #1: Improper storage and containment of fuels and/or other hazardous materials was present on site.

Photo 7. 55 gallon drums of hydraulic fluid; looking southeast.

CORRECTIVE ACTIONS: All storage tanks, petroleum and any hazardous materials on site for any period of time shall have appropriate secondary containment. The site will also have to comply with all applicable SPCC requirements. Please supply photo documentation that any fuel or hazardous materials containers are stored properly - including applicable secondary containment structures by the corrective action date. Note that secondary containment structures shall consist of an impermeable containment which could contain all contents of the tanks and various containers (when full) plus 10% of the total capacity. The operator may also provide photo documentation that all containers have been removed from the site on or before the corrective action date.

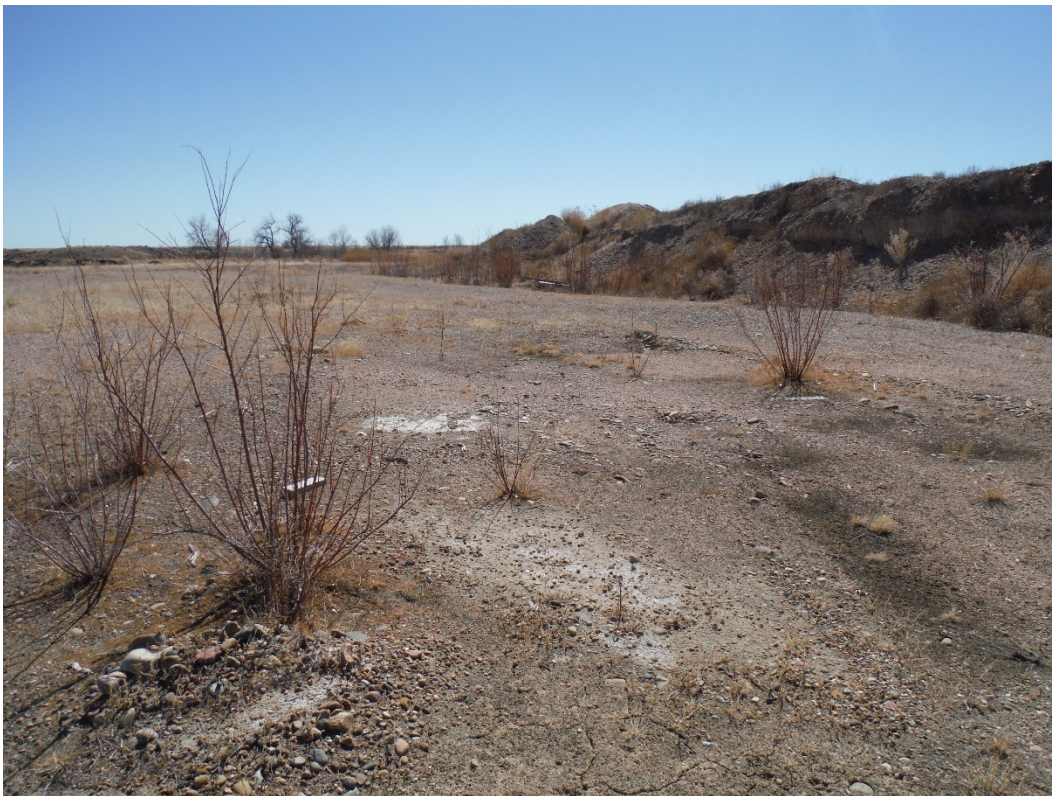
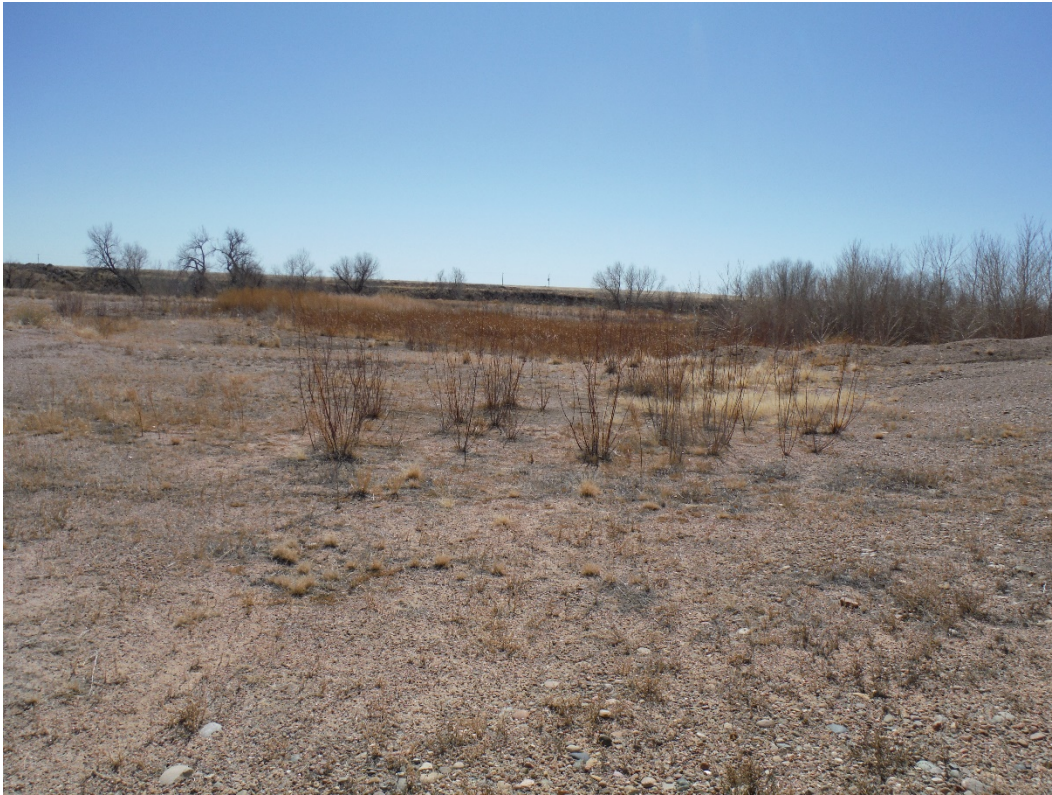
COMPLIANCE PROBLEM #2: Tamarisk (salt cedar) trees are present within or have volunteered into the permit area and are becoming established. This is a problem for failure to employ weed control methods for a state listed noxious weed species within the permitted area, and to reduce the spread of weeds to nearby areas as required by Rule 3.1.10 (6).

Revegetation: Tamarisk (salt cedar) trees were observed on the older portion of the site (see **Photos 8 & 9**). This is a noxious weed List B species which will need to be controlled in accordance to the approved weed control plan within the 2007 permit application materials. This is cited as Compliance Problem #2 on page two of this report.

Photo 8. Tamarisk located on older portion of site; looking south.

Photo 9. Tamarisk located on older portion of site; looking south.

CORRECTIVE ACTIONS: The operator shall implement the existing weed control plan and provide proof of implementation.

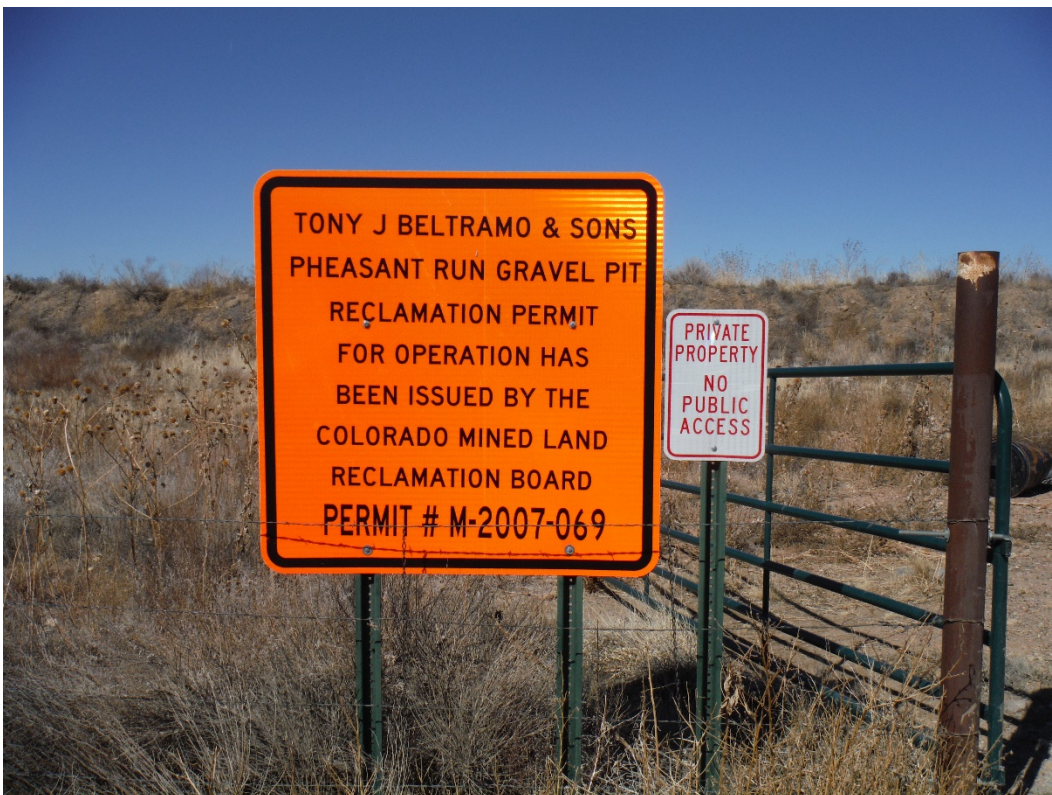
Signs and Markers: The permit sign was properly posted at the entrance to the site (see **Photo 10**). Boundary markers, delineating the permit boundary, were all observed in place.

Photo 10. Mine identification sign along Nepesta Road; looking north.
