MINERALS PROGRAM INSPECTION REPORT
PHONE: (303) 866-3567

MINE NAME: Austin Pit	MINE/PROSPECTING ID#: M-1986-047	MINERAL: Sand, gravel, clay	COUNTY: Phillips
INSPECTION TYPE: Monitoring	INSPECTOR(S): Elliott R. Russell	INSP. DATE: May 17, 2017	INSP. TIME: 11:10
OPERATOR: Phillips County	OPERATOR REPRESENTATIVE: Randy Schafer	TYPE OF OPERATION: 110c - Construction Limited Impact

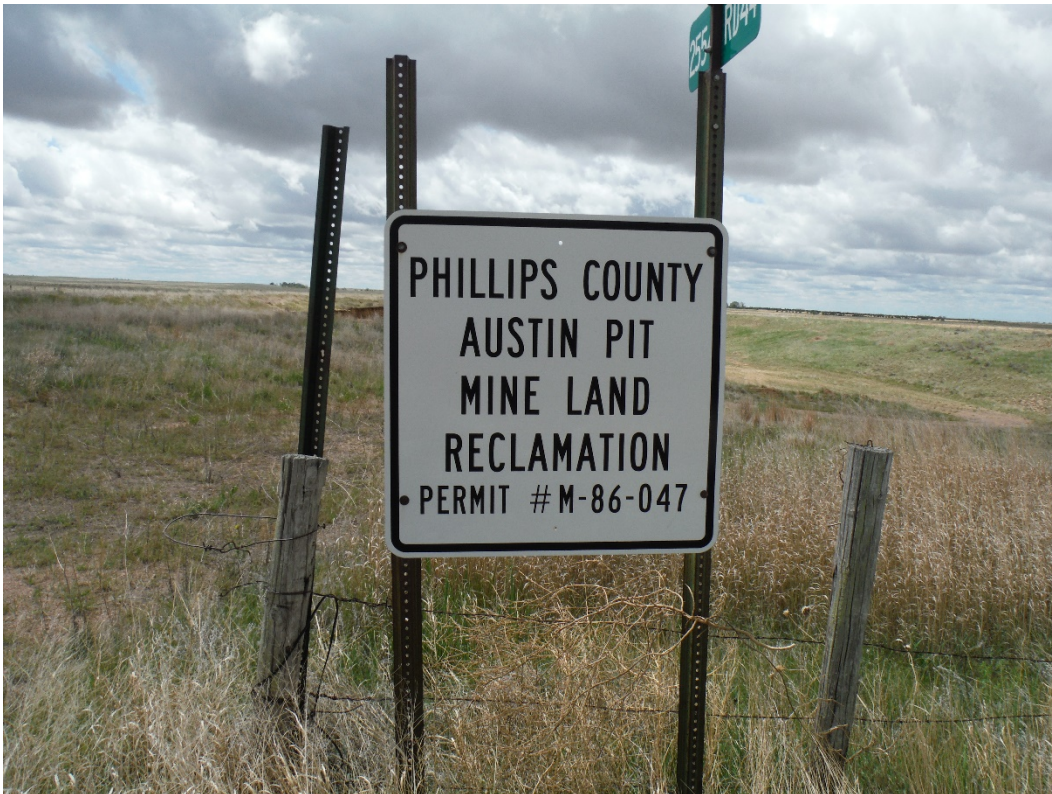
Signs and Markers: The permit sign was properly posted and permit boundary was marked by fence lines.

Photo 1. Permit identification sign posted at the site entrance; looking south.

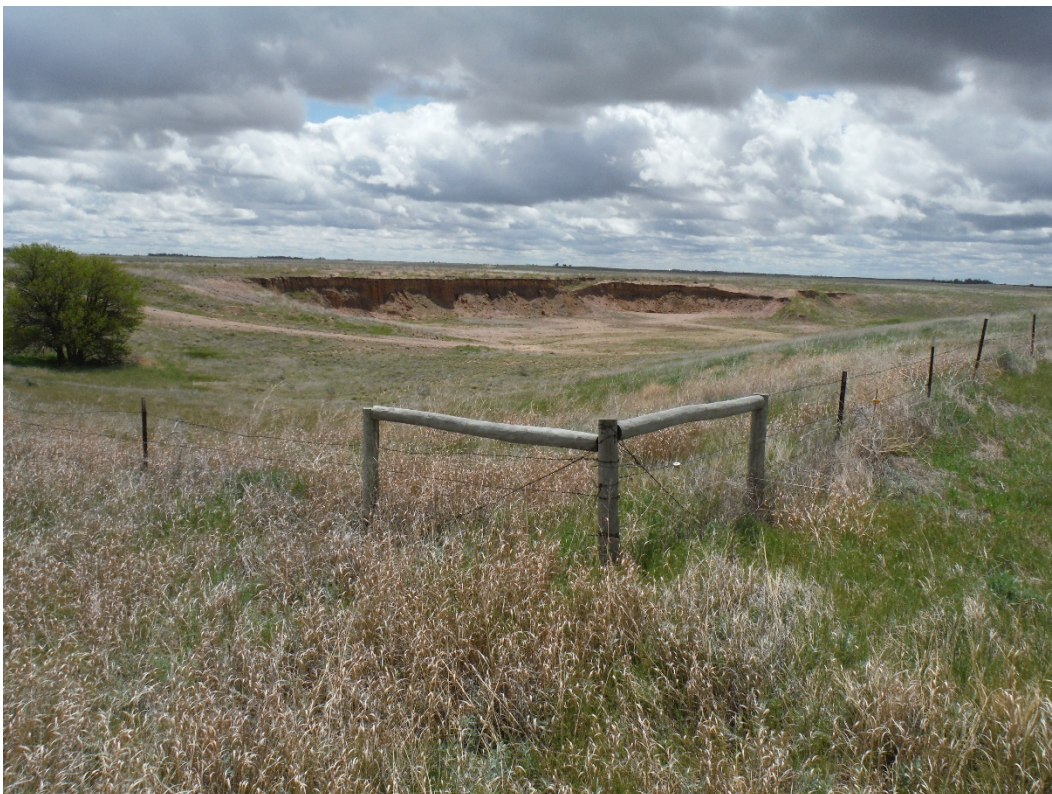
Photo 2. Northwest boundary corner and site overview; looking southeast.

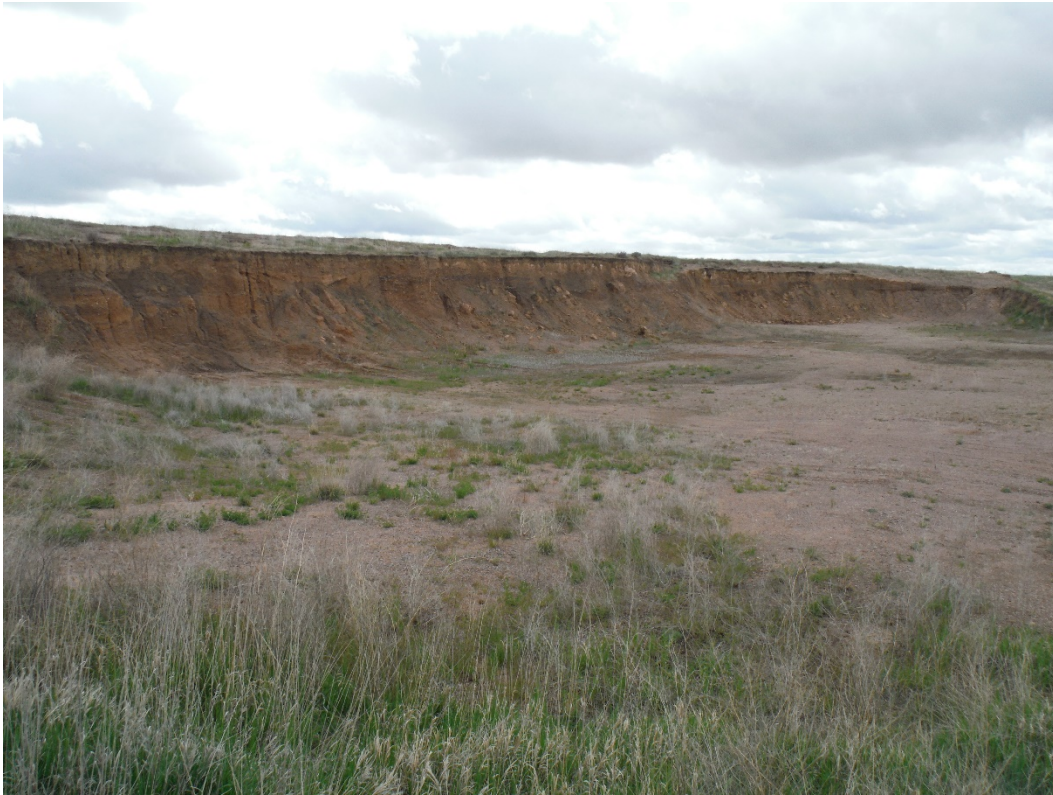
Photo 3. Mining highwall along eastern side of the site; looking southeast.

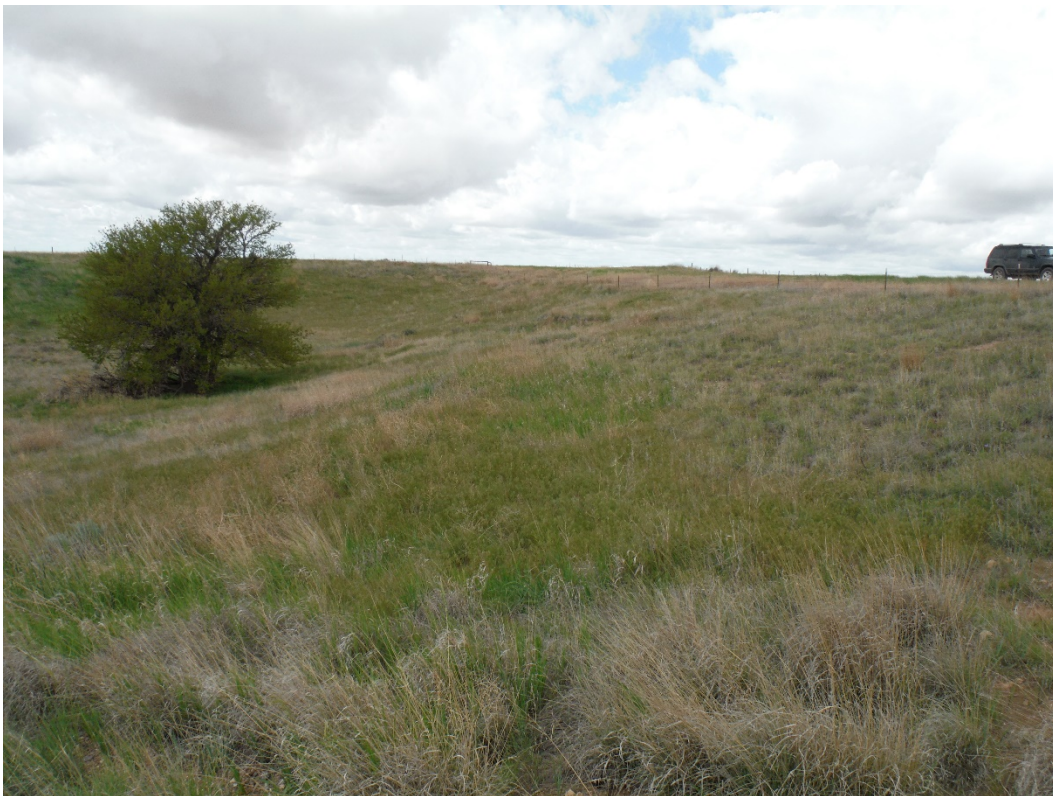
Backfilling and Grading: The northern and western slopes appeared to be appropriately graded.

Revegetation: The northern and western slopes were revegetated. No noxious weeds were observed.

Photo 4. Reclaimed northern slope of the site; looking west.

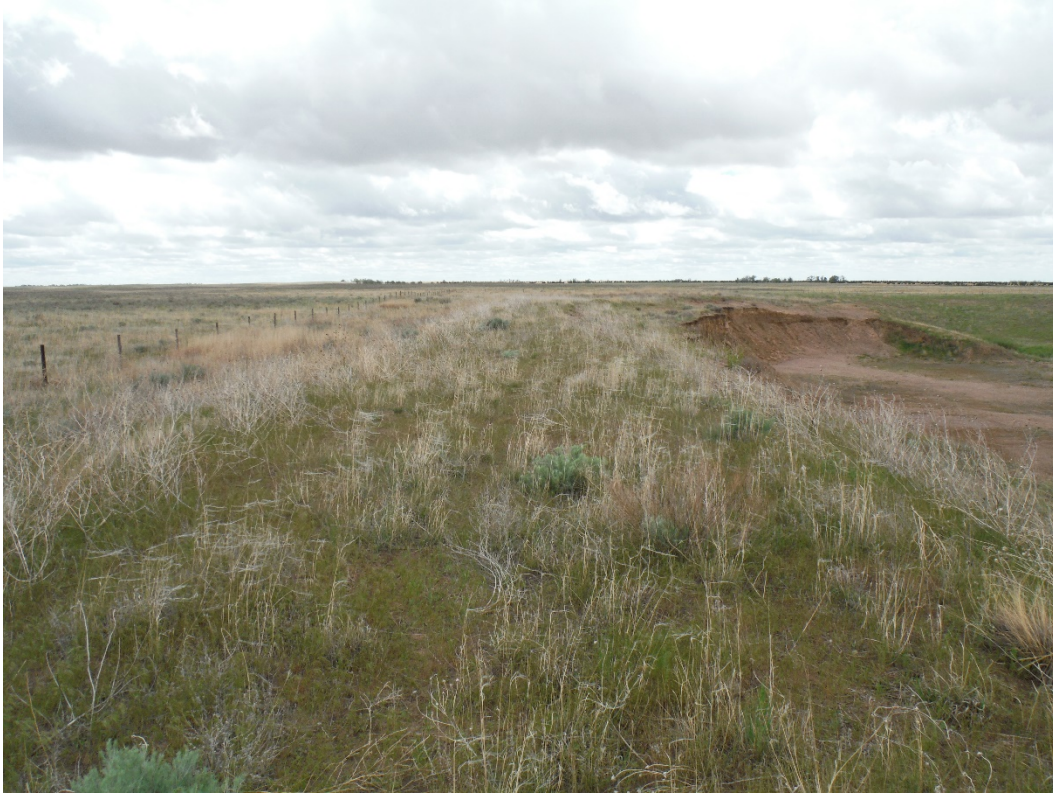
Topsoil: A topsoil stockpile is located along the eastern permit boundary. This stockpile was vegetated and appeared stable.

Photo 5. Topsoil stockpile located between the highwall and eastern boundary; looking south.
