**MINERALS PROGRAM INSPECTION REPORT**  
**PHONE: (303) 866-3567**

<b>MINE NAME:</b> Kennedy Pit	<b>MINE/PROSPECTING ID#:</b> M-1990-116	<b>MINERAL:</b> Sand and gravel	<b>COUNTY:</b> Phillips
<b>INSPECTION TYPE:</b> Monitoring	<b>INSPECTOR(S):</b> Elliott R. Russell	<b>INSP. DATE:</b> May 17, 2017	<b>INSP. TIME:</b> 12:15
<b>OPERATOR:</b> Phillips County	<b>OPERATOR REPRESENTATIVE:</b> Randy Schafer	<b>TYPE OF OPERATION:</b> 112c - Construction Regular Operation

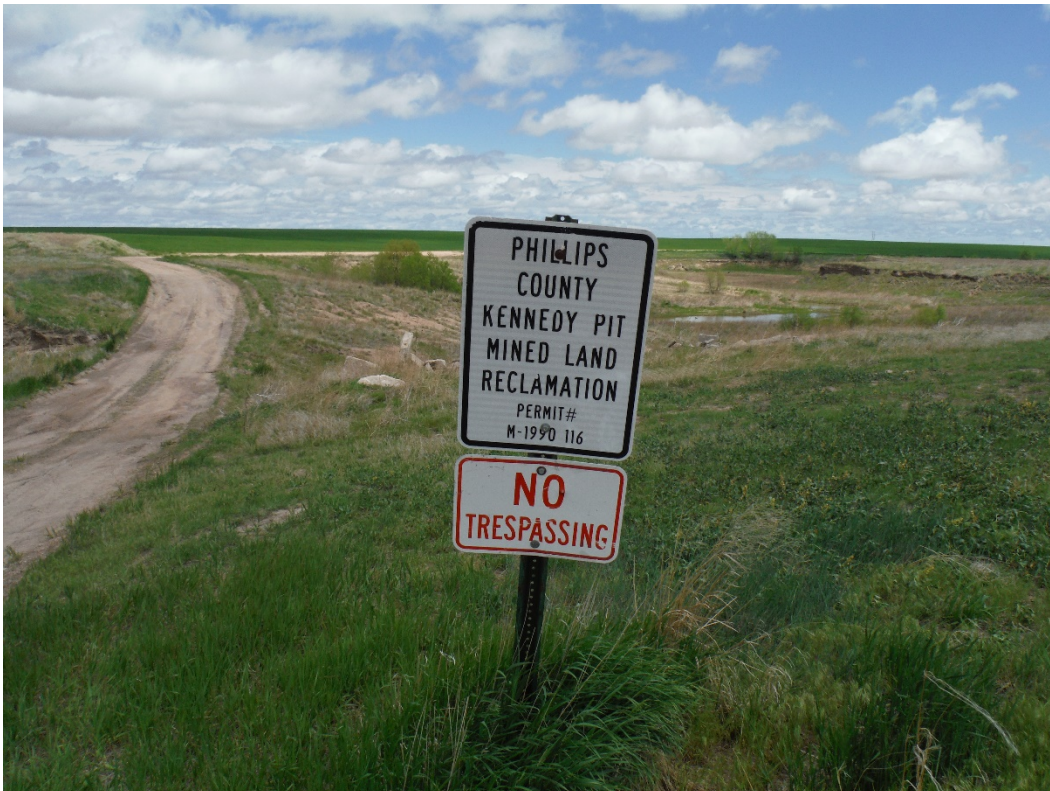
Signs and Markers: A permit identification sign is properly posted at each entrance to the site.

**Photo 1.** Mine identification sign at the western entrance; looking northeast.

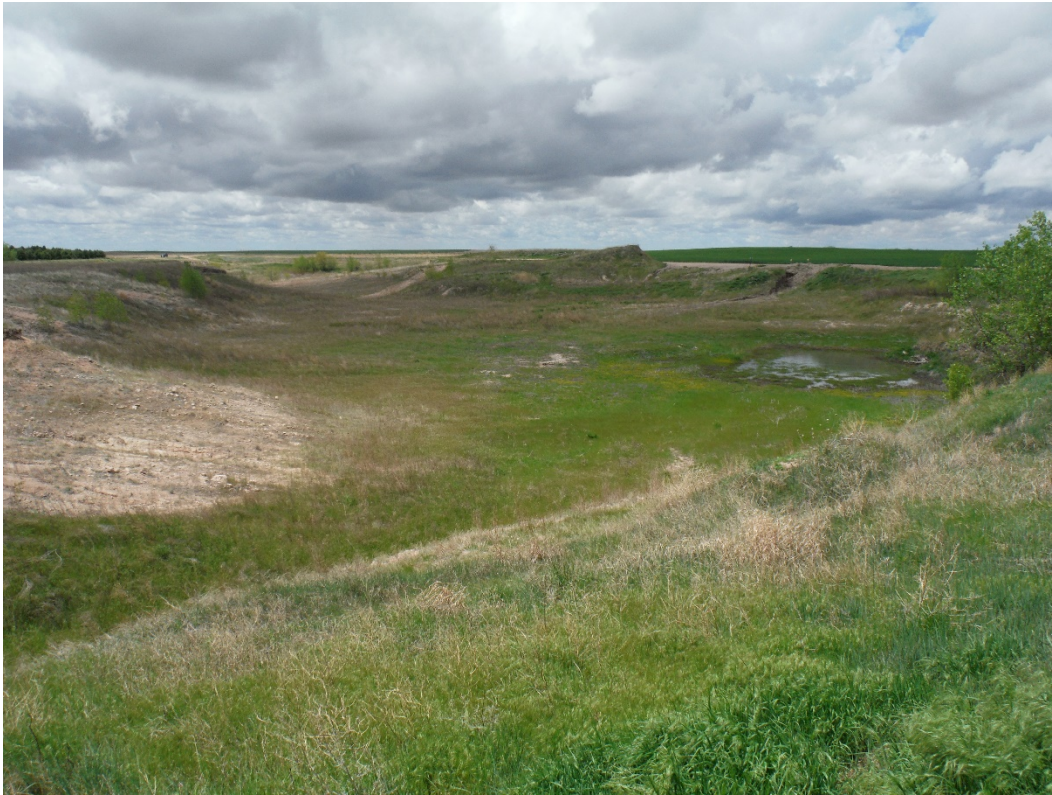
**Photo 2.** Site overview, eastern portion; looking west.

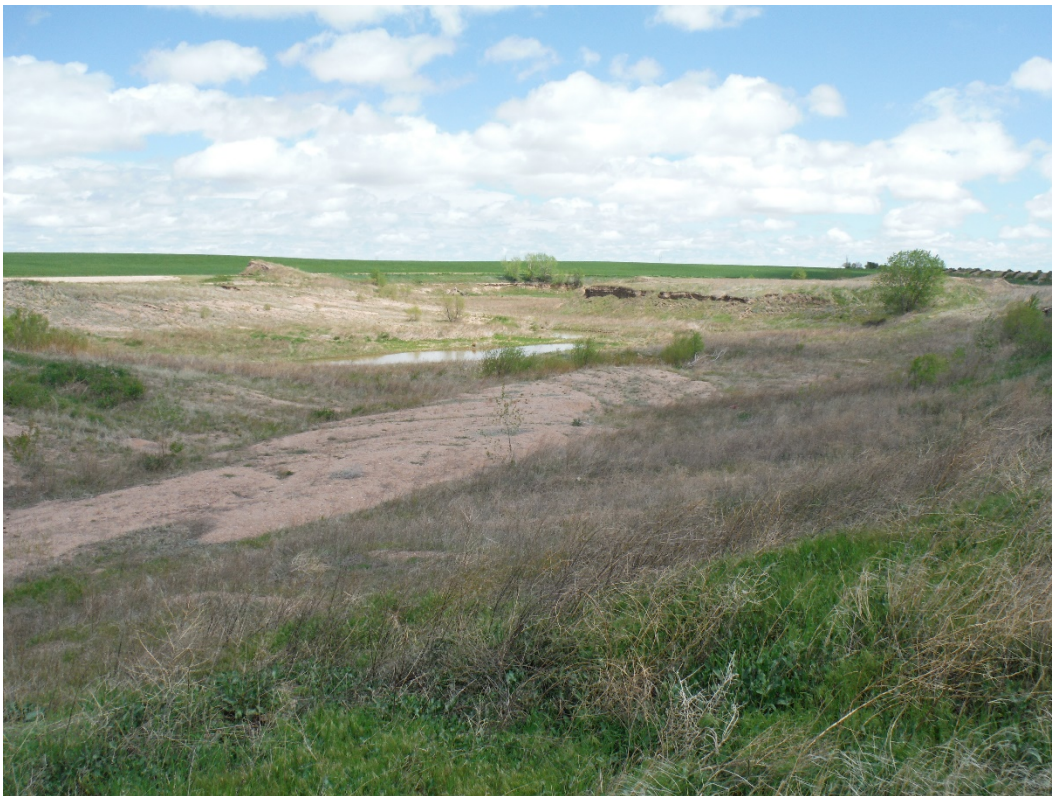
**Photo 3.** Site overview, western portion; looking northeast.

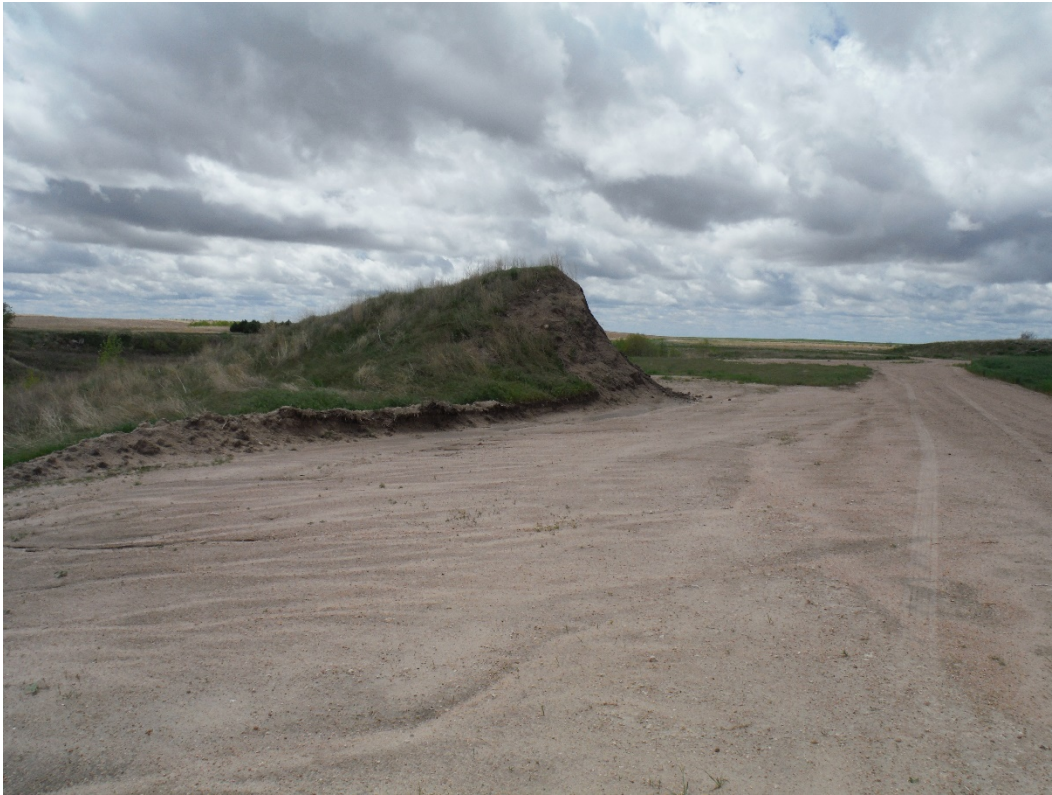
**Photo 4.** Product stockpile; looking southwest.

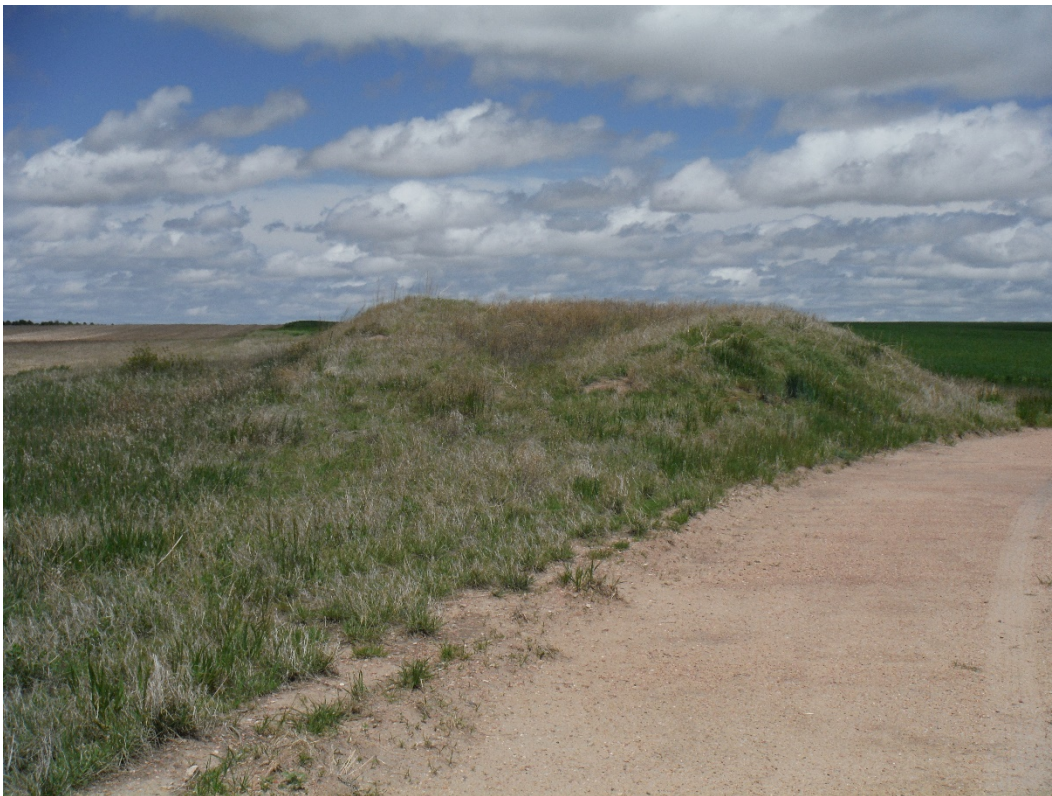
Topsoil: Topsoil stockpiles are located in the northwestern and southeastern portions of the site. Both stockpiles are vegetated and appeared stable.

**Photo 5.** Topsoil stockpile located in northwest portion of the site; looking north.

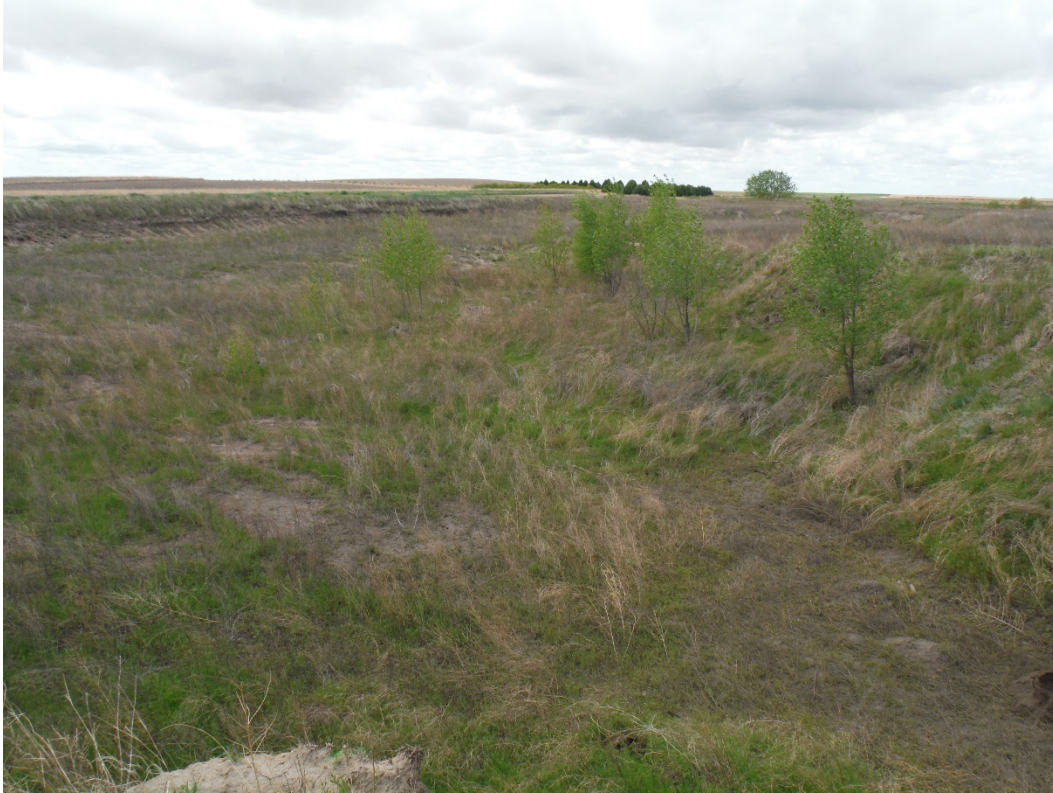
**Photo 6.** Small pit located in the southern portion of the site, on the inside meander of Frenchman Creek; looking southwest.

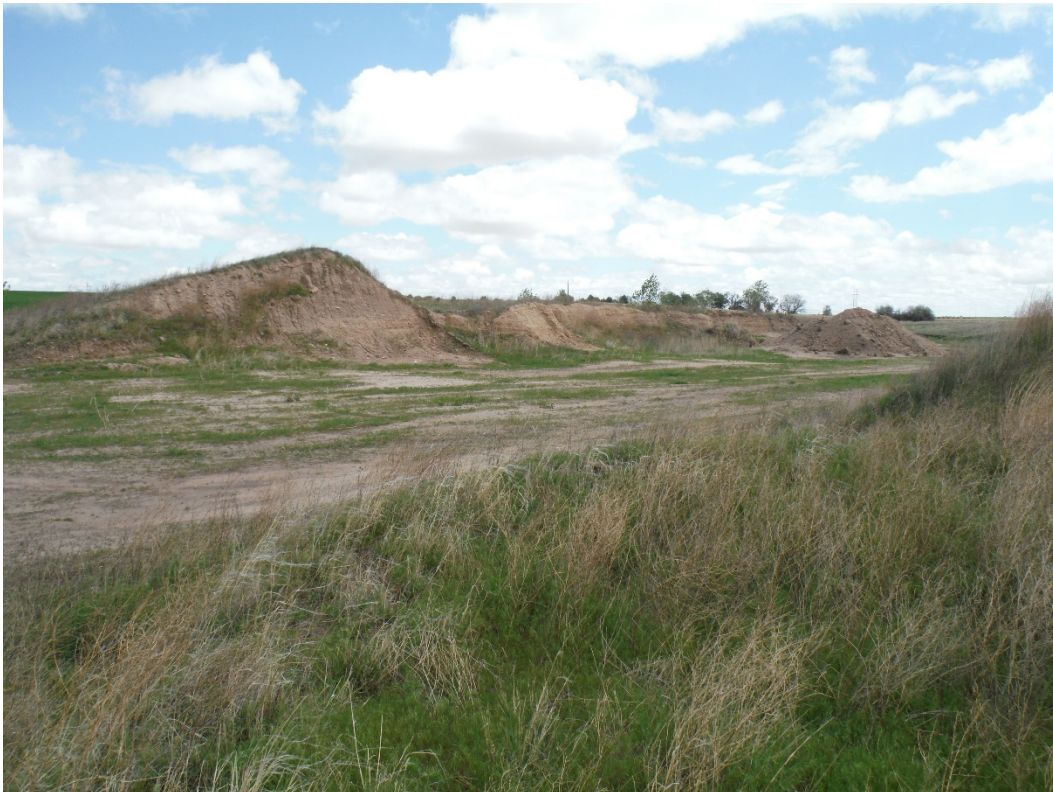
**Photo 7.** Product stockpiles located in southeast portion of the site; looking east.

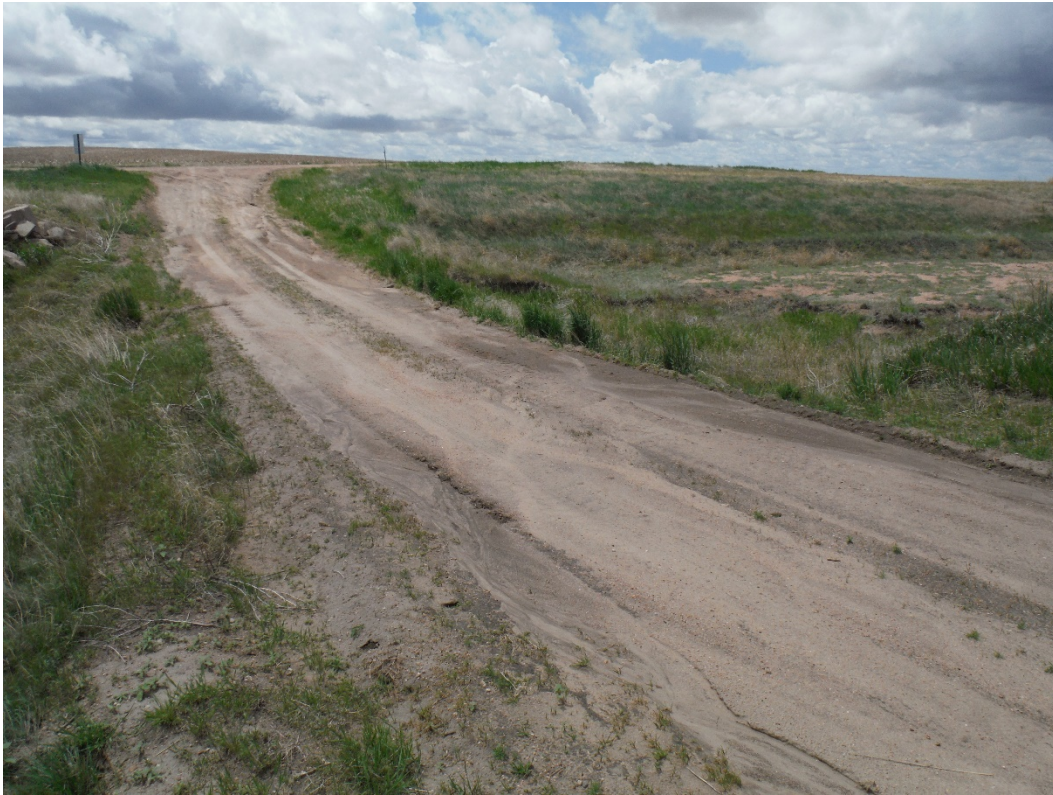
**COMPLIANCE PROBLEM:** The Operation's western access road is currently blocking the channel of Frenchman Creek.

Hydrologic Balance: By constructing the western access road across Frenchman Creek, the Operator has prevented the natural flow of the creek. The material that is placed across the creek channel for the access road, appears to prevent the natural flow of the creek. This is cited as a Compliance Problem.

**Photo 8.** Western access road across Frenchman Creek; looking southwest.

**CORRECTIVE ACTIONS:** The Operator shall remove the material blocking the natural flow of Frenchman Creek and submit photographs of the completed work before the corrective action deadline. The Operator may choose to submit a Technical Revision to the permit requesting the installation of appropriately-sized culverts instead of creating an at-grade crossing. The revision shall be submitted before the corrective action deadline.

**CORRECTIVE ACTION DUE DATE: September 22, 2017**

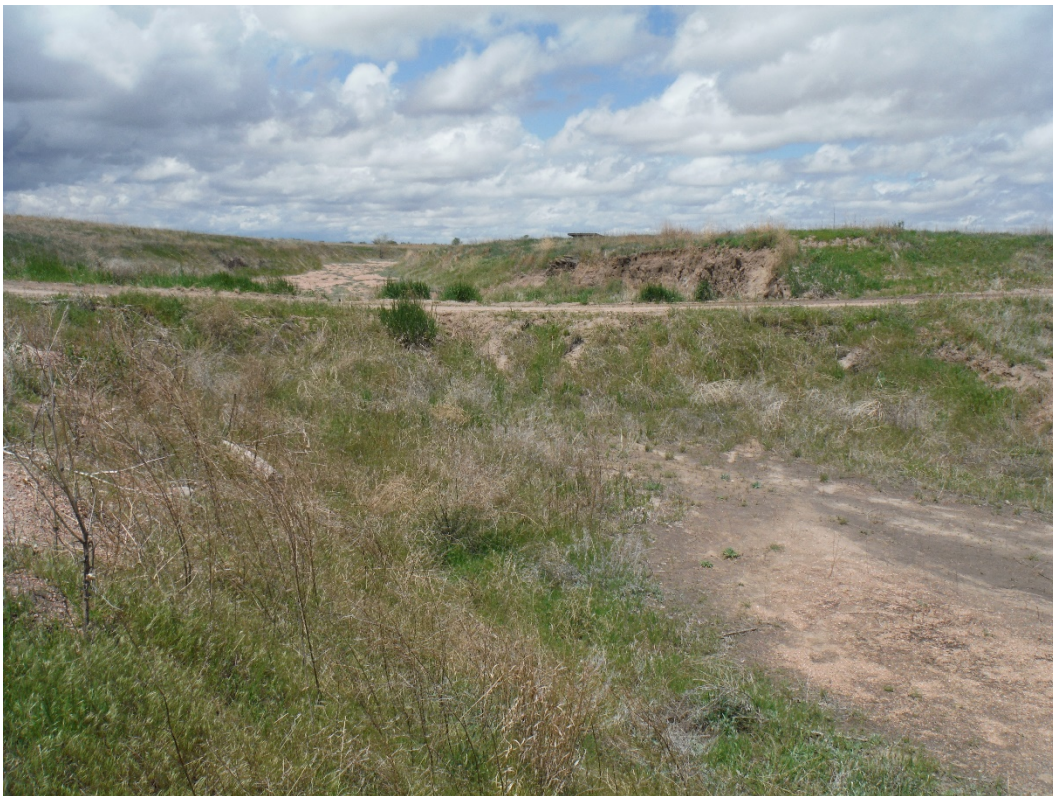
**Photo 9.** Western access road across Frenchman Creek; looking west (upstream).
