MINERALS PROGRAM INSPECTION REPORT
PHONE: (303) 866-3567

MINE NAME: Big "G" Gravel Pit	MINE/PROSPECTING ID#: M-2006-081	MINERAL: Sand and gravel	COUNTY: Pueblo
INSPECTION TYPE: Monitoring	INSPECTOR(S): Elliott R. Russell	INSP. DATE: May 18, 2017	INSP. TIME: 11:45
OPERATOR: Daniel J. Gaudreault and Barbara J. Gaudreault	OPERATOR REPRESENTATIVE: Daniel Gaudreault	TYPE OF OPERATION: 112c - Construction Regular Operation

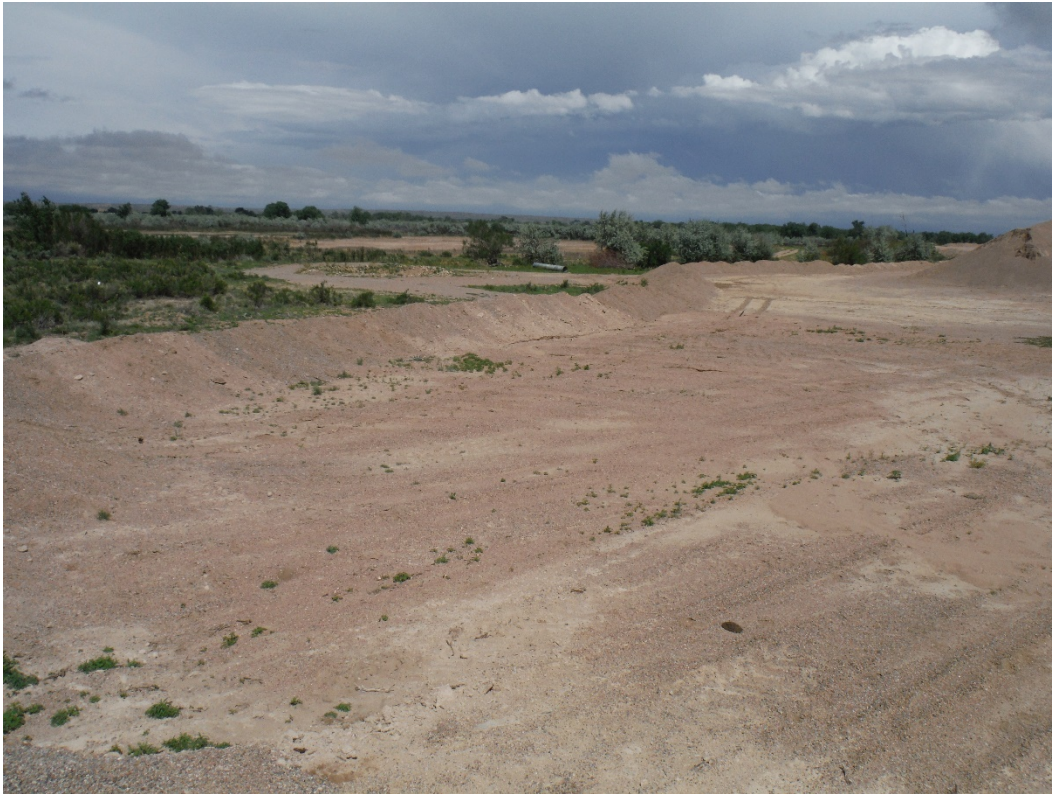
After discussing the various issues at the site involving off-site damage, phased bonding, and past due Annual Reports and Fees, the Division inspected the status of the implementation of storm water controls in the northern mining area. An appropriate berm has been installed between the Highland Canal and the large processing area. Based on silt levels, it appears the berm has already been effective at controlling storm water allowing sediment to settle out on-site. However, the drainage ravine located southeast of the first terrace being mined does not have appropriate storm water controls in place. This has been cited as Compliance Problem #1 requiring the Operator to establish an adequate berm before the Highland Canal to keep storm water and sediment on-site.

Photo 1. Storm water control berm around lower portion of the processing/stockpile area; looking northeast.

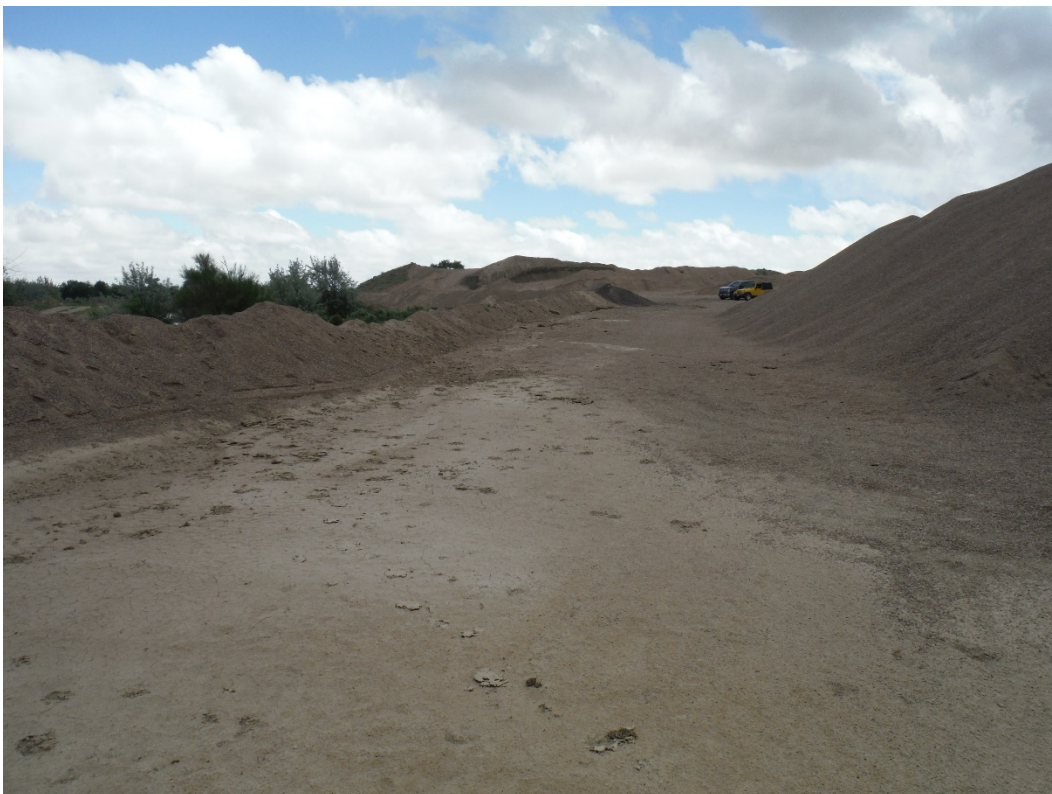
Photo 2. Storm water control berm around lower portion of the processing/stockpile area; looking southeast.

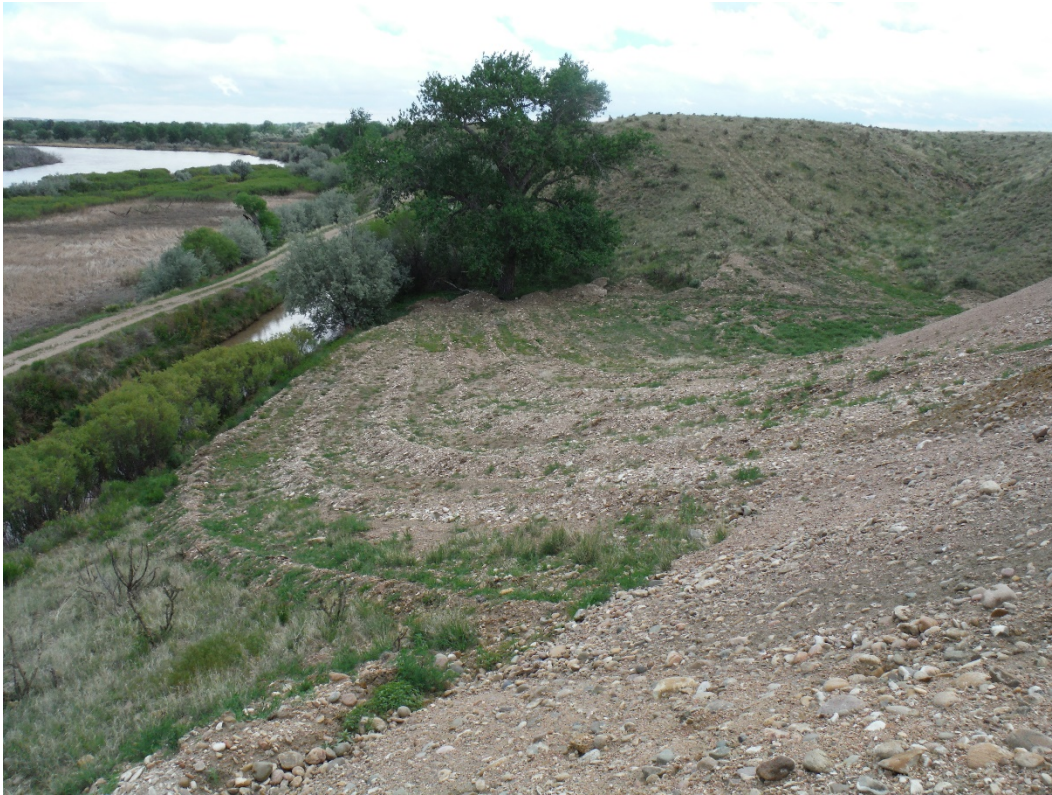
COMPLIANCE PROBLEM #1: Approved storm water control and sedimentation prevention methods have not been implemented or have not been constructed appropriately.

Photo 3. Drainage ravine where additional storm water management techniques are needed; looking southeast.

CORRECTIVE ACTIONS: The operator shall submit photographic evidence showing storm water control methods have been implemented.

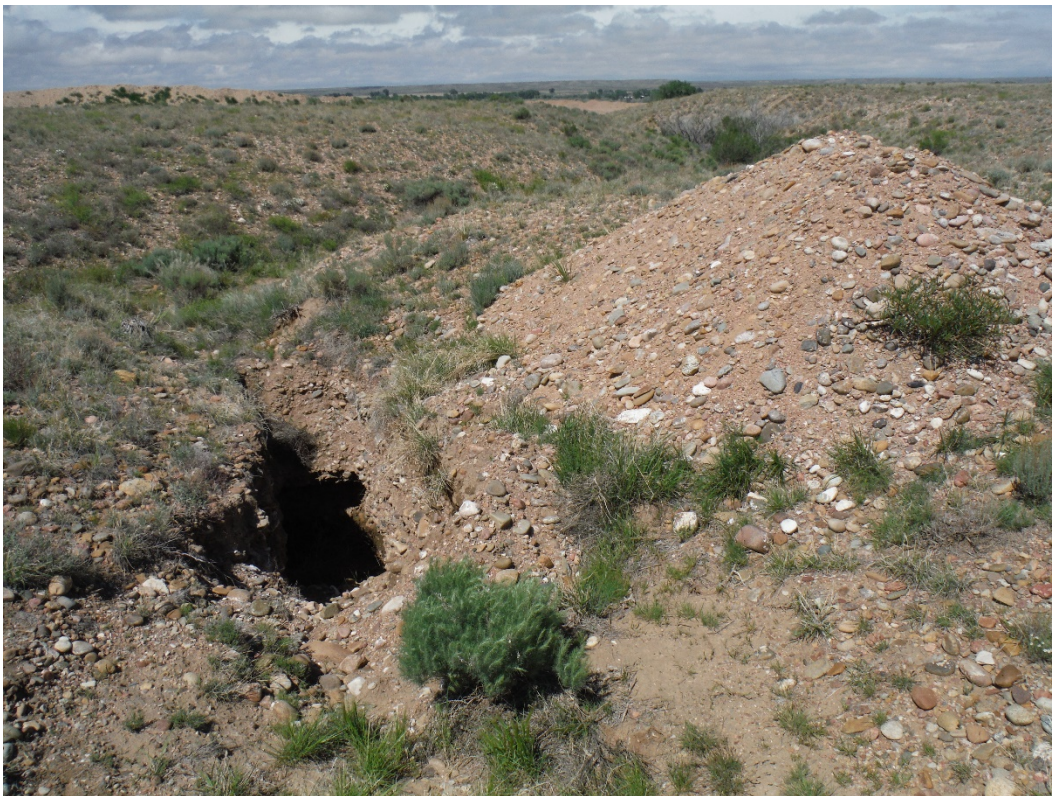
COMPLIANCE PROBLEM #2: An open test pit poses a threat to wildlife/livestock.

During the inspection, the Division observed an open test pit just south of the active mining area at 38.188640° N 104.191612° W. It appears this pit/trench was used to determine the depth of the deposit, however, since it was left open with vertical sides, it is a wildlife hazard. If the site is grazed, this test pit could also be a hazard for the livestock. This has been cited as Compliance Problem #2 requiring the operator to either backfill the test pit or safeguard it by other means.

Photo 4. Open test pit which poses as a hazard; looking north.

CORRECTIVE ACTIONS: The operator shall submit photographic evidence showing the test pit has been backfilled or safeguarded.
