MINERALS PROGRAM INSPECTION REPORT
PHONE: (303) 866-3567

MINE NAME: Rex Quarry - Sec 36	MINE/PROSPECTING ID#: M-1977-304	MINERAL: Limestone (general)	COUNTY: Larimer
INSPECTION TYPE: Monitoring	INSPECTOR(S): Jared L. Ebert	INSP. DATE: July 18, 2017	INSP. TIME: 11:00
OPERATOR: Pete Lien & Sons, Inc.	OPERATOR REPRESENTATIVE: Rob Kisner	TYPE OF OPERATION: 112c - Construction Regular Operation	
REASON FOR INSPECTION: Normal I&E Program	BOND CALCULATION TYPE: Complete Bond	BOND AMOUNT: \$654,500.00	
DATE OF COMPLAINT: NA	POST INSP. CONTACTS: None	JOINT INSP. AGENCY: None	
WEATHER: Clear	INSPECTOR'S SIGNATURE:

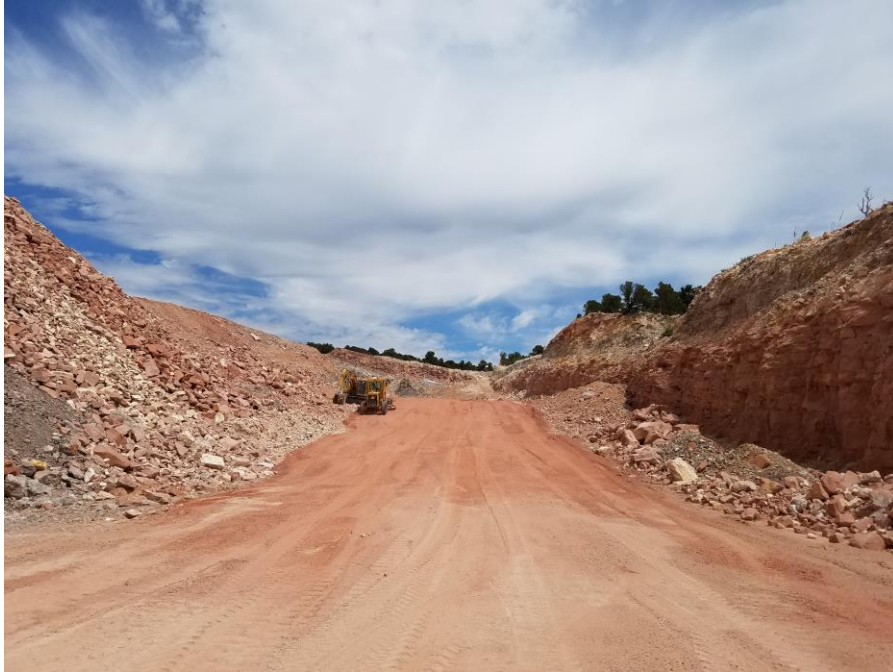
Figure 1. From the southeast end of mining Area C looking north.

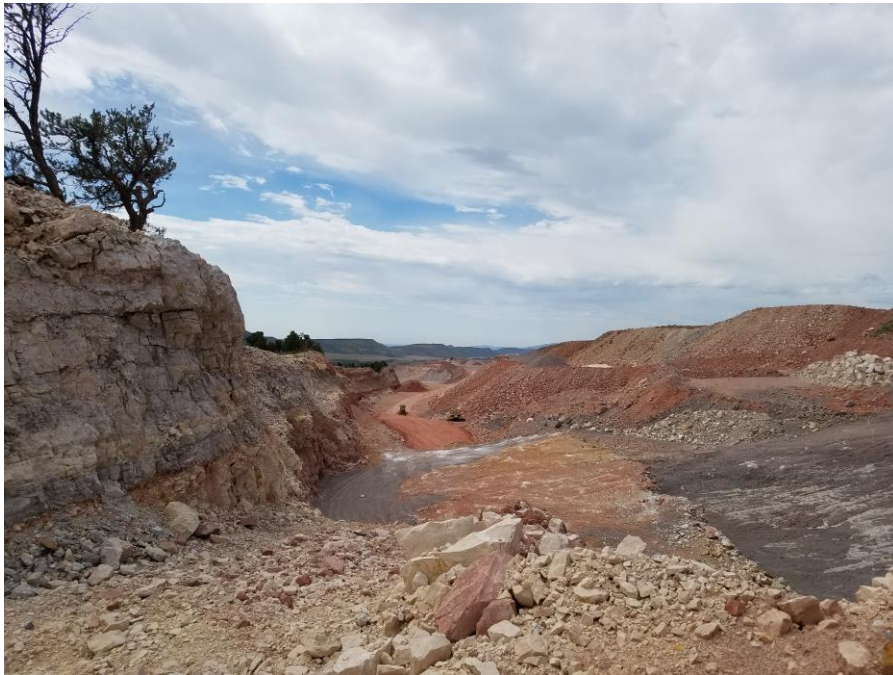
Figure 2. From the north of the excavation in area C3 looking south.

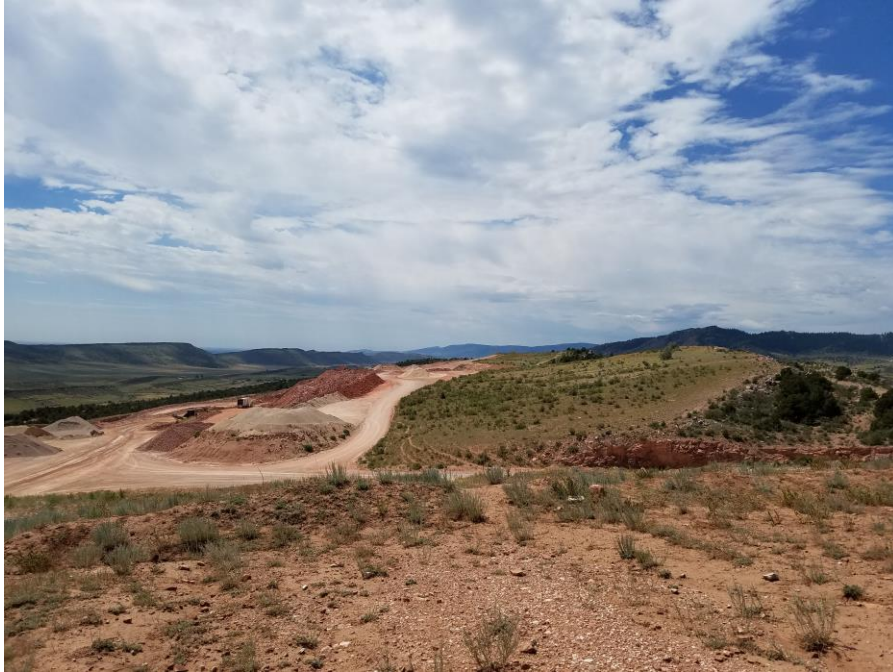
Portions of the affected area on the west side of the site have been backfilled, graded and revegetated. These areas north and south of the main quarry access road were observed. These areas were stable and vegetated with native grasses and forbs; also a significant amount of mountain mahogany and rabbit brush shrubs have established in these areas.

Figure 3. From the reclaimed area north of the main quarry access road looking south.

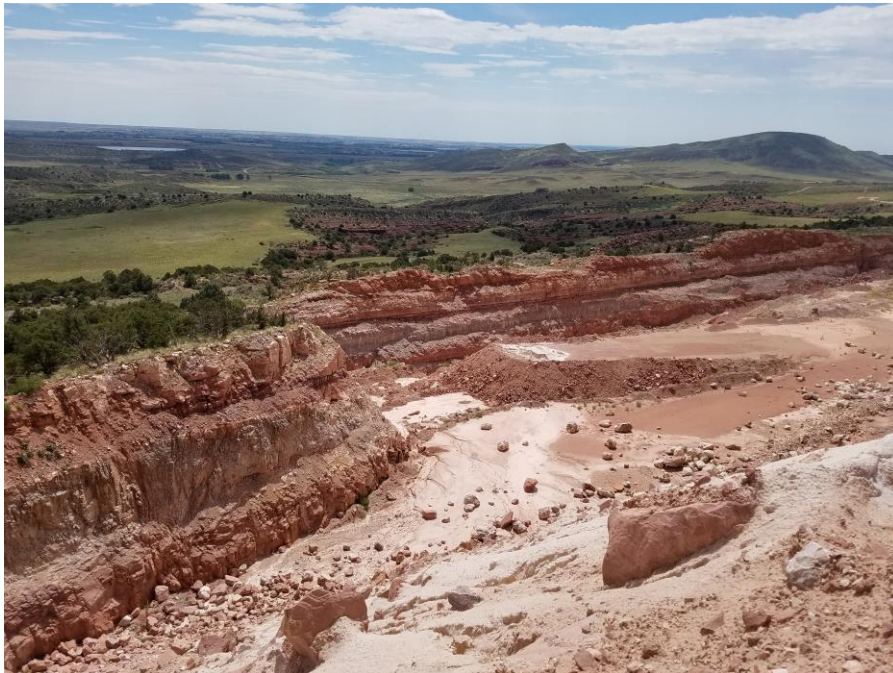
Mining has created a long highwall along the eastern side of the affected area with a significant amount of waste-rock and spoil placed in benches behind the advancing highwall to the west. In the northern portion of the site, the highwall is about 35 feet in height and is generally vertical. On the southern end of the site the highwall is 50 to 60 feet in height. Waste-rock piles are shown in the Back Fill "BF" areas on the approved mining plan map approved with TR06. The waste benches are located in the BF-I and BF-II areas.

Figure 4. View of the highwall from the top of the first bench at the east end of mining Area A5.

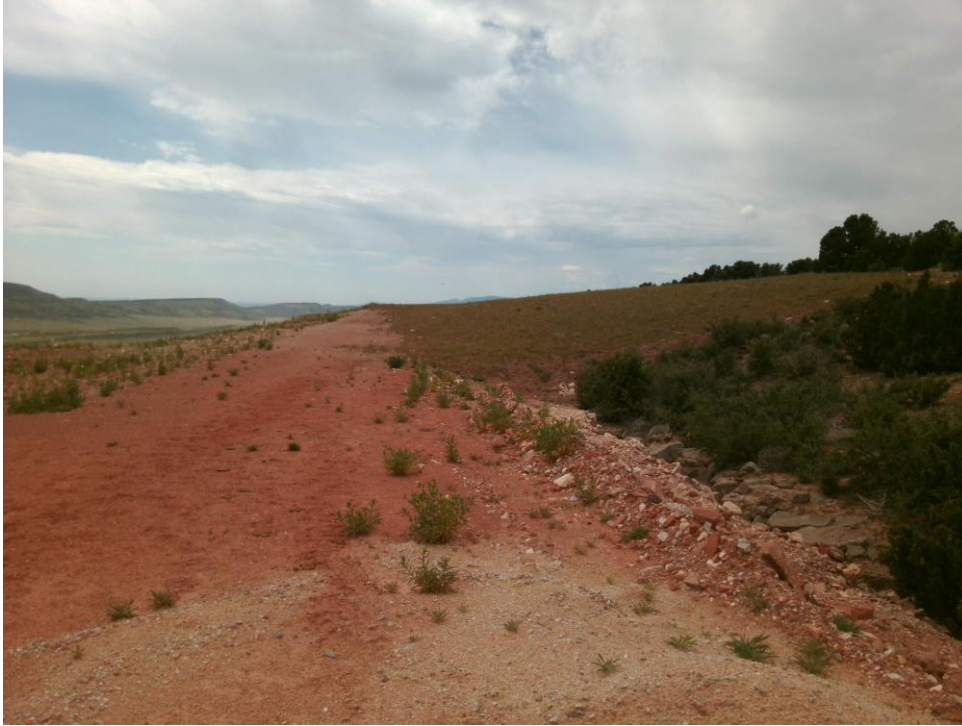
Figure 5. Reclaimed area north of main quarry access road looking south.
