**MINERALS PROGRAM INSPECTION REPORT**  
**PHONE: (303) 866-3567**

<b>MINE NAME:</b> Hay Camp Pit	<b>MINE/PROSPECTING ID#:</b> M-1990-025	<b>MINERAL:</b> Gravel	<b>COUNTY:</b> Montezuma
<b>INSPECTION TYPE:</b> Multi Person Inspection	<b>INSPECTOR(S):</b> Lucas J. West, Russ Means	<b>INSP. DATE:</b> July 17, 2017	<b>INSP. TIME:</b> 13:15
<b>OPERATOR:</b> Montezuma County	<b>OPERATOR REPRESENTATIVE:</b> Randy Smith, Rob Englehart	<b>TYPE OF OPERATION:</b> 112c - Construction Regular Operation	
<b>REASON FOR INSPECTION:</b> Surety Release Requested	<b>BOND CALCULATION TYPE:</b> None	<b>BOND AMOUNT:</b> \$0.00	
<b>DATE OF COMPLAINT:</b> NA	<b>POST INSP. CONTACTS:</b> None	<b>JOINT INSP. AGENCY:</b> None	
<b>WEATHER:</b> Clear	<b>INSPECTOR'S SIGNATURE:</b>

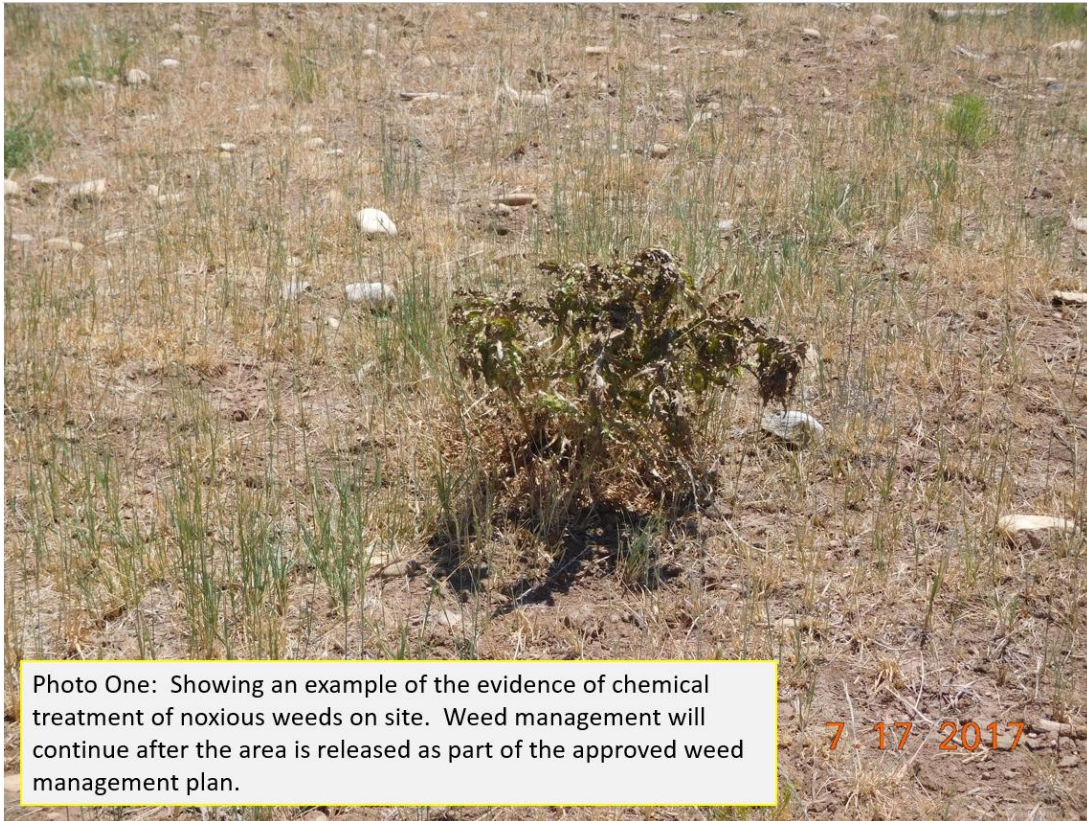
Proper mine identification signage was observed at the entrance to the site. The permitted areas will be reclaimed to support the intended post mining land use of pastureland. All grading of the area has been completed and appears to be approximately 4H: 1V with variations in some places. All grading appears to be stable and exhibit positive drainage. No erosional features were noted during the inspection. The vegetation, appears to be temporarily stressed due to recent livestock activity and lack of precipitation. Despite the seasonal stress it appears to be adequate in both density and diversity. Evidence of chemical treatment of noxious weeds was observed and can be seen in Photo One. Examples of the stable grading and vegetation can be seen in Photos Two and Three.
