MINERALS PROGRAM INSPECTION REPORT
PHONE: (303) 866-3567

MINE NAME: Owl Canyon Quarry	MINE/PROSPECTING ID#: M-1977-302	MINERAL: Limestone (general)	COUNTY: Larimer
INSPECTION TYPE: Monitoring	INSPECTOR(S): Jared L. Ebert	INSP. DATE: July 18, 2017	INSP. TIME: 11:45
OPERATOR: Pete Lien & Sons, Inc.	OPERATOR REPRESENTATIVE: Rob Kisner	TYPE OF OPERATION: 112c - Construction Regular Operation	
REASON FOR INSPECTION: Normal I&E Program	BOND CALCULATION TYPE: Complete Bond	BOND AMOUNT: \$677,100.00	
DATE OF COMPLAINT: NA	POST INSP. CONTACTS: None	JOINT INSP. AGENCY: None	
WEATHER: Clear	INSPECTOR'S SIGNATURE:

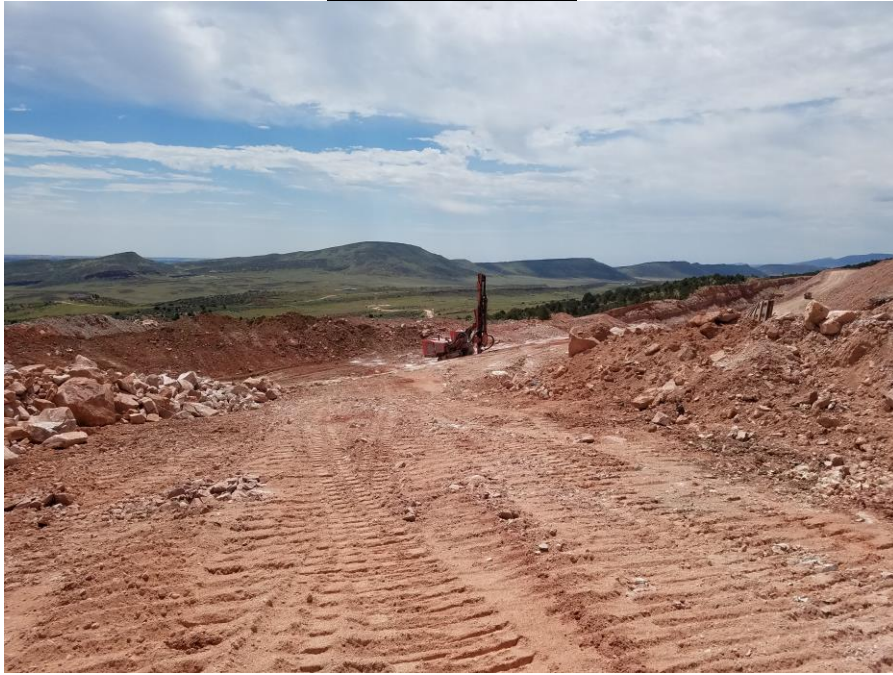
At the time of the inspection, the Operator was drilling holes for a blast in the A4 mining area.

Figure 1. Blast pad preparation in Mine Area A4

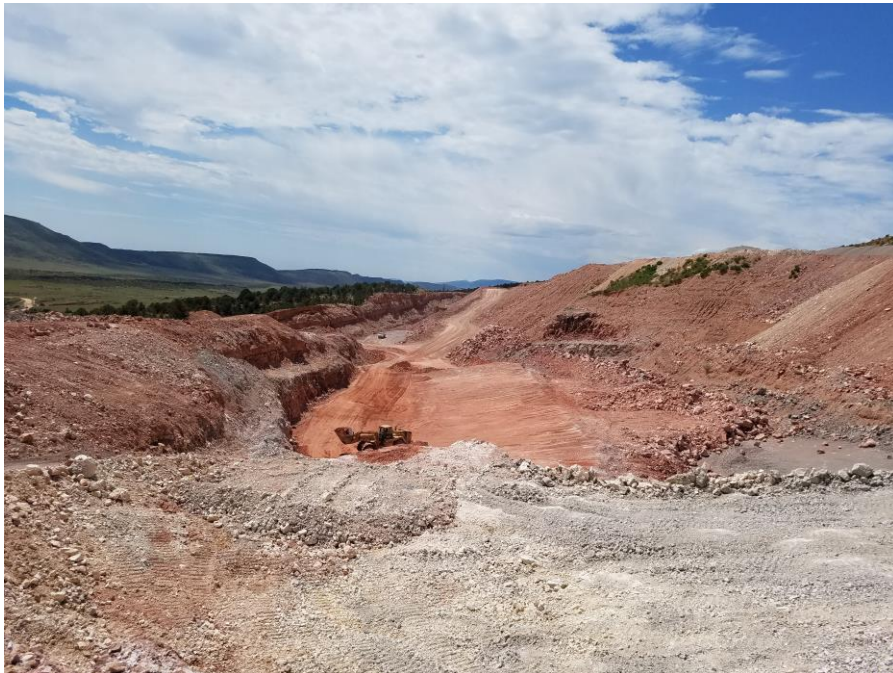
Figure 2. From Mine Area A4 looking south.

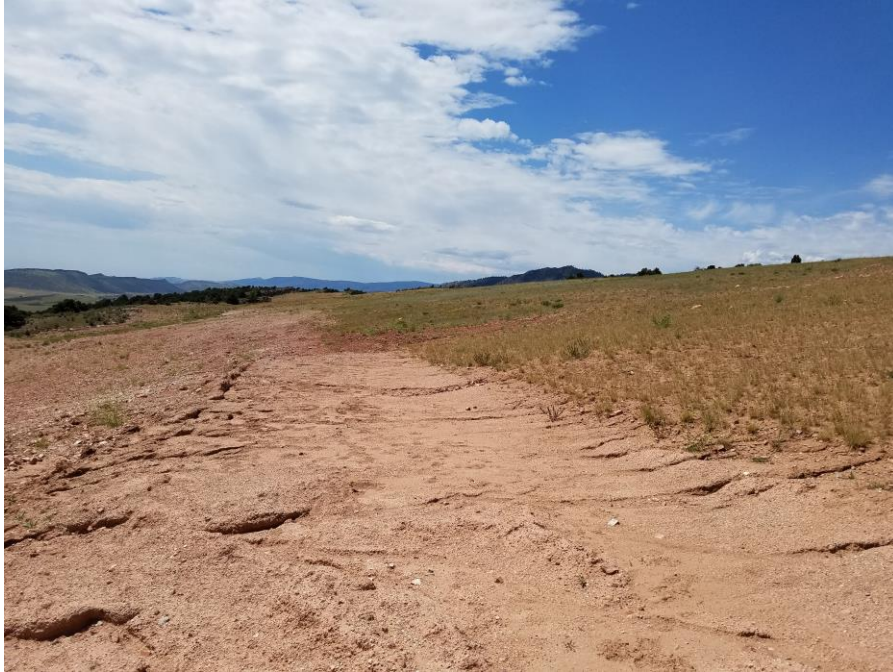
The Operator has concurrently backfilled previously mined areas as mining has progressed. Mining has progressed from west to east and to the south. Portions of the western mined area has been graded to a gentle slopes (4H:1V or less). A relatively new area at the southern end of "Back Fill Area" (BF-1) shown on the approved Exhibit C map was observed. Waste Rock and spoil material was backfilled in this area to the top of the highwall or within a few feet of the highwall. This area appeared stable.

Figure 3. From the south end of the BF-1 area looking south.

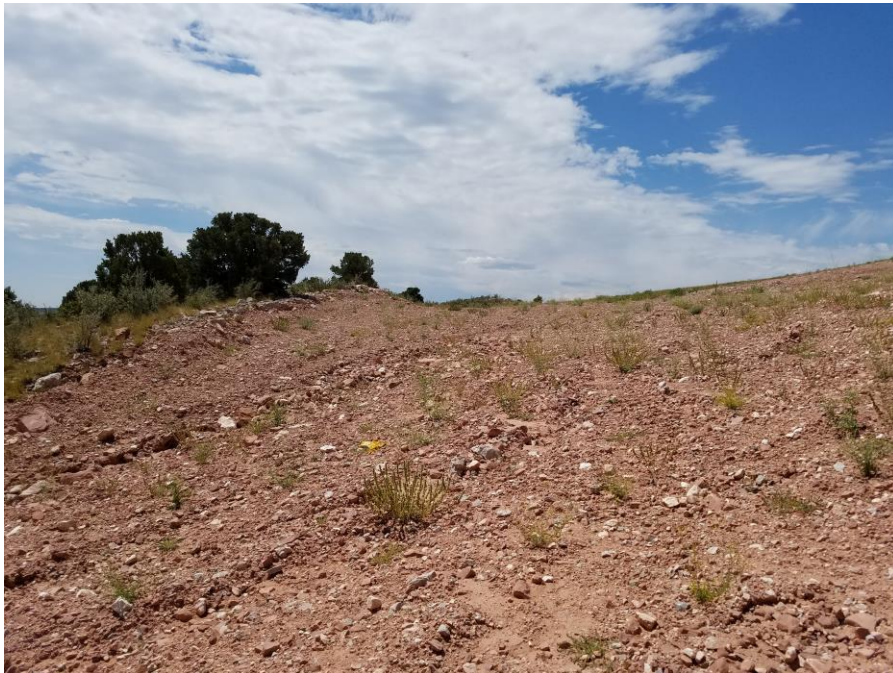
Figure 4. View of the southeast end of the BF-1 area.

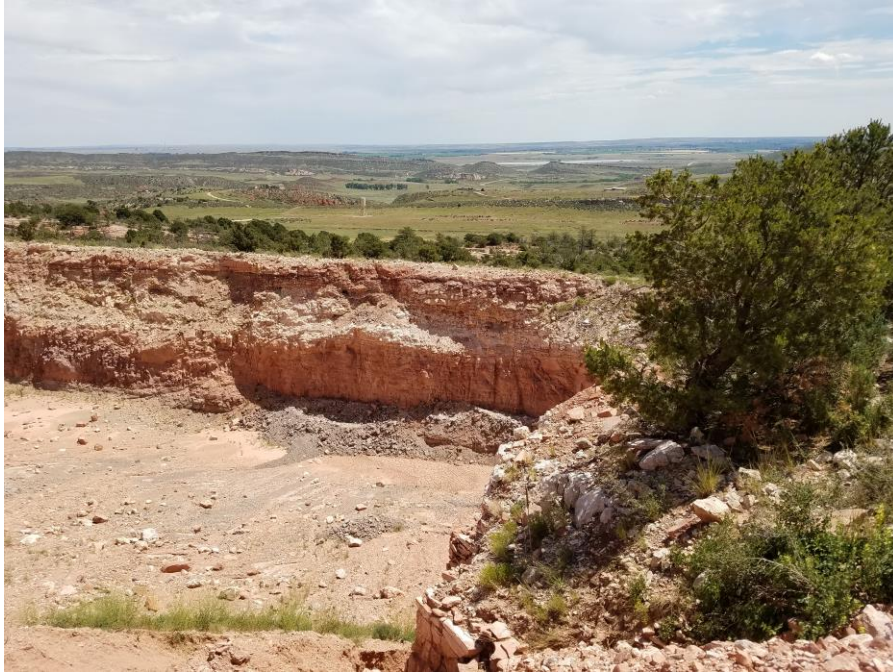
Figure 5. View of the southeast corner of the A3 mining area.
