MINERALS PROGRAM INSPECTION REPORT**PHONE: (303) 866-3567**

MINE NAME: Gloria Z Mine	MINE/PROSPECTING ID#: M-1984-094	MINERAL: Sand, gravel, gold	COUNTY: Park
INSPECTION TYPE: Monitoring	INSPECTOR(S): Michael A. Cunningham	INSP. DATE: June 20, 2017	INSP. TIME: 11:45
OPERATOR: Sanborn Sand and Gravel/dba Golden Cross Aggregates, Inc.	OPERATOR REPRESENTATIVE: Mike Pfister	TYPE OF OPERATION: 112c - Construction Regular Operation

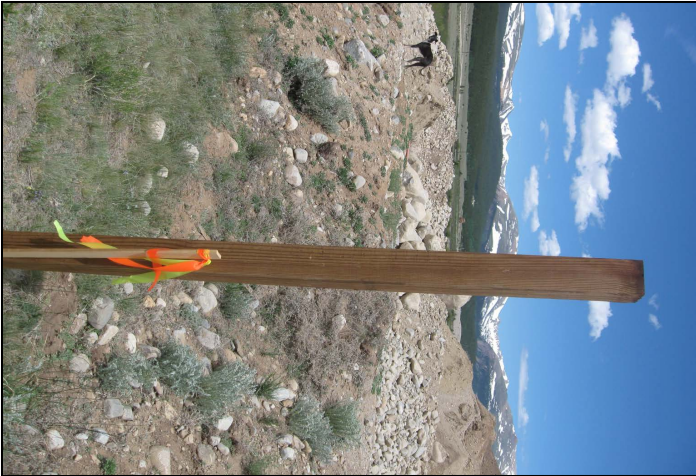
During the inspection the Division confirmed the Operator had replaced the boundary markers around the affected area. The Operator has used 4 x 4 posts for several of the boundary markers and survey lath stakes were in place for the remainder of the boundary markers. The Operator stated that all of the survey lath stakes would be replaced with 4 x 4 posts. It is the Operator's responsibility to ensure the boundary of the affected land remains delineated at all times. The problem cited during the May 17, 2017 inspection is considered to be resolved.

1. Representative photo of boundary markers.

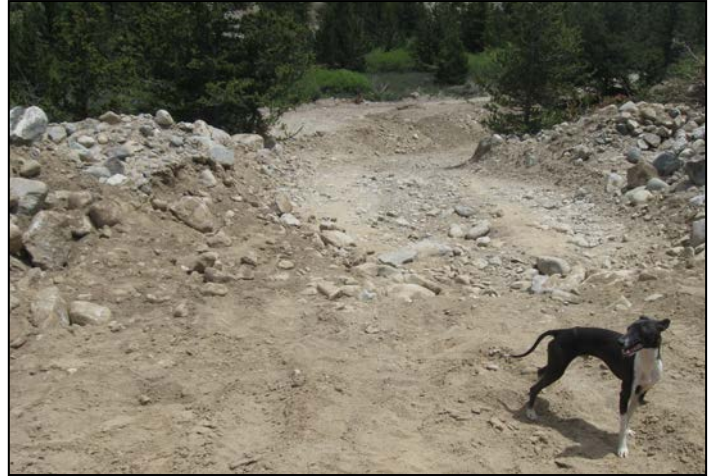
PROBLEM/POSSIBLE VIOLATION: Problem: The current mine plan does not account for the newly constructed access roads. This is a problem pursuant to C.R.S. 34-32.5-112 (1)(c)(VI).

During the inspection the Division observed two new roads within the affected area which are not accounted for in the approved Mining Plan. The first road is located in the southeast corner of the site and was constructed in an area historically disturbed by sluicing operations. The road is approximately 200 ft. in length and 12 ft. in width. The Operator constructed a berm and a sediment catchment basin halfway down the road to prevent stormwater runoff from leaving the site. The Operator does not have a stormwater discharge permit and all stormwater runoff is to be contained within the permit area. The road will need to be evaluated by the Water Quality Control Division of the Colorado Department of Public Health and Environment to determine if the stormwater controls which are in place are adequate. The second road which the Division observed is located along the northern perimeter of the site and to the south of the stormwater collection ditches. The Operator informed the Division the road was constructed to provide access to the stormwater collection ditches, so that equipment would not need to traverse within the buffer between the Middle Fork of the South Platte River and the stormwater collection ditches.

2. New access road constructed in southeast corner of mine. Photo taken facing downslope.

CORRECTIVE ACTIONS: The operator shall submit a Technical Revision, with the required \$216 revision fee, to update and clarify the current approved mine plan and reclamation plan to reflect existing and proposed activities by the corrective action date.

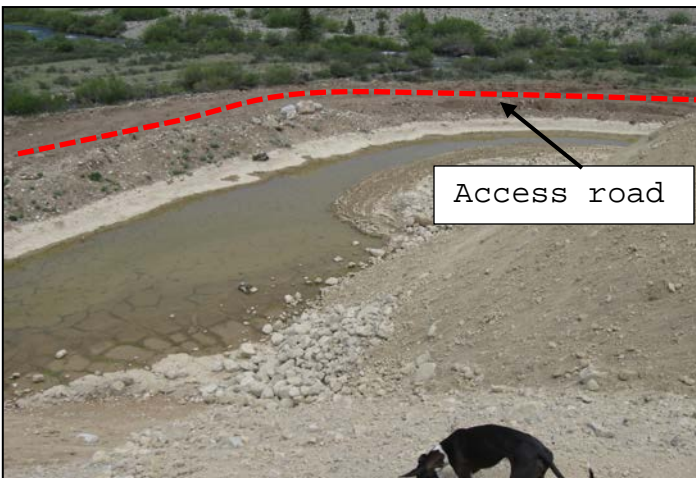
3. Access road constructed between mine pit and stormwater collection ditch.
