**MINERALS PROGRAM INSPECTION REPORT**  
**PHONE: (303) 866-3567**

<b>MINE NAME:</b> May Day Idaho Mine Complex	<b>MINE/PROSPECTING ID#:</b> M-1981-185	<b>MINERAL:</b> Gold and silver	<b>COUNTY:</b> La Plata
<b>INSPECTION TYPE:</b> Multi Person Inspection	<b>INSPECTOR(S):</b> Lucas J. West, Russ Means	<b>INSP. DATE:</b> July 18, 2017	<b>INSP. TIME:</b> 11:45
<b>OPERATOR:</b> Sunrise Mining LLC	<b>OPERATOR REPRESENTATIVE:</b> Sarah Glinatsis	<b>TYPE OF OPERATION:</b> 112d-1 - Designated Mining Operation	
<b>REASON FOR INSPECTION:</b> Normal I&E Program	<b>BOND CALCULATION TYPE:</b> None	<b>BOND AMOUNT:</b> \$204,562.00	
<b>DATE OF COMPLAINT:</b> NA	<b>POST INSP. CONTACTS:</b> None	<b>JOINT INSP. AGENCY:</b> None	
<b>WEATHER:</b> Clear	<b>INSPECTOR'S SIGNATURE:</b>

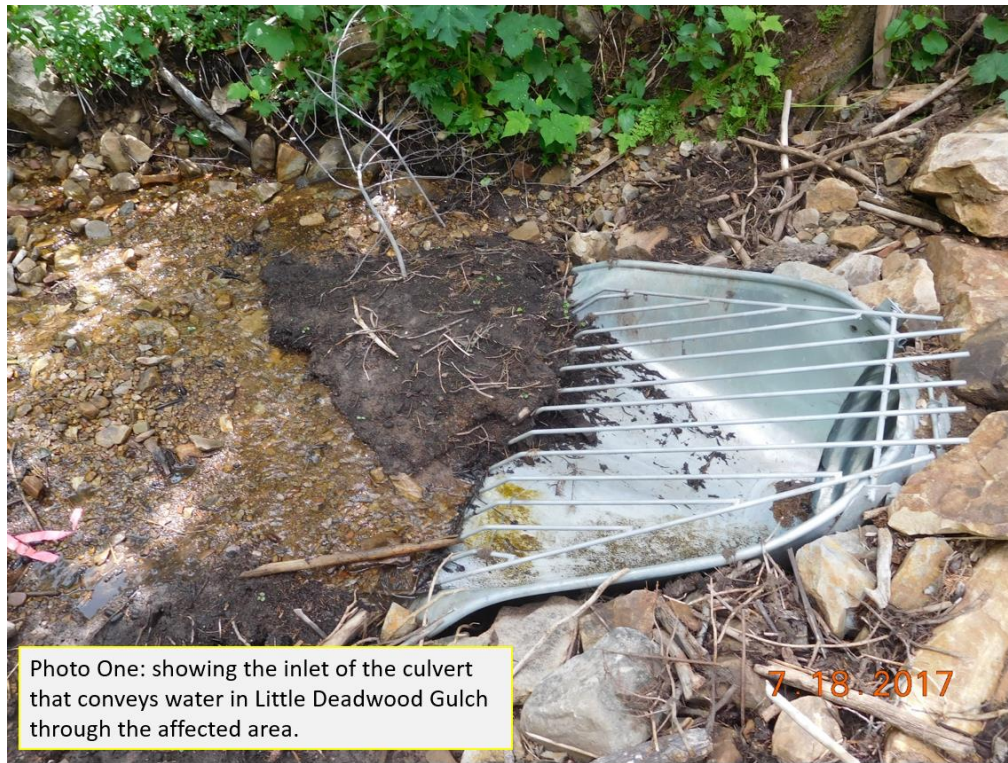
The restoration activities at the Chief Portal Area were completed and inspected in the fall of 2016. The Chief Portal is designed to function as a secondary escape way and underground access point. As seen in Photo One, the culvert in Little Deadwood Gulch has been installed with a grated closure on the inlet to prevent plugging and it appears to be functioning as designed. The outfall of the culvert has been armored with rip rap to prevent down cutting shown in Photo Two. All backfilled areas appear to be stable and in good condition, no evidence of settling, slumping or subsidence was observed. The matting extends from the access road down to the bottom of the gulch as well as up the other side. Photos Three and Four show examples of the matting with vegetation beginning to grow. The secondary escape / emergency access has been further buttressed with the restoration of Little Deadwood Gulch. The portal was not secured with a grated closure, however this was brought to the Operator's attention and within 24 hours photo documentation of a temporary closure was received. Photo Five shows the secondary escape way prior to the installation of the temporary closure. A secondary drain has been installed to allow any water generated from the portal to be conveyed into Little Deadwood Gulch. The slope above the secondary access which had been backfilled as of the previous inspection by Division staff appears to be in good condition. The areas that were identified to be revegetated or secured with the vegetative matting have been addressed. No evidence of erosion, slumping or subsidence was noted. The area at the top of the slope, adjacent to the road was identified to need a safety barrier which has been installed.

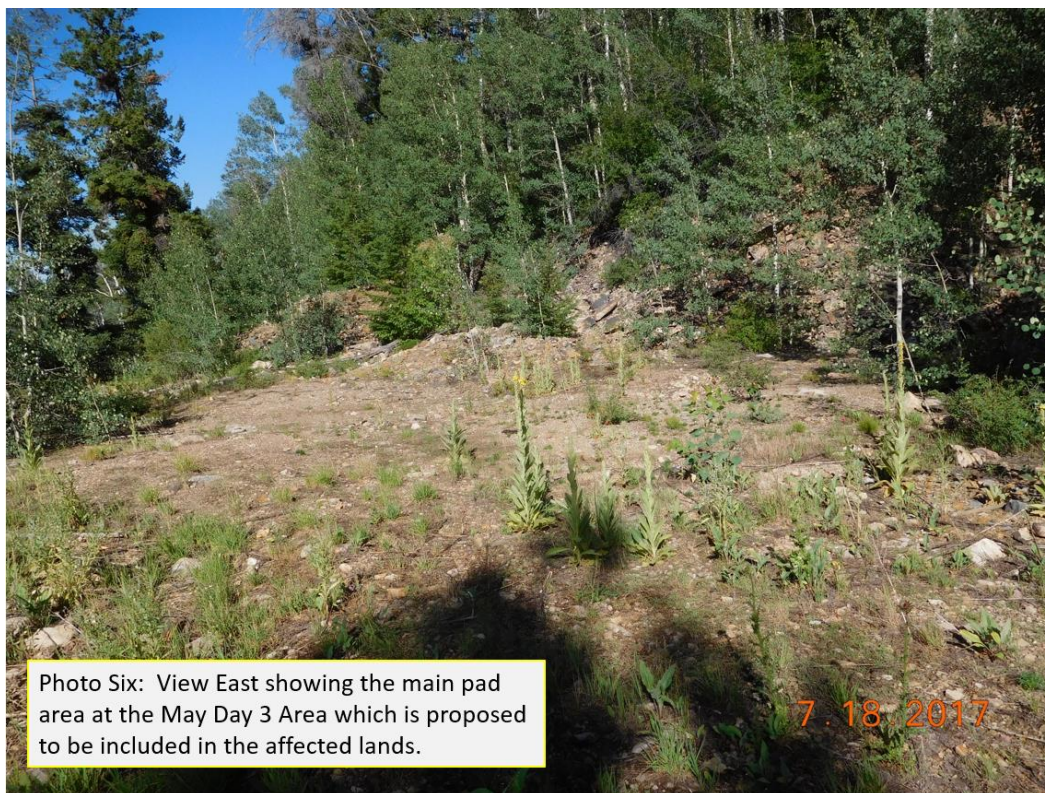
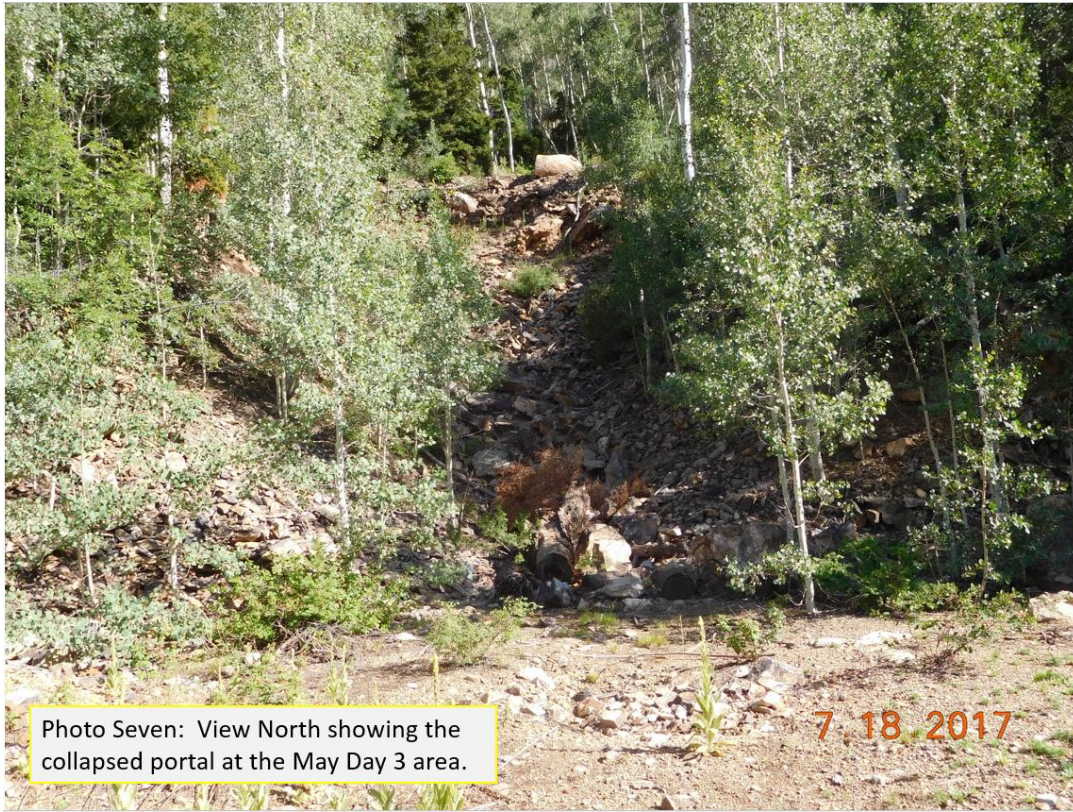
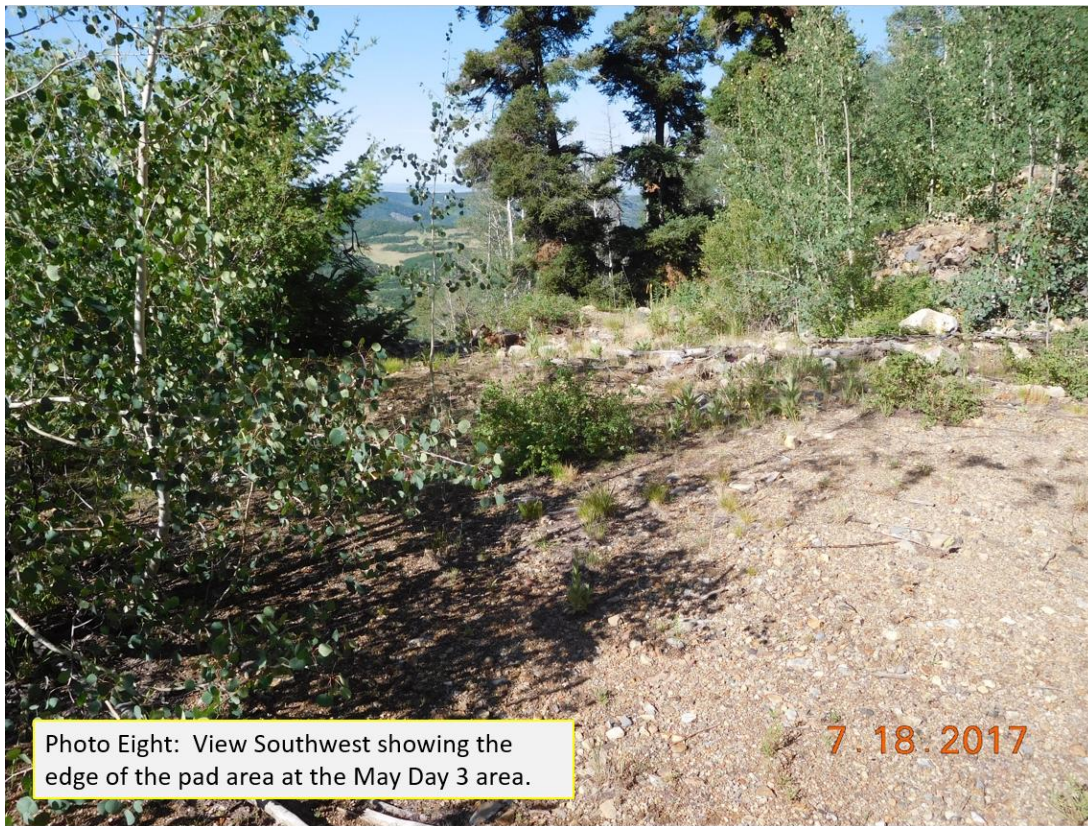
The May Day 3 Area is currently outside the boundaries of the affected lands. It is however proposed to be included in AM-2. Further clarifications on the extent of the activities to take place at the May Day 3 area are required and will be addressed through the adequacy review process. Photos Six, Seven and Eight show the area which is the location of historic mining activity. Within the area is a collapsed portal, miners shack and flat pad area. The area is currently sparsely vegetated but appears to be stable and in good condition.

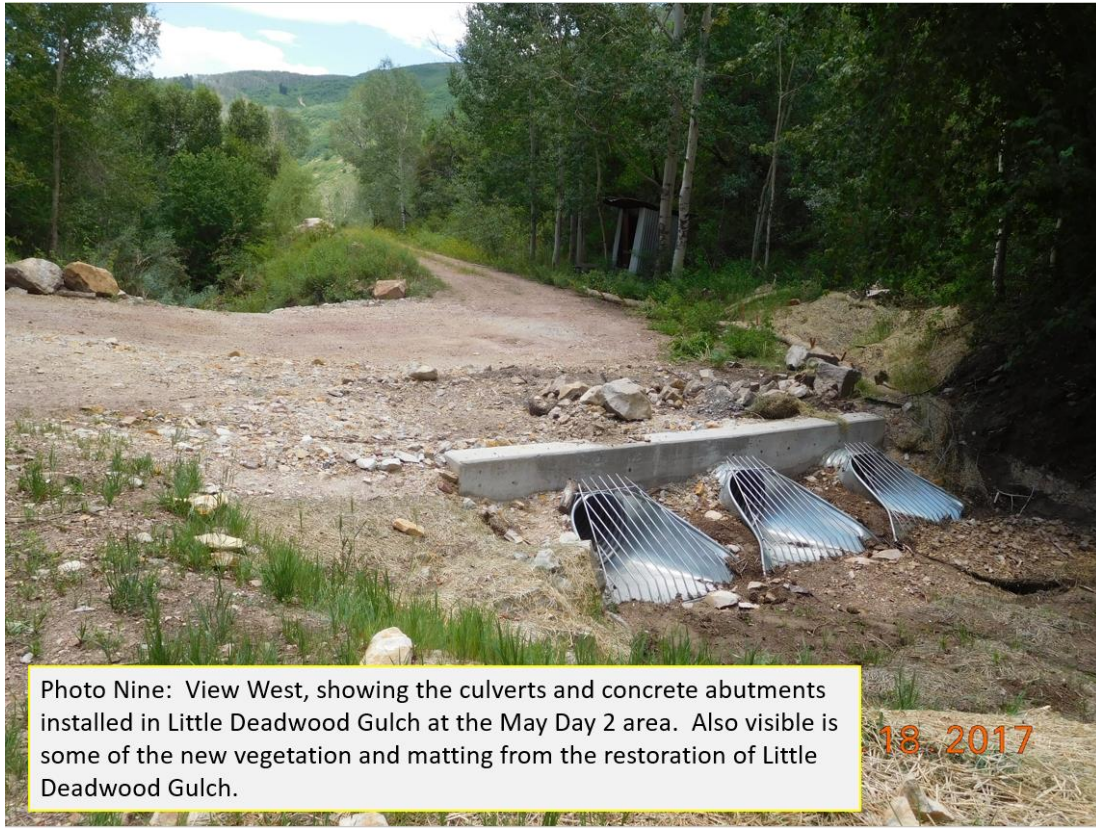
three culverts, with grated closures at their inlets to prevent clogging, as well as concrete abutments to prevent degradation of the surrounding material has appear to be functioning as designed and are in good condition as seen in Photo Nine. The outfall of the culverts has been armored to prevent down cutting of the channel immediately downstream of the culverts. Within the channel immediately upstream of the culverts, two water bars have been installed to help dissipate the energy as the stream flow approaches the crossing. Heavy flows have caused the channel to route around one of the water bars, causing some minor erosion of the far bank as seen in Photo Ten. It is recommended that the Operator install some bouldering and other armoring to the banks of the stream to prevent further migration of the channel. The portal at the May Day 2 Area remains partially collapsed. A small waste rock pile was located adjacent to the closure, and was present during the previous inspection. The pile appears to be stable and in good condition.

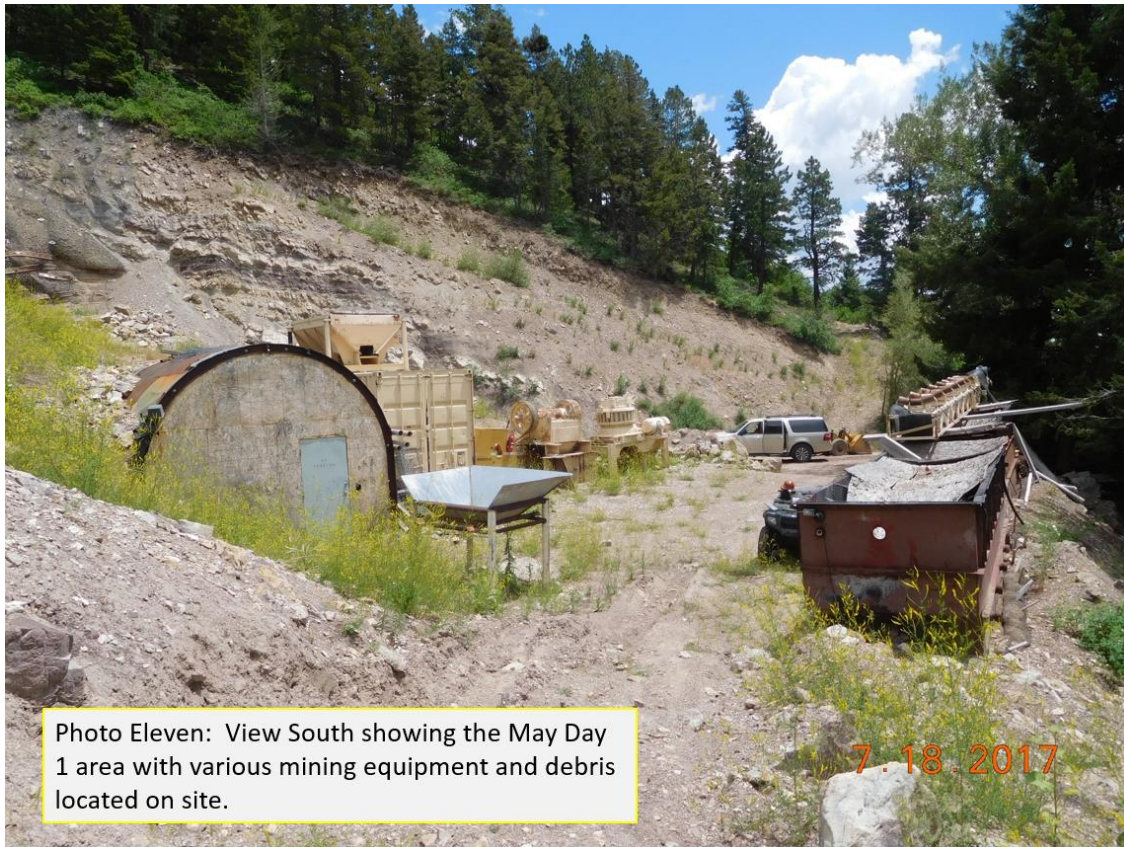
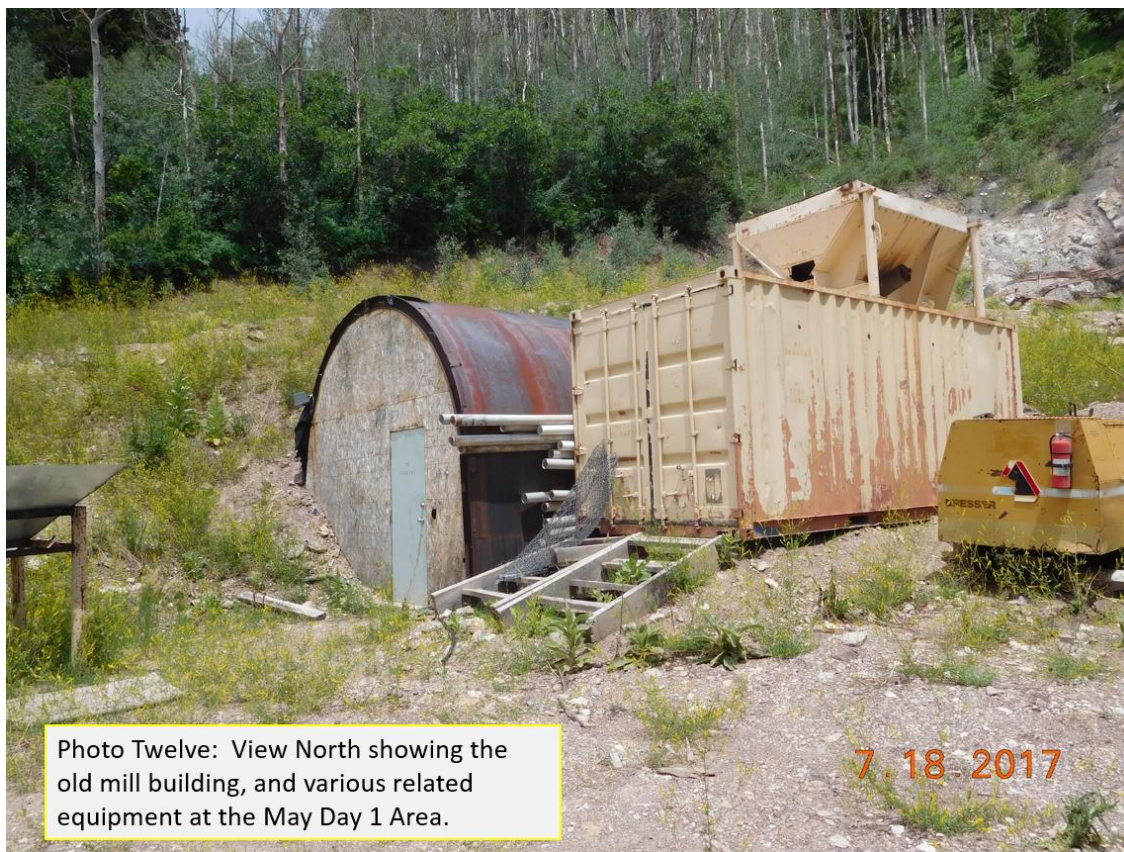
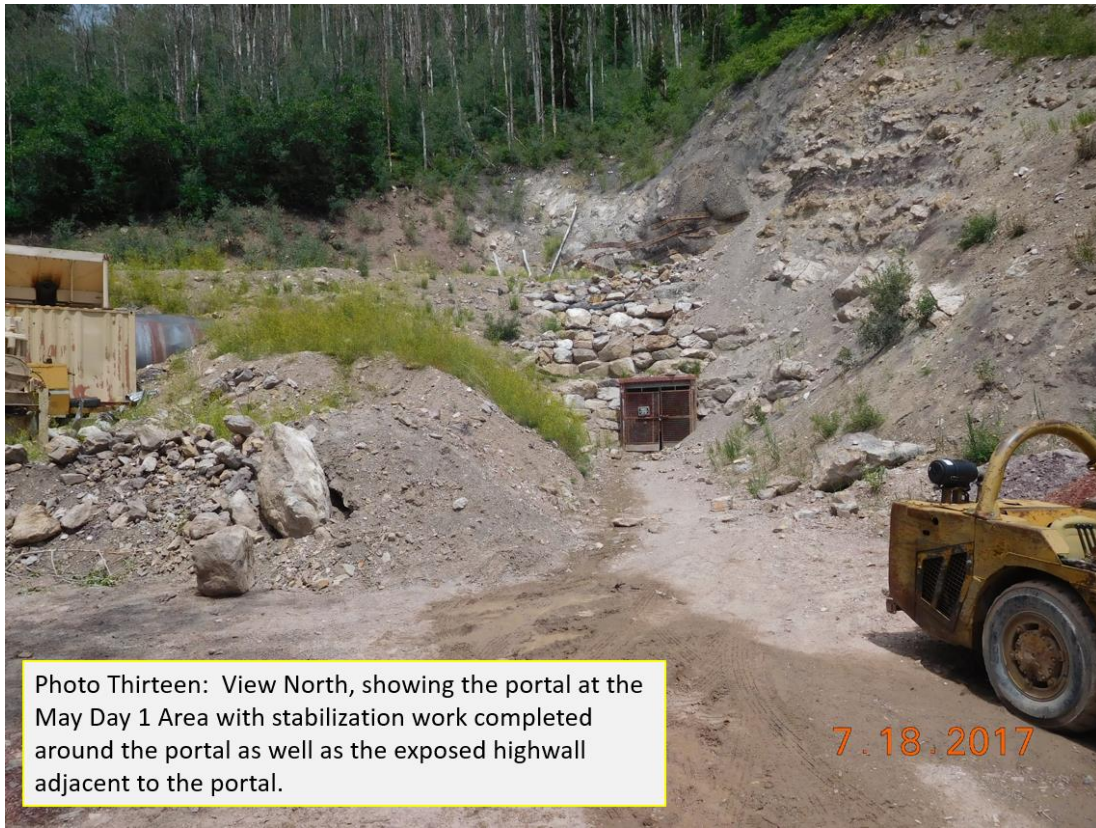
The portal remains closed with a locked gate, and the surrounding slopes buttressed with the placement of large boulders. The area above the portal has been stabilized with wire mesh and rock bolts. The old mill building was not inspected at this time. A variety of equipment was observed throughout the May Day 1 area including an underground loader, several shipping containers and various other mining related debris. The surface conditions of the area are largely unchanged from the October 2016 Inspection. Photos Eleven, Twelve and Thirteen show the conditions of the May Day 1 Area.
