**MINERALS PROGRAM INSPECTION REPORT**  
**PHONE: (303) 866-3567**

<b>MINE NAME:</b> Ace in the Hole- CMC284074	<b>MINE/PROSPECTING ID#:</b> M-2013-056	<b>MINERAL:</b> Gemstones	<b>COUNTY:</b> Teller
<b>INSPECTION TYPE:</b> Surety-Related Inspection	<b>INSPECTOR(S):</b> Elliott R. Russell	<b>INSP. DATE:</b> June 14, 2017	<b>INSP. TIME:</b> 12:30
<b>OPERATOR:</b> Richard Fretterd	<b>OPERATOR REPRESENTATIVE:</b> Richard Fretterd	<b>TYPE OF OPERATION:</b> 110(2) - Hard Rock Limited Impact

<b>REASON FOR INSPECTION:</b> Surety Related	<b>BOND CALCULATION TYPE:</b> Complete Bond	<b>BOND AMOUNT:</b> \$3,900.00
<b>DATE OF COMPLAINT:</b> NA	<b>POST INSP. CONTACTS:</b> None	<b>JOINT INSP. AGENCY:</b> Forest Service
<b>WEATHER:</b> Clear	<b>INSPECTOR'S SIGNATURE:</b>

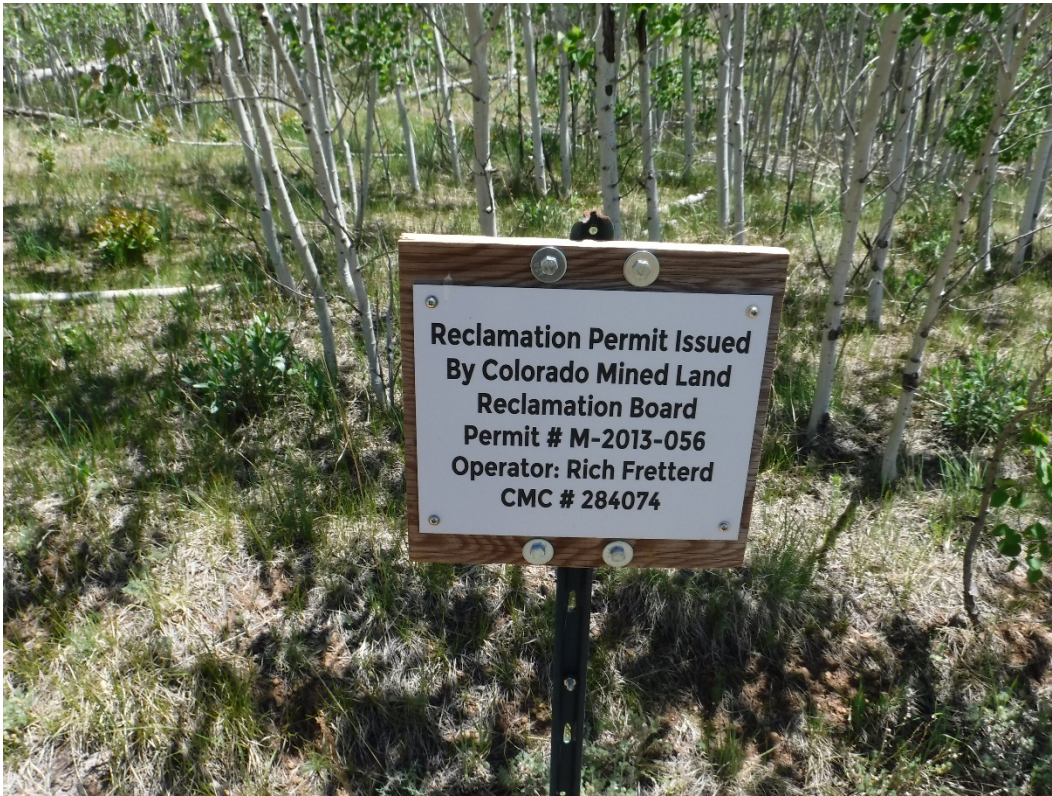
**Photo 1.** Mine identification sign along FS 273; looking east.

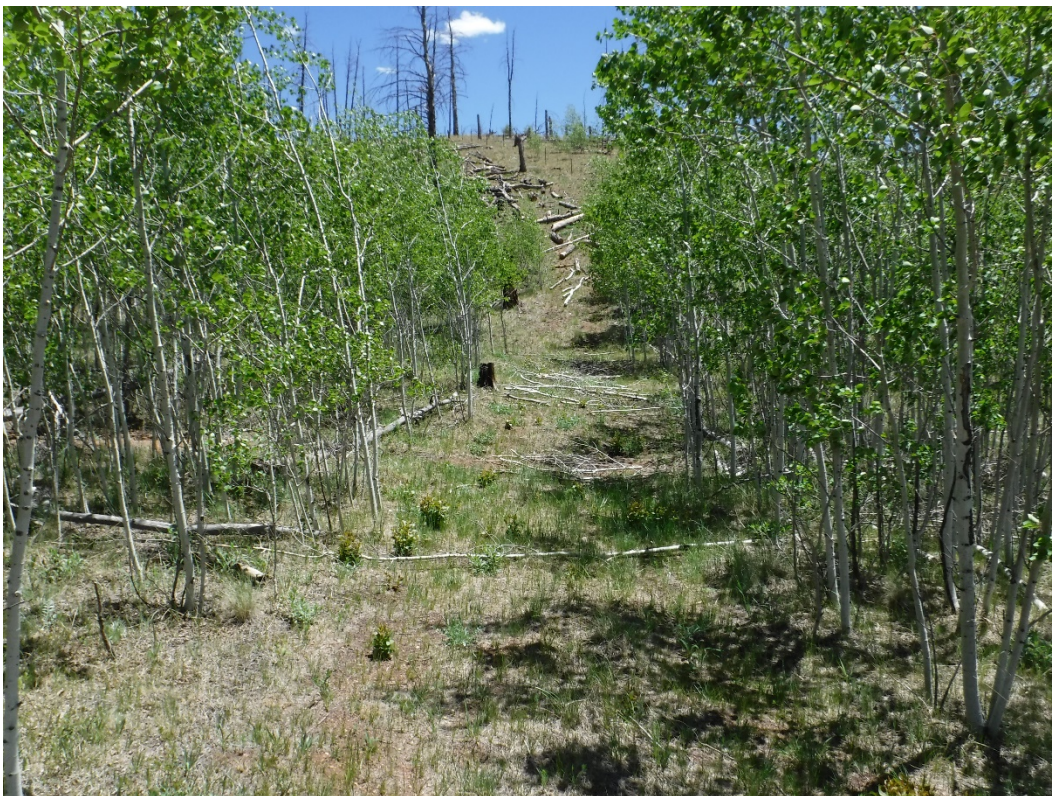
**Photo 2.** Temporary access road from FS 273 up to the dig areas; looking east.

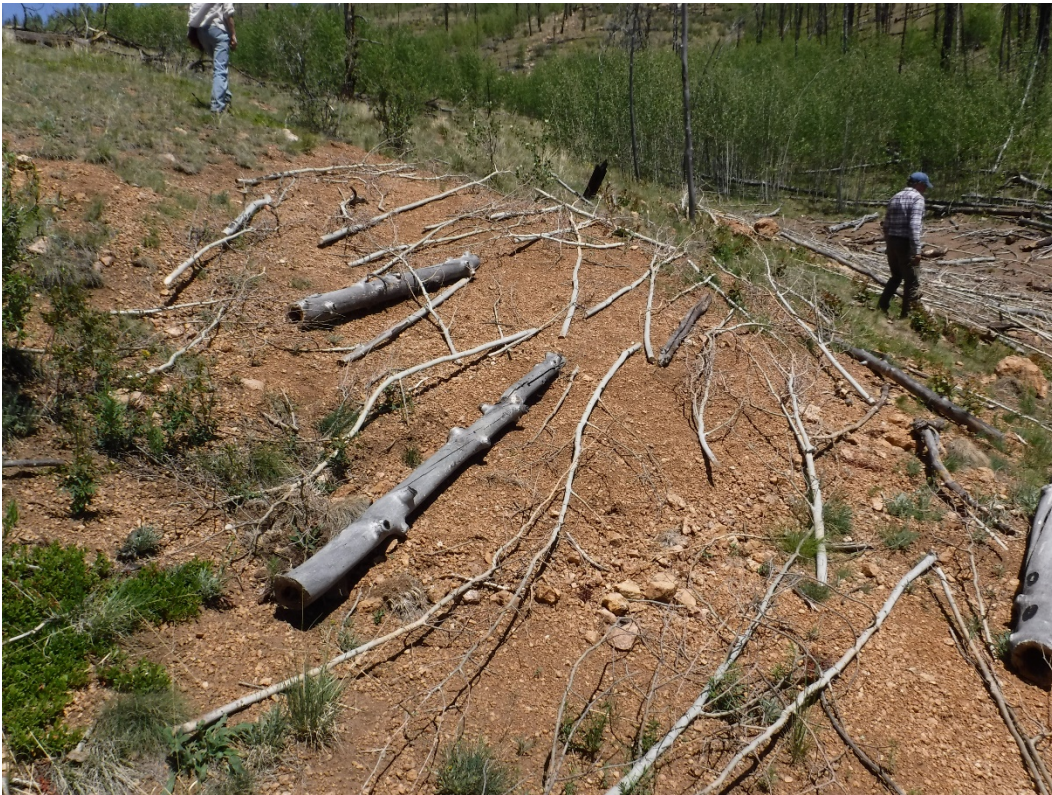
**Photo 3.** Backfilled excavation, small trees used to control erosion and aid revegetation efforts; looking east.

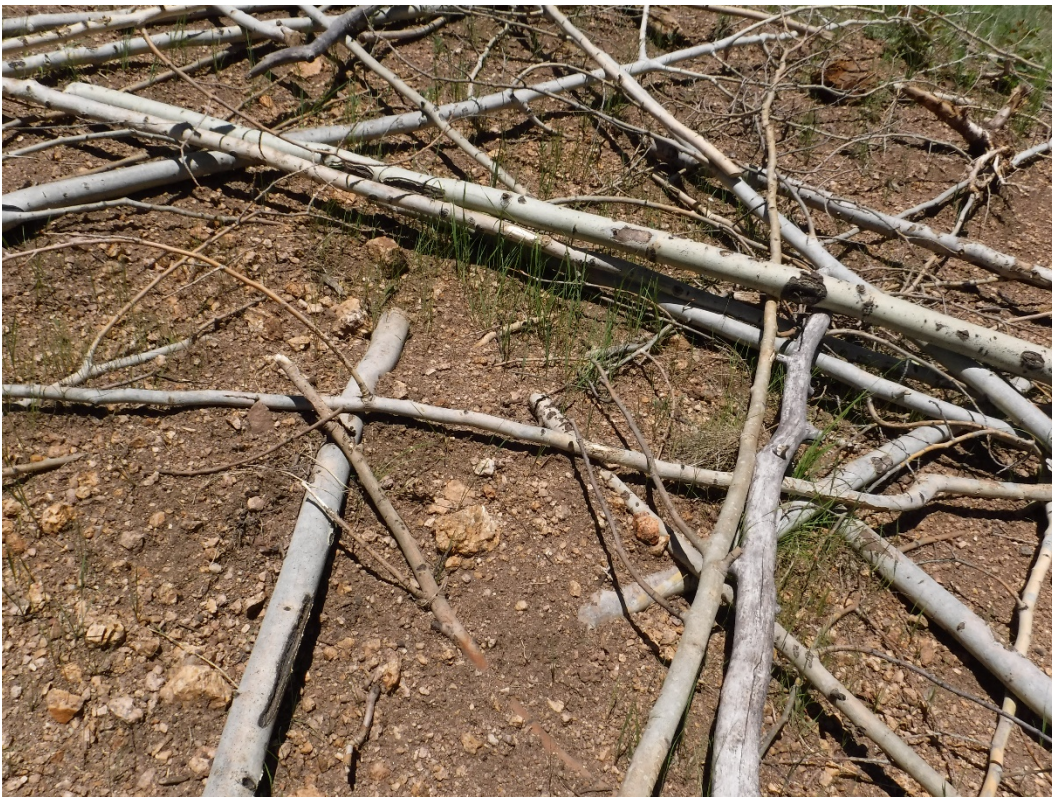
**Photo 4.** Grasses are starting to establish; looking northeast.

The Division recommends the operator monitor the revegetation efforts and possibly inter-seed this fall depending on the success. The Operator stated they would do so and at the same time this fall would backfill any small hand-digs on the permit that may show up over the summer.

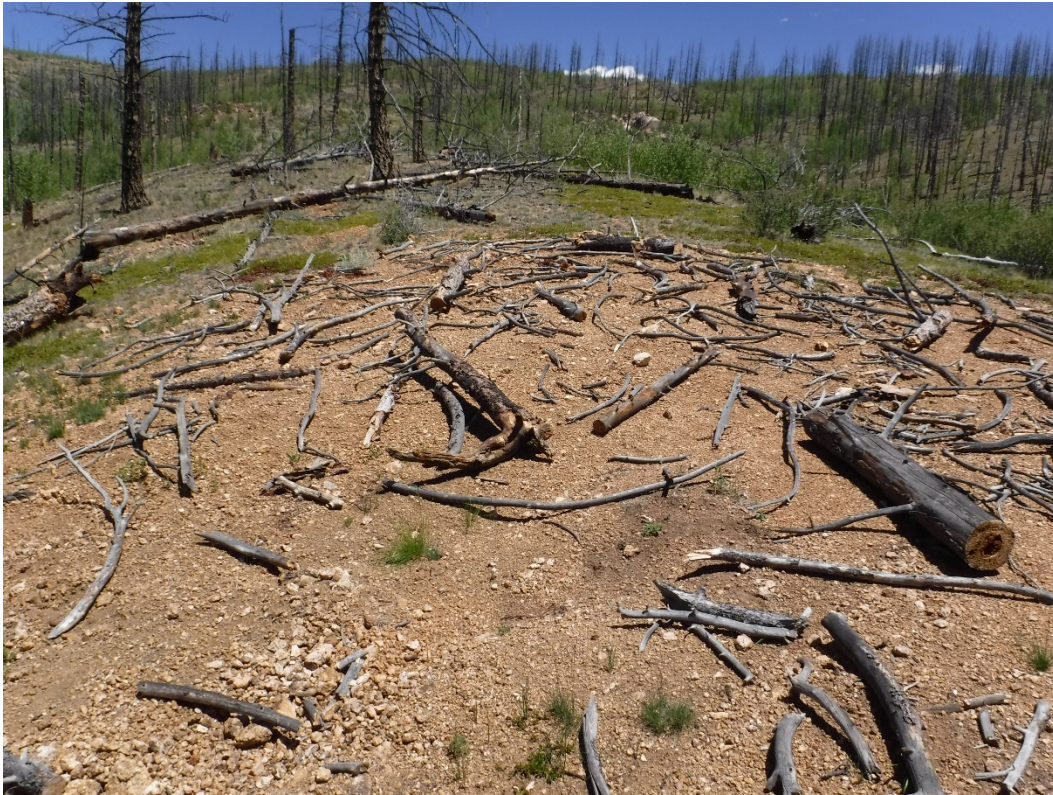
**Photo 5.** Backfilled excavation, small trees used to control erosion and aid revegetation efforts; looking north.

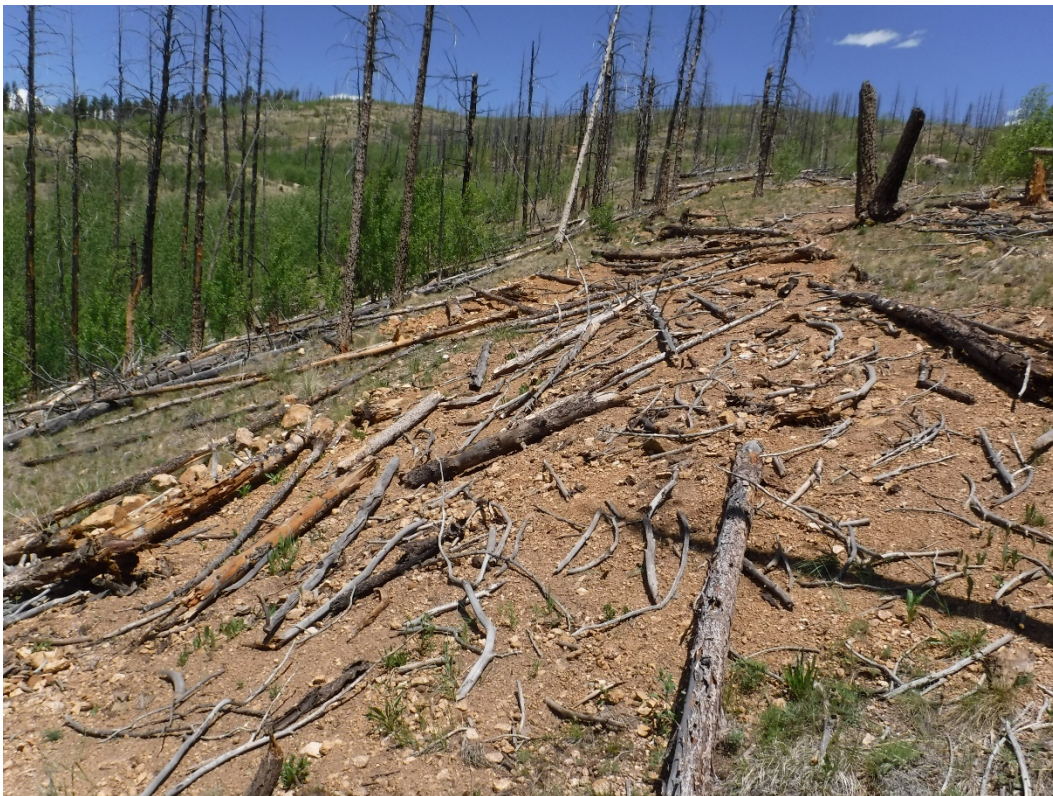
**Photo 6.** Backfilled excavation, small trees used to control erosion and aid revegetation efforts; looking north.
