**MINERALS PROGRAM INSPECTION REPORT**  
**PHONE: (303) 866-3567**

<b>MINE NAME:</b> Ace in the Hole- CMC284074	<b>MINE/PROSPECTING ID#:</b> M-2013-056	<b>MINERAL:</b> Gemstones	<b>COUNTY:</b> Teller
<b>INSPECTION TYPE:</b> Surety-Related Inspection	<b>INSPECTOR(S):</b> Elliott R. Russell	<b>INSP. DATE:</b> June 14, 2017	<b>INSP. TIME:</b> 12:30
<b>OPERATOR:</b> Richard Fretterd	<b>OPERATOR REPRESENTATIVE:</b> Richard Fretterd	<b>TYPE OF OPERATION:</b> 110(2) - Hard Rock Limited Impact

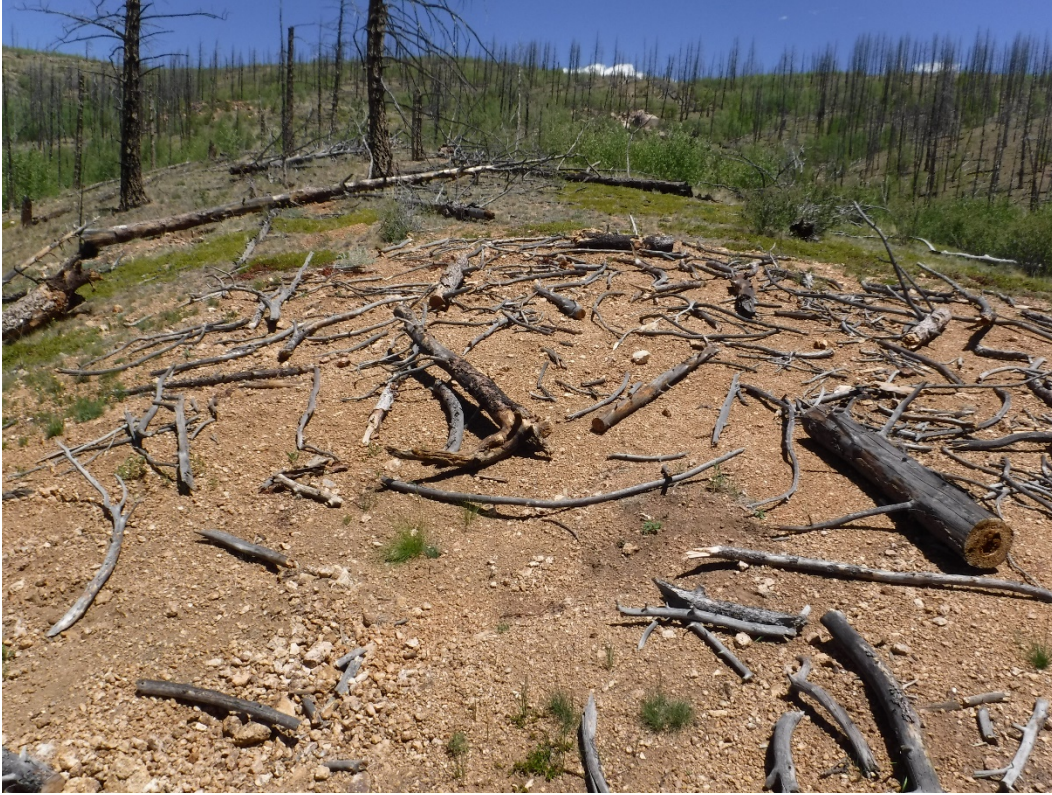
**Photo 5.** Backfilled excavation, small trees used to control erosion and aid revegetation efforts; looking north.

The Division recommends the operator monitor the revegetation efforts and possibly inter-seed this fall depending on the success. The Operator stated they would do so and at the same time this fall would backfill any small hand-digs on the permit that may show up over the summer.

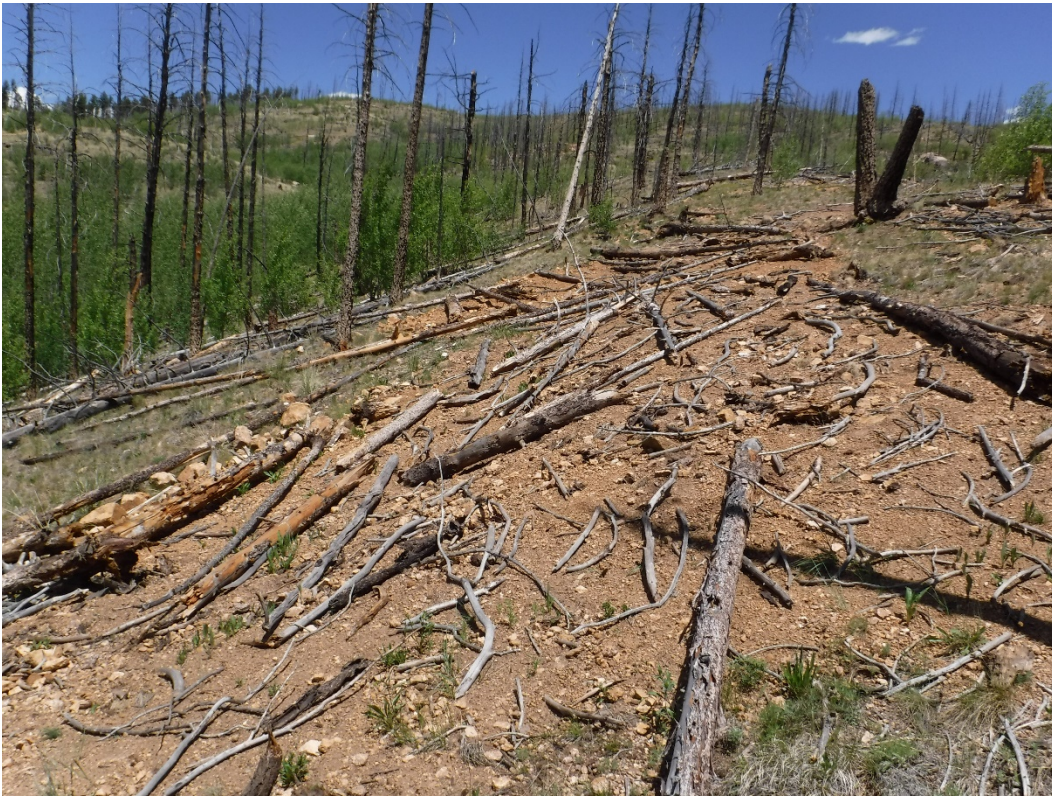
**Photo 6.** Backfilled excavation, small trees used to control erosion and aid revegetation efforts; looking north.
