## MINERALS PROGRAM INSPECTION REPORT

<b>MINE NAME:</b> Jemadojin Sand Mine	<b>MINE/PROSPECTING ID#:</b> M-2006-017	<b>MINERAL:</b> Sand	<b>COUNTY:</b> El Paso
<b>INSPECTION TYPE:</b> Surety-Related Inspection	<b>INSPECTOR(S):</b> Timothy A. Cazier	<b>INSP. DATE:</b> July 26, 2017	<b>INSP. TIME:</b> 11:30
<b>OPERATOR:</b> Premier Silica LLC	<b>OPERATOR REPRESENTATIVE:</b> Jeff & Maria Jindra	<b>TYPE OF OPERATION:</b> 112c - Construction Regular Operation	
<b>REASON FOR INSPECTION:</b> Surety Related	<b>BOND CALCULATION TYPE:</b> Partial Bond	<b>BOND AMOUNT:</b> \$64,439.00	
<b>DATE OF COMPLAINT:</b> NA	<b>POST INSP. CONTACTS:</b> None	<b>JOINT INSP. AGENCY:</b> None	
<b>WEATHER:</b> Clear	<b>INSPECTOR'S SIGNATURE:</b>

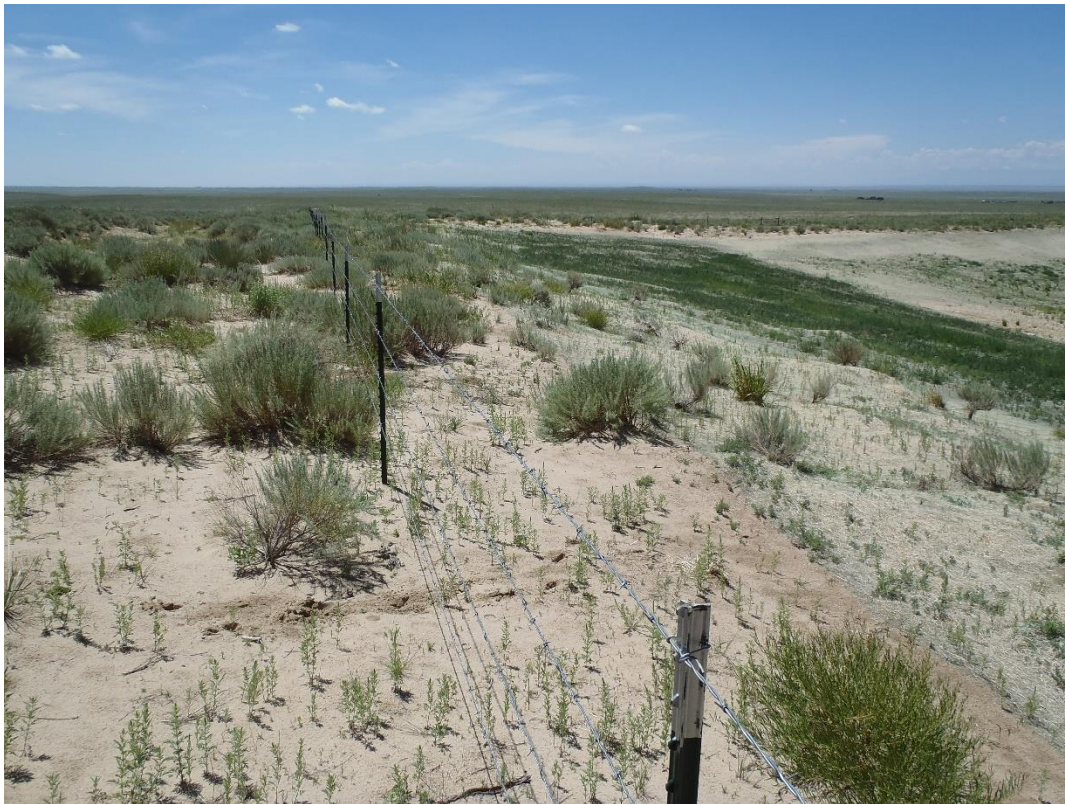
Off-site Damage: The operation appeared to be confined to the permit boundary. The Jindras stated Premier Silica has fenced off the two disturbed areas: pit (see **Photo 1**) and stormwater diversion cut (see **Photo 2**).

Photo 1. Barbed wire fence along pit, east side (looking south).

Financial Warranty: The \$64,439.00 bond held by the Division is more than adequate for the remaining reclamation required: reseeding and possible watering for approximately 10 acres or less. The new fence will need to be removed prior to reclamation release, unless a revision is made to the permit using the proper application and submitting the appropriate fee.

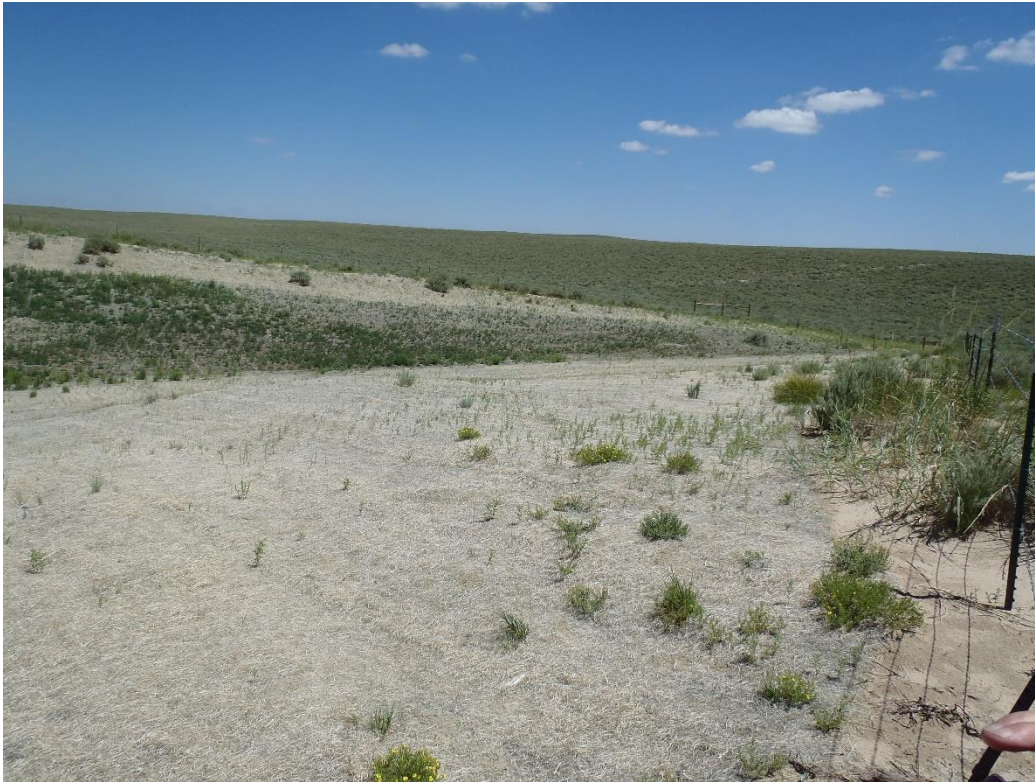
Photo 2. Barbed wire fence along stormwater cut, south side (looking east).

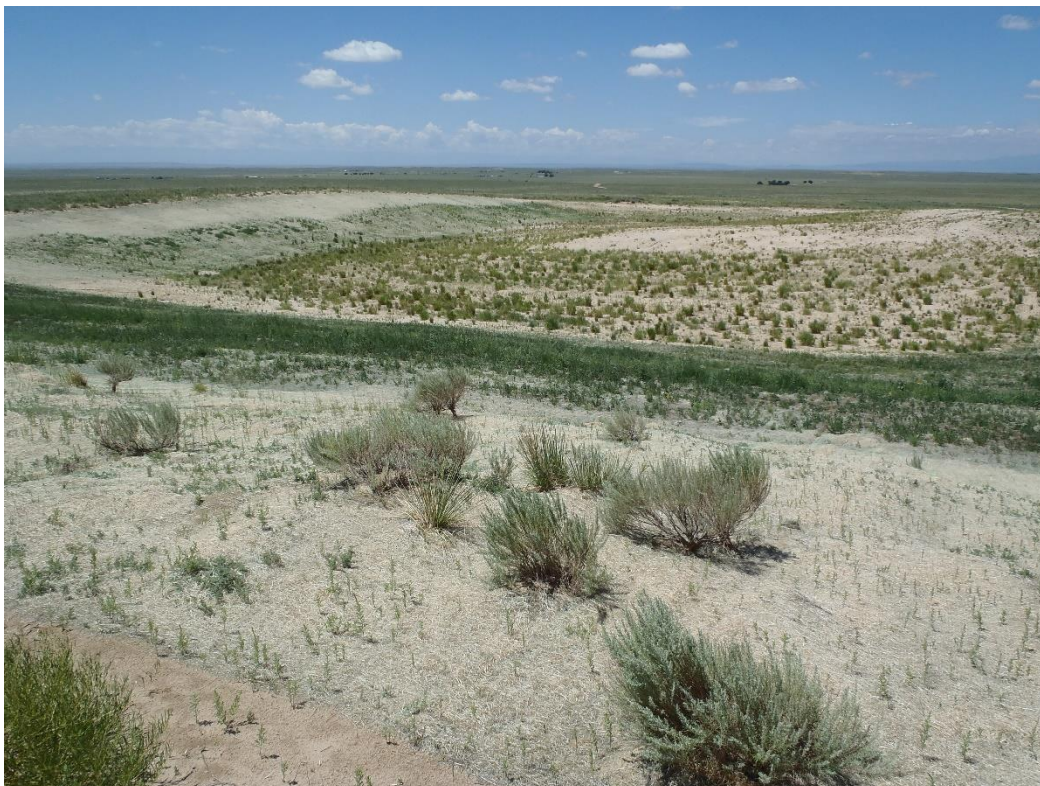
Reclamation Success/Revegetation: Since the last inspection, the upper slopes of the pit (see **Photo 3**) and the stormwater diversion cut (see **Photo 4**) have been seeded and covered with a light weight erosion control mat (see **Photo 5**) consisting of coconut mulch and a fine polymer net. Ms. Jindra pointed out grasses (see **Photo 6**) that had come up well with moisture earlier this summer, but had wilted and turned brown with the recent hot weather. No noxious weeds were observed.

Photo 3. Recent revegetation effort on upper pit slopes (looking WSW).

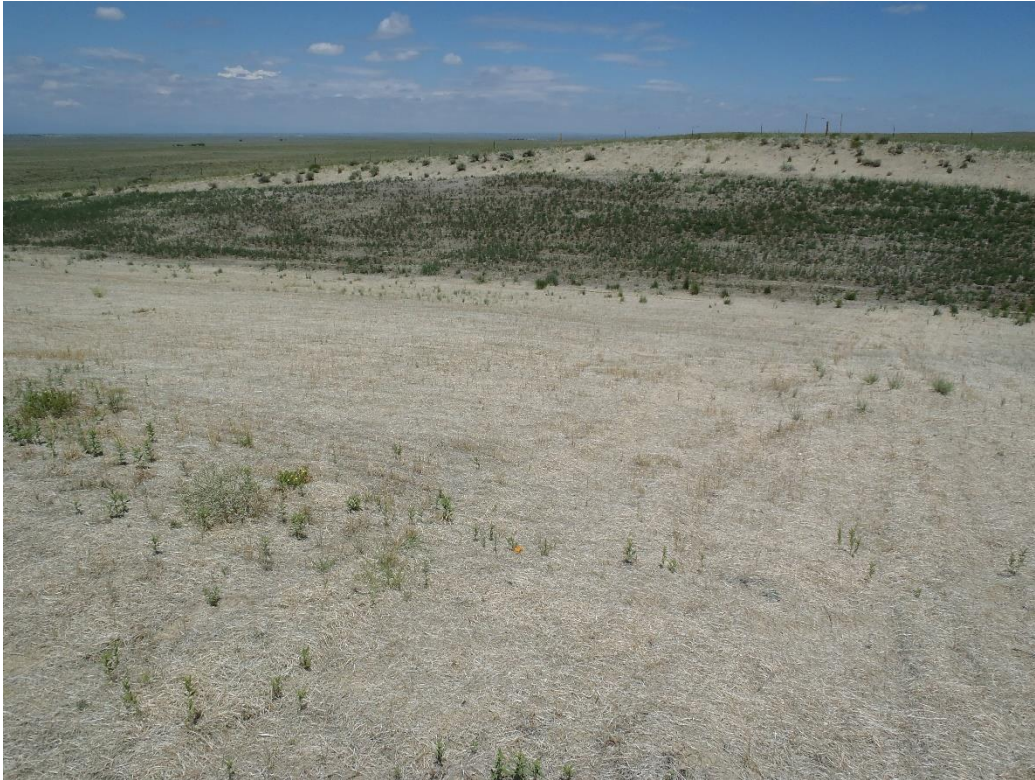
Photo 4. Recent revegetation effort on stormwater cut (looking north).

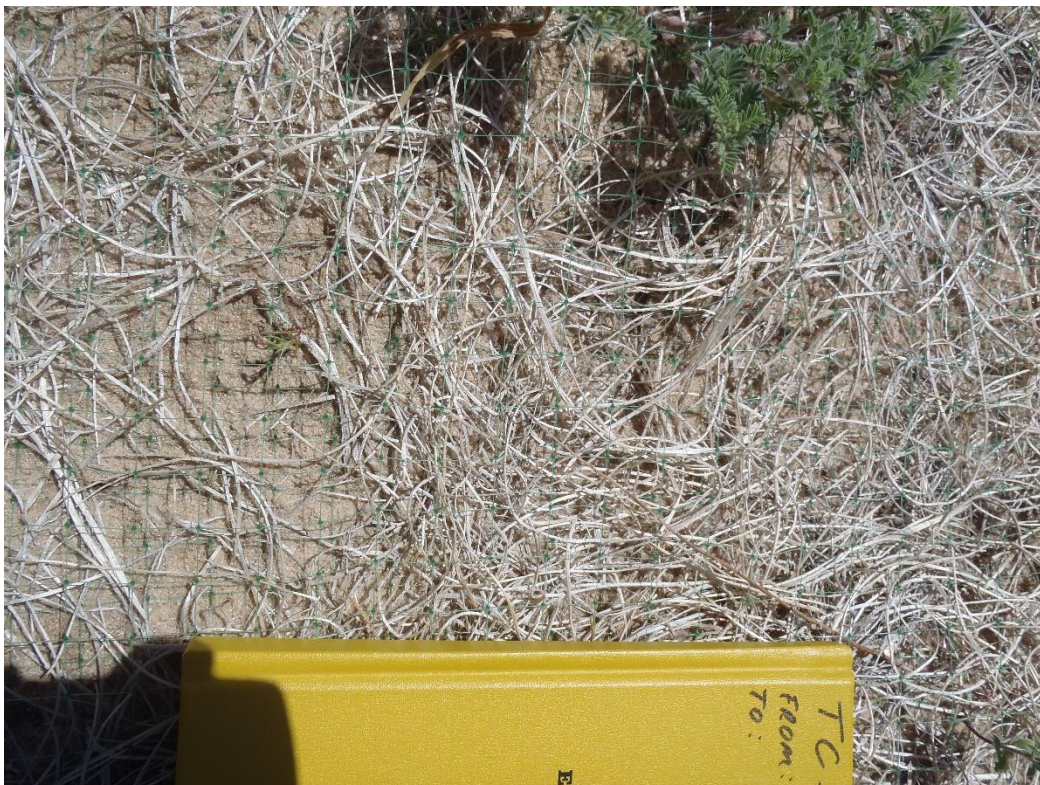
Photo 5. Light weight erosion control mat consisting of coconut mulch and a fine polymer net.

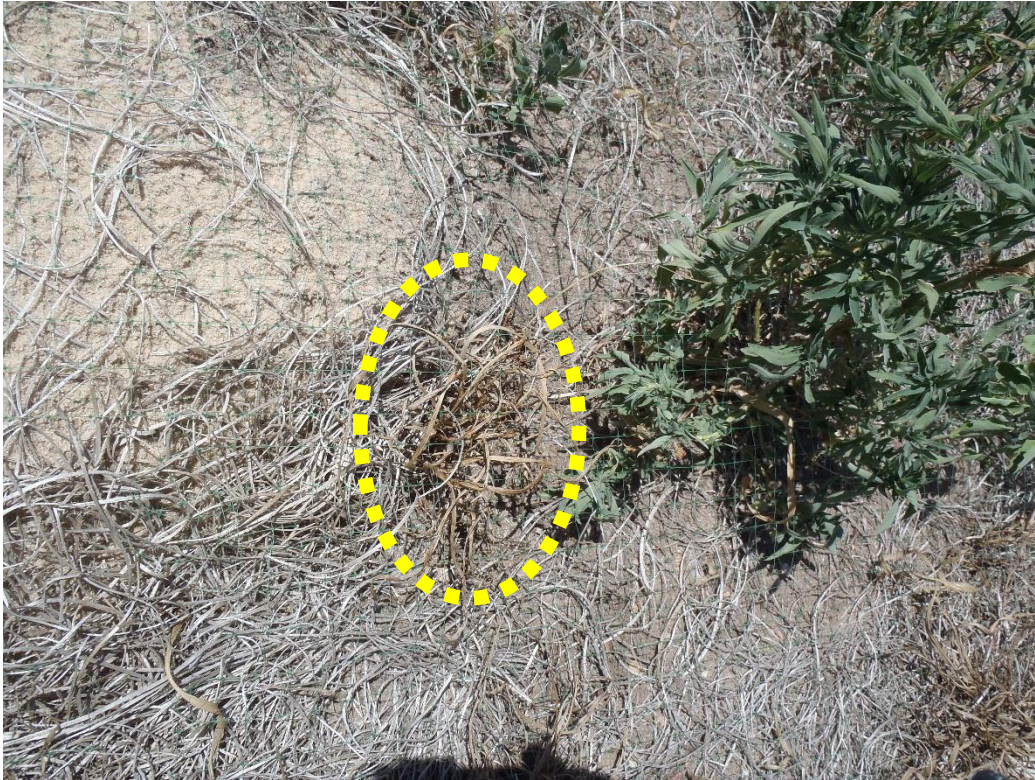
Photo 6. Typical probable failed growth from earlier this summer.

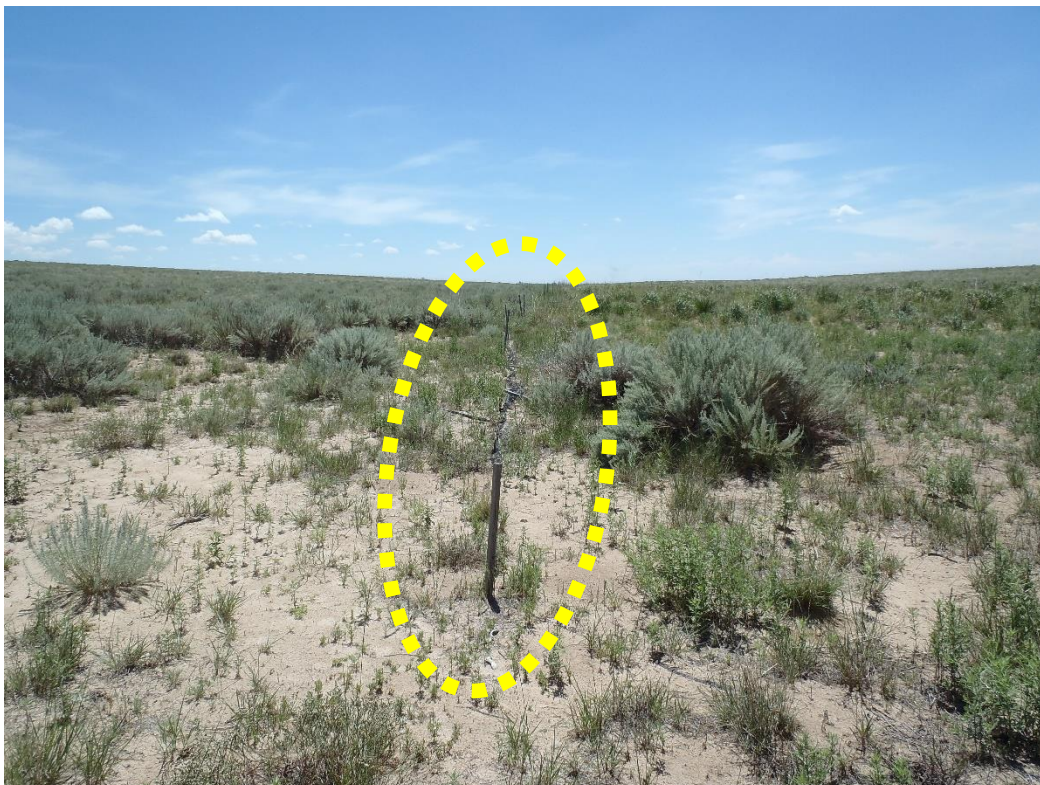
Sediment Control: No erosion problems were observed and no BMPs were needed at the time of the inspection. Some old silt fence (see **Photo 7**) was observed east of the stormwater diversion cut. The posts and remaining fabric should be removed.

Photo 7. Old silt fence posts (erosion control) observed east of diversion cut (looking south).

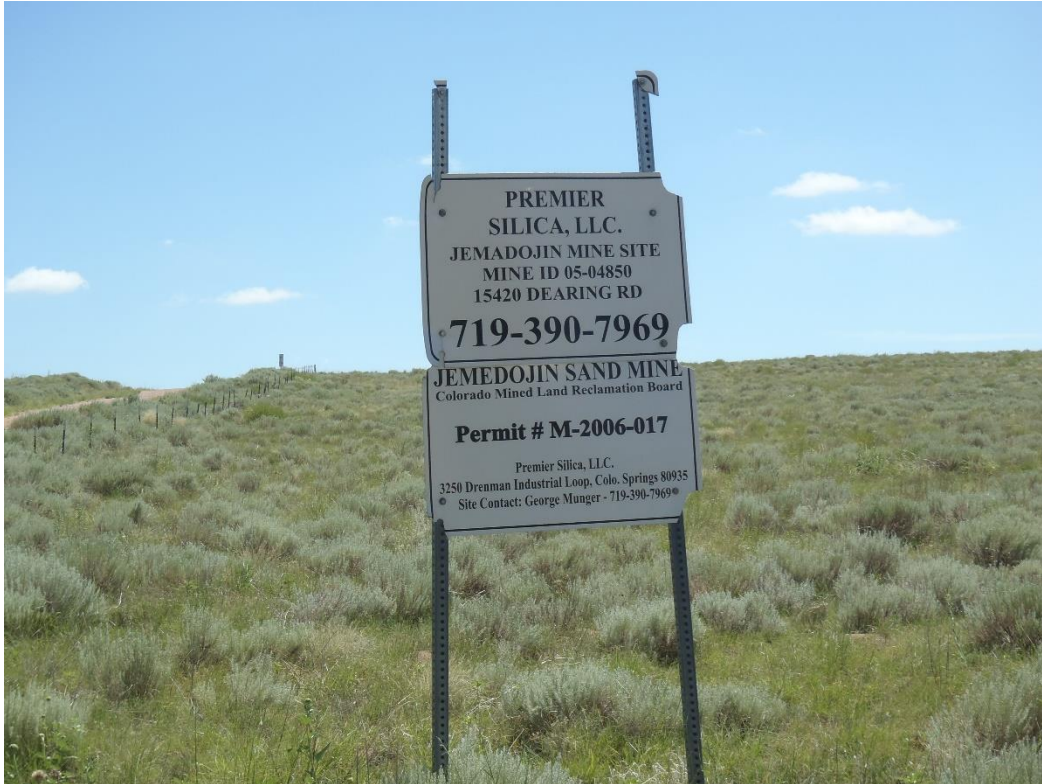
Signs and Markers: The permit sign was properly posted (see **Photo 8**).

Photo 8. Permit sign at entrance gate off Dearing Road.
