MINERALS PROGRAM INSPECTION REPORT PHONE: (303) 866-3567

MINE NAME:	MINE/PROSPECTING ID#:	MINERAL:	COUNTY:	
Limon Pit	M-2013-080	Sand and gravel	Lincoln	
INSPECTION TYPE:	INSPECTOR(S):	INSP. DATE:	INSP. TIME:	
Monitoring	Timothy A. Cazier	July 26, 2017	9:00	
OPERATOR:	OPERATOR REPRESENTATIVE:	TYPE OF OPERATION:		
Pine Bluffs Gravel & Excavating, Inc.	John Craig	112c - Construction Regular Operation		
REASON FOR INSPECTION:	BOND CALCULATION TYPE:	BOND AMOUNT:		
Normal I&E Program	Partial Bond	\$239,213.00		
DATE OF COMPLAINT:	POST INSP. CONTACTS:	JOINT INSP. AGENCY:		
NA	None	None		
WEATHER:	INSPECTOR'S SIGNATURE:	SIGNATURE DAT	E:	
Clear	him AC-	July 28, 2017

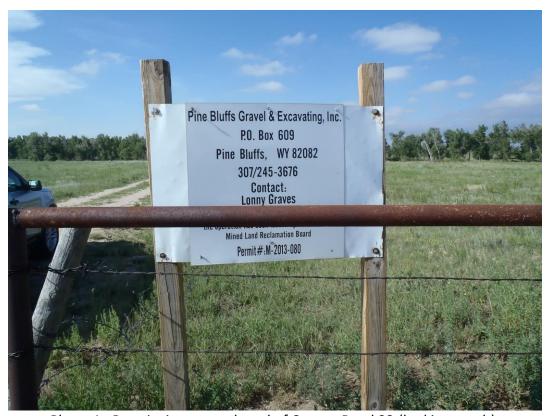
<u>Signs and Markers:</u> The permit sign was properly posted (see **Photo 1**) and large diameter steel post boundary markers were observed to delineate the permit boundary (see **Photo 2**).

Photo 1. Permit sign at south end of County Road 23 (looking south).

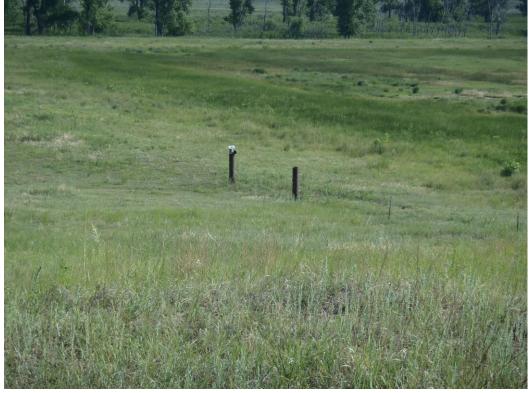
Photo 2. Typical steel posts delineating the permit boundary (south side, looking NNE).

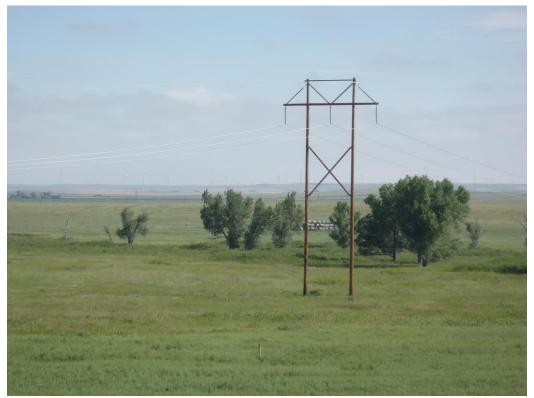
<u>Structures:</u> Two power lines were observed crossing and on the west boundary of the permitted area. Mr. Craig indicated the electric transmission line (see **Photo 3**) was owned by Tri-State, and the electric distribution line (see **Photo 4**) was owned by Mountain View Electric. Mr. Craig also owns the windmill (see **Photo 5**) used to pump water from the adjacent well in the permit area. He believed the mining lease limited disturbance in the vicinity of the windmill to an acceptable distance. Regardless, prior to commencing any mining operations, the Permittee should ensure all structure damage compensation agreements (pursuant to Rule 6.4.19) are current for the utilities and the windmill/well.

Photo 3. Electric transmission line crossing permit area (looking north).

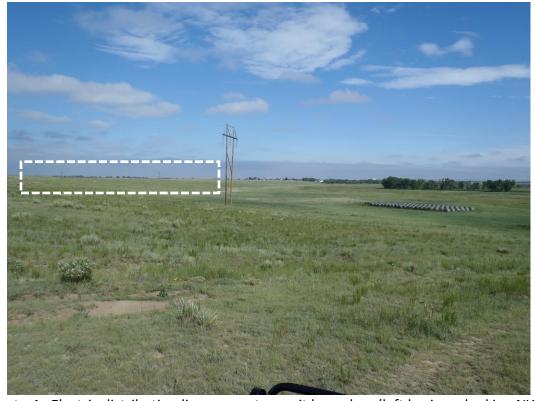
Photo 4. Electric distribution line on west permit boundary (left horizon, looking NW).

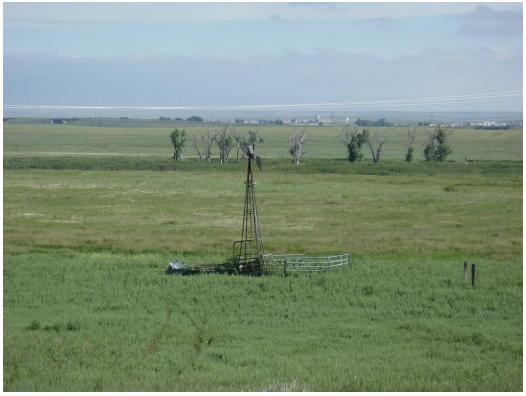
Photo 5. Windmill (looking north).
