COLORADO
Division of Reclamation,
Mining and Safety
Department of Natural Resources

Permit Number: C-1981-012 Mine Name: New Elk Mine Operator: New Elk Coal Company, LLC Operator Address: Mr. Louis Head 12250 Highway 12 Weston, CO 81091	County: Las Animas Operation Type: Underground Permit Status: Active Ownership: Private
	Operator Representative Present: Vince Massarotti
Operator Representative Signature: (Field Issuance Only)

Inspection Start Date: July 26, 2017 Inspection Start Time: 10:00 Inspection End Date: Inspection End Time:	Inspection Type: Coal Partial Inspection Inspection Reason: Normal I&E Program Weather: Clear
Joint Inspection Agency: None	Joint Inspection Contacts:
Post Inspection Agency: None	Post Inspection Contacts:
Inspector(s): Robert D. Zuber, P.E.	Inspector's Signature: <i>Robert D. Zuber</i> Signature Date: 7/31/2017

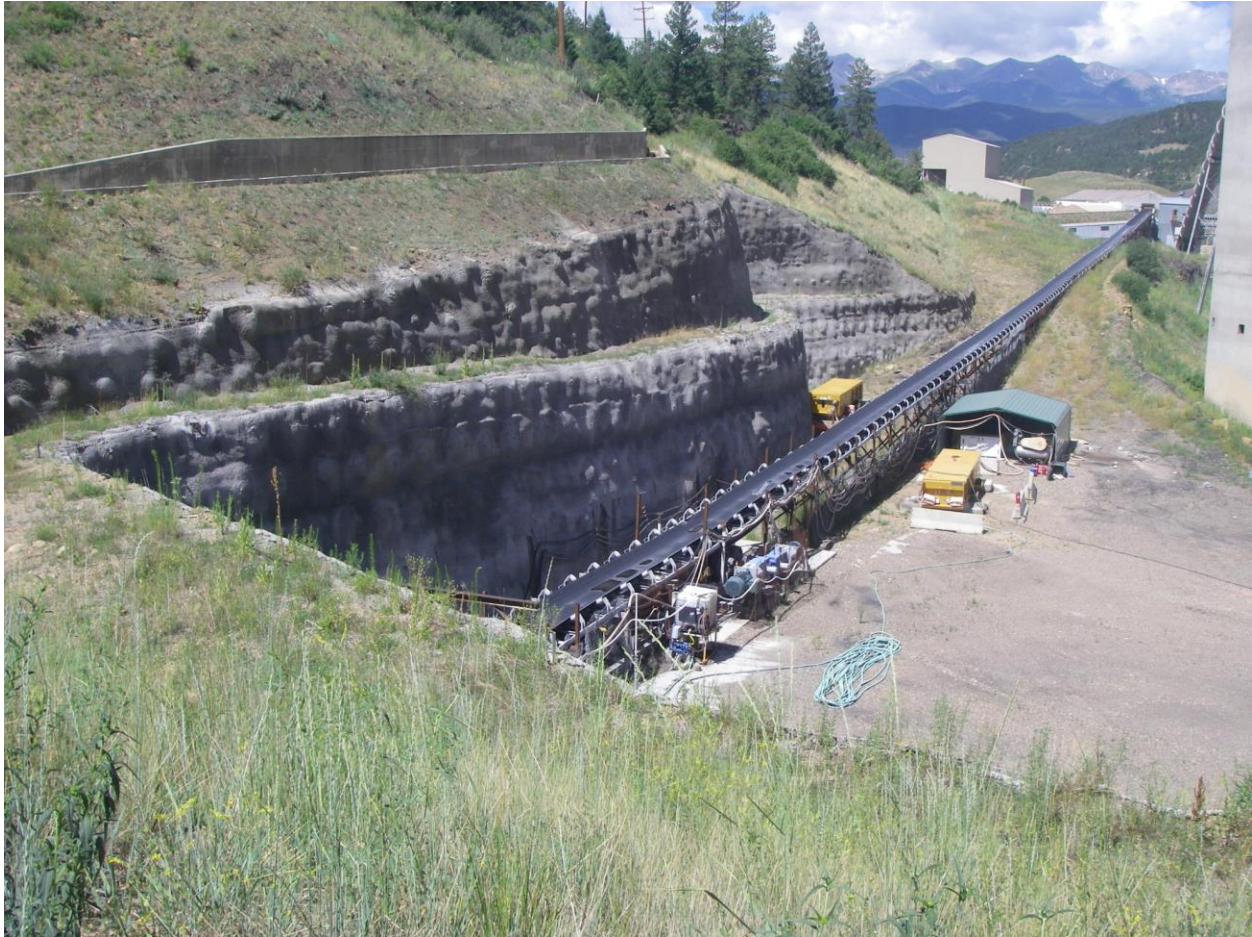
Retaining wall near Bates Portals

No significant issues were seen with the facility areas, including the retaining wall above the Bates Portal area. The pond cleaning material on the clean coal storage area needs to be removed as soon as it is dry enough to transport.

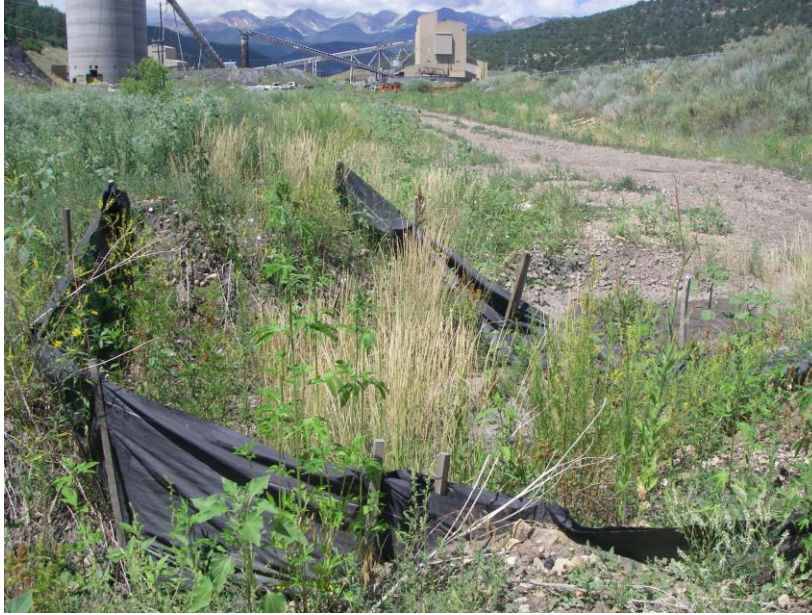
Silt fence below SAE by Pond 007A

Additional sediment control BMPs have been added below and in the SAE by Pond 007A. They appear to be functioning well.

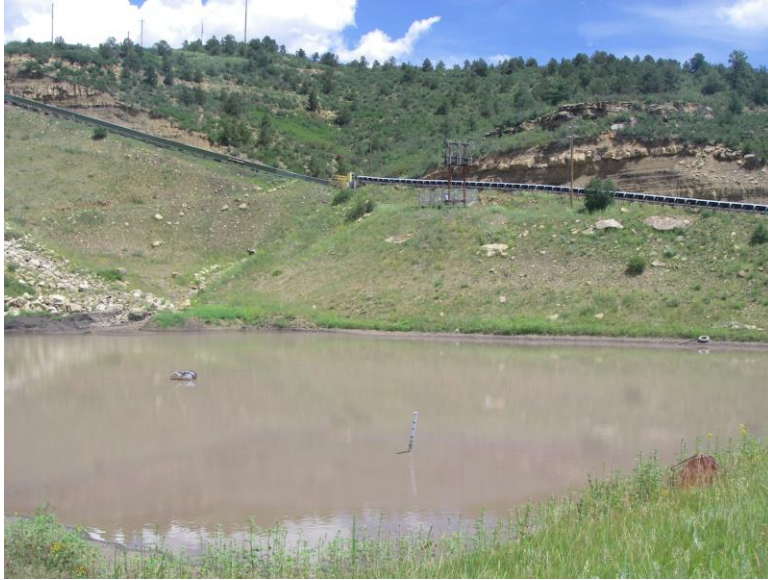
Hill above Pond 08

The slope above Pond 08 has seen decent vegetation growth in 2017.

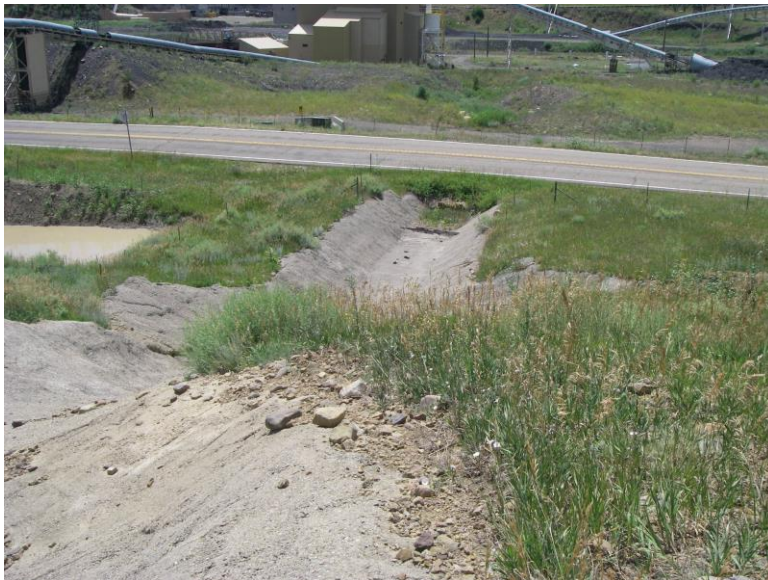
Pond 08 spillway and Containment Area 5

Ponds 001A, 007A, and 08 were inspected, and none of them were discharging. The impounded water was relatively high in all three ponds due to rains. No significant issues were seen with the pond spillways or embankments, and the liner at Pond 001A appears to be in good shape.

Containment Area 5 was holding water that was several feet below the top of the structure. There was no sign of problems with this structure.

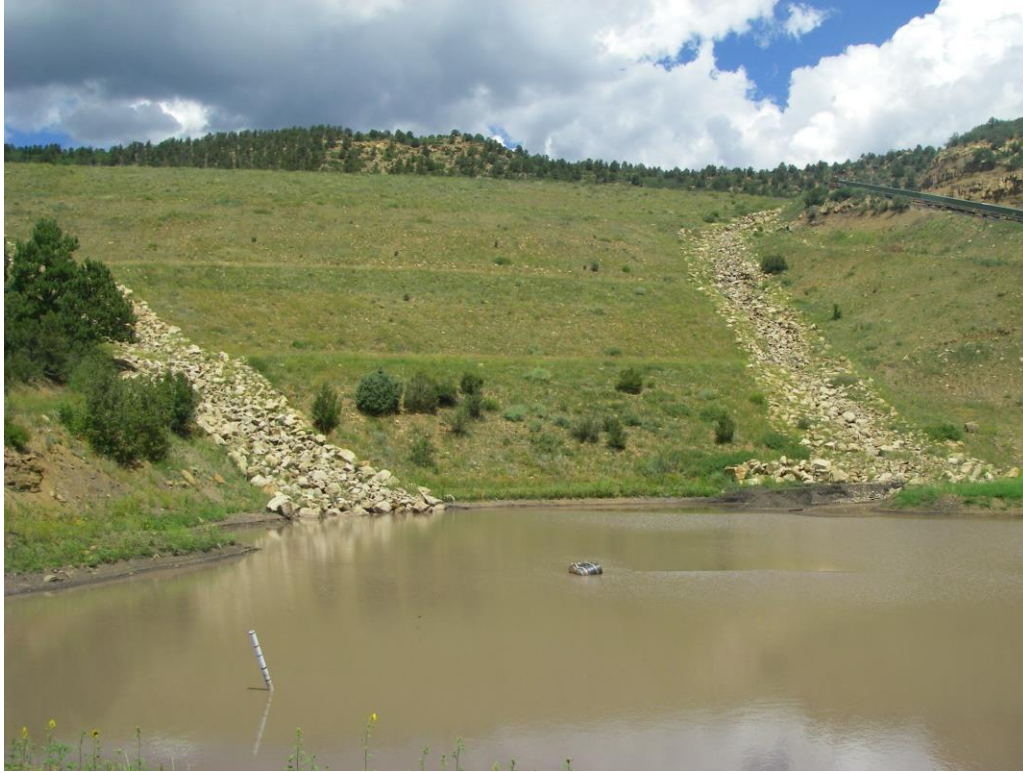
Pond 08 and RDA

There is good vegetation cover on the reclaimed portion of the RDA, and no large rills or gullies were seen on the face or in the side ditches (the RDA was inspected from below).
