Permit Number: C-1996-084 Mine Name: Lorencito Canyon Mine Operator: New Elk Coal Company, LLC Operator Address: Mr. Louis Head 12250 Highway 12 Weston, CO 81091	County: Las Animas Operation Type: Surface Permit Status: Permanent Cessation Ownership: Private
	Operator Representative Present: Vince Massarotti
Operator Representative Signature: (Field Issuance Only)

Inspection Start Date: July 26, 2017 Inspection Start Time: 12:30 Inspection End Date: Inspection End Time:		Inspection Type: Coal Partial Inspection Inspection Reason: Normal I&E Program Weather: Cloudy	
Joint Inspection Agency: None		Joint Inspection Contacts:	
Post Inspection Agency: None		Post Inspection Contacts:	
Inspector(s): Robert D. Zuber, P.E.	Inspector's Signature:

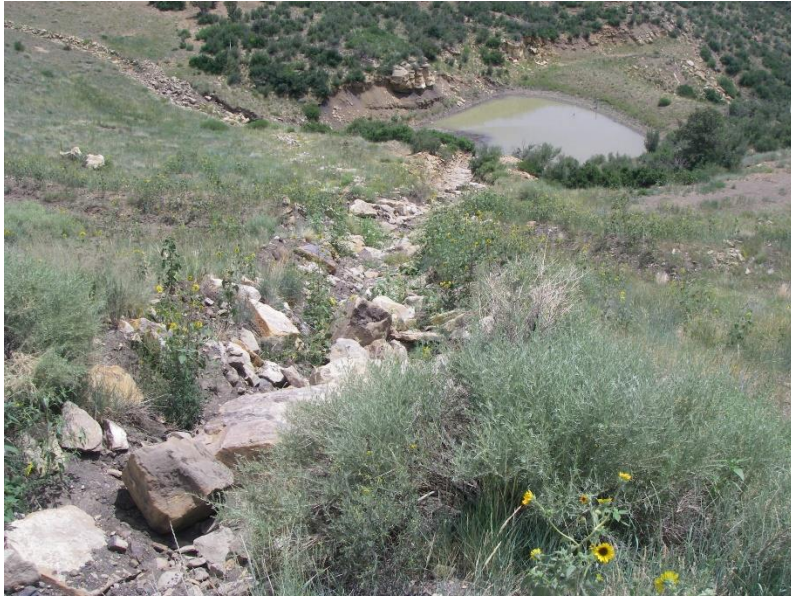
- At Fill 7, areas that are somewhat bare have been seeded and mulched.
- At Fill 8, rock work has been done to address erosion at the bottom of the west channel. (Additional work may be needed here if erosion continues.)
- At Fill 9, rock work has been done to improve the side channels.

Fill 9 side channel

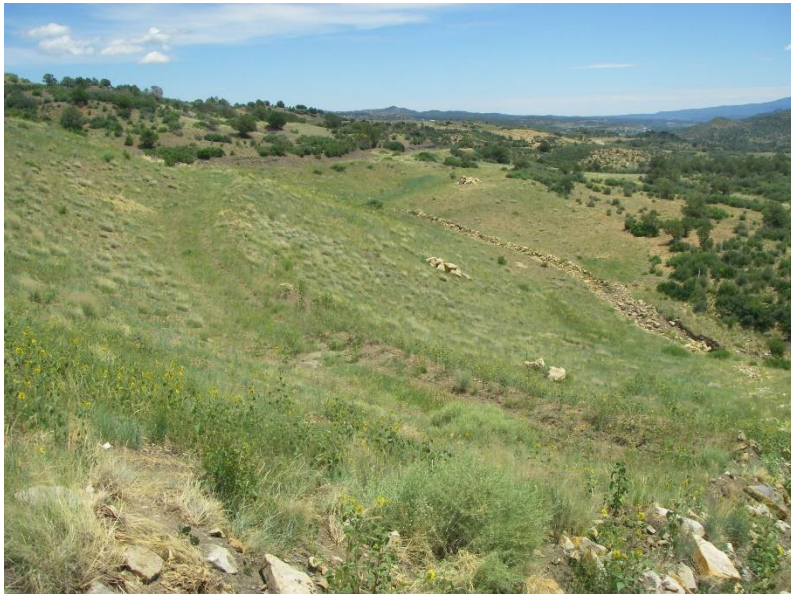
Fill 9 with excellent vegetation

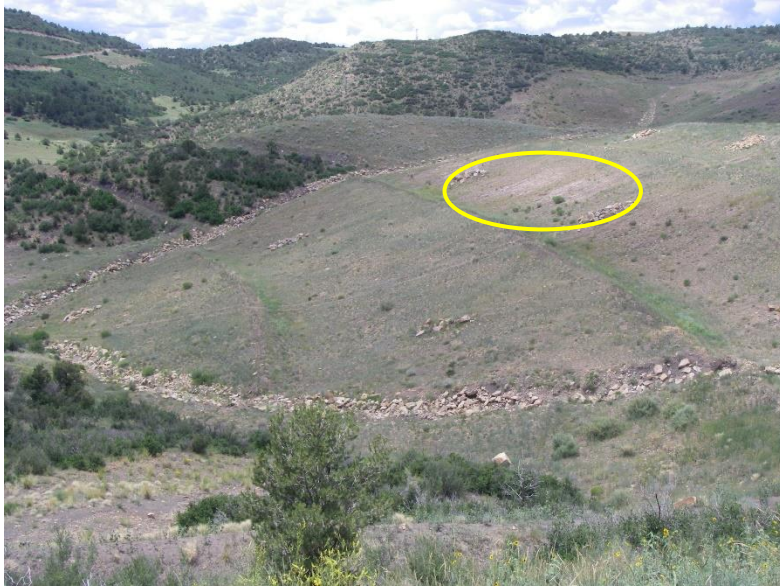
Fill 7 (seeded area in circle)

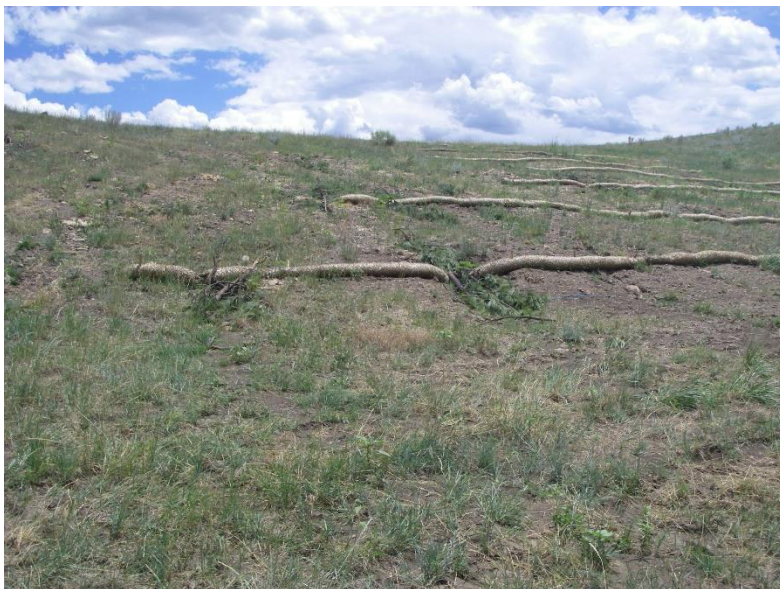
Rill repairs near shrub plot

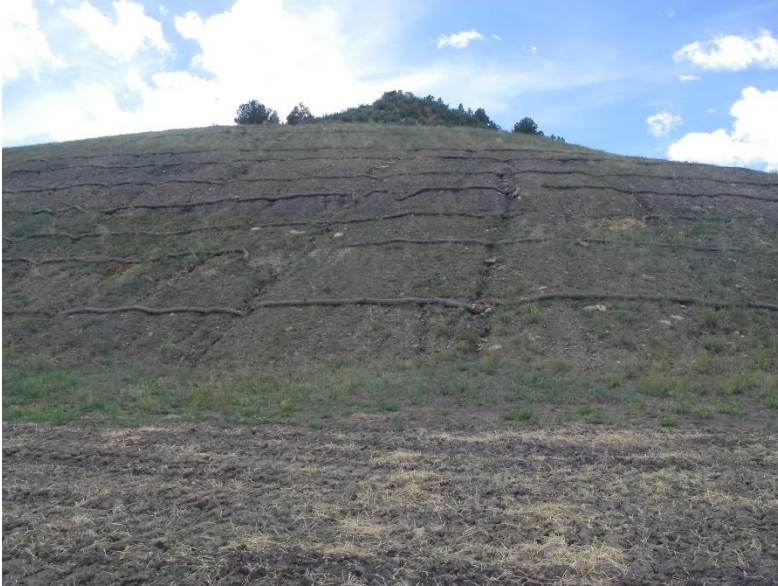
The pond cleaning dump area has been seeded and mulched. Tree branches have been placed in rills on the hill above this dump area.

Hill above pond cleaning dump – need for more branches

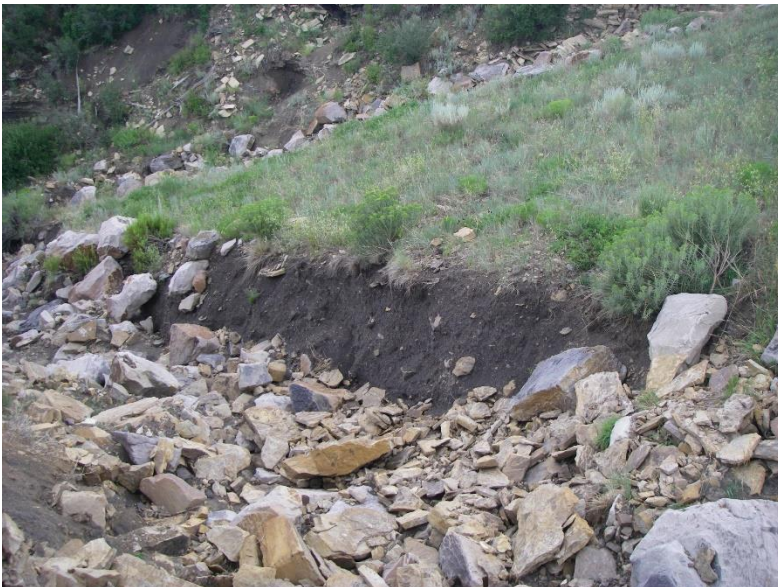
Channel below Fill 8 where additional rock work may be needed (if safe to access)
