**COLORADO**Division of Reclamation,
Mining and Safety

MINERALS PROGRAM INSPECTION REPORT**PHONE: (303) 866-3567**

MINE NAME: Red Arrow Dome	MINE/PROSPECTING ID#: P-2009-018	MINERAL: Silver, gold and copper	COUNTY: Montezuma
INSPECTION TYPE: Multi Person Inspection	INSPECTOR(S): Lucas J. West, Russ Means	INSP. DATE: July 17, 2017	INSP. TIME: 14:00
OPERATOR: Red Arrow Gold Corporation in Receivership	OPERATOR REPRESENTATIVE: None	TYPE OF OPERATION: MP - Mineral Prospecting	
REASON FOR INSPECTION: Surety Related	BOND CALCULATION TYPE: None	BOND AMOUNT: \$2,000.00	
DATE OF COMPLAINT: NA	POST INSP. CONTACTS: None	JOINT INSP. AGENCY: None	
WEATHER: Clear	INSPECTOR'S SIGNATURE:

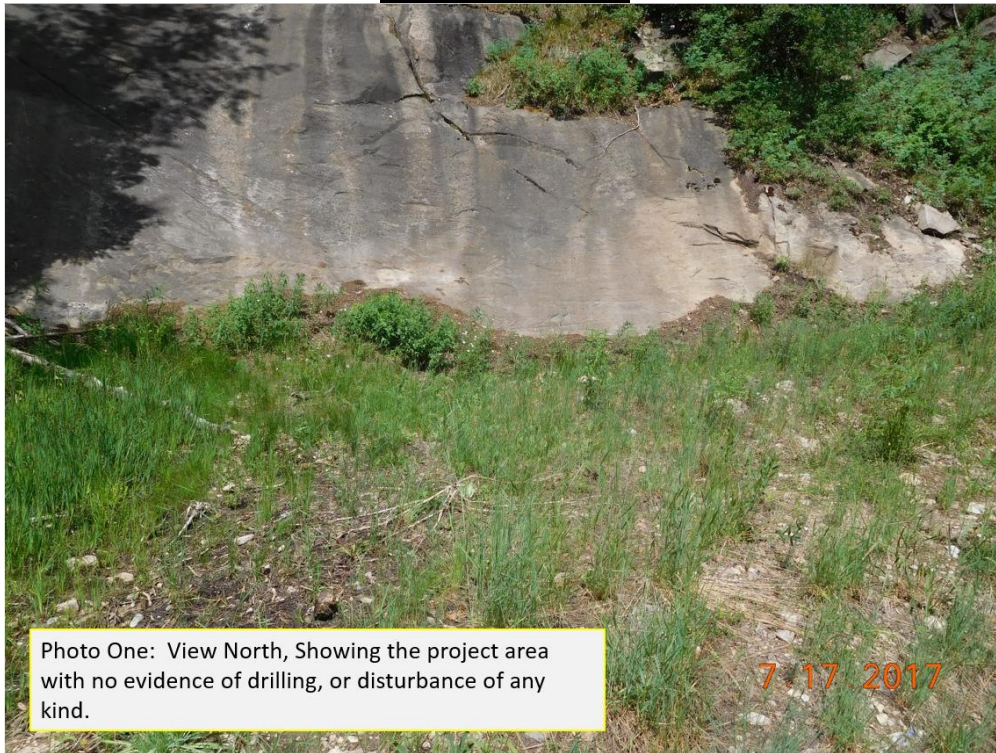
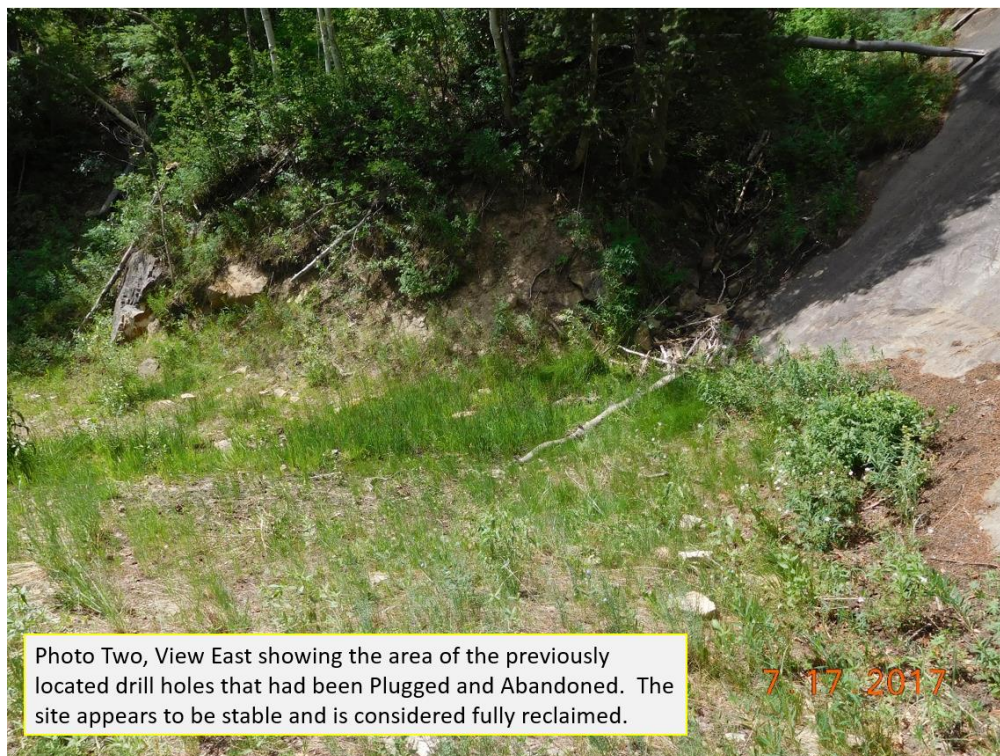
The project involved drilling up to three drill holes along a bend in a historic mining road west of the Red Arrow Mine property. There was no prospecting equipment on site, no any cuttings, drilling debris or other project related features. Photos One and Two show the project area. Debris and sediment flows have covered up the previously located drill holes that had been capped. The site is considered fully reclaimed at this time.
