MINERALS PROGRAM INSPECTION REPORT

MINE NAME: Red Arrow Mine Drill 2	MINE/PROSPECTING ID#: P-2012-007	MINERAL: Silver, Gold and Cop	COUNTY: Montezuma
INSPECTION TYPE: Multi Person Inspection	INSPECTOR(S): Lucas J. West, Russ Means	INSP. DATE: July 17, 2017	INSP. TIME: 14:30
OPERATOR: Red Arrow Gold Corporation in Receivership	OPERATOR REPRESENTATIVE: None	TYPE OF OPERATION: MP - Mineral Prospecting	
REASON FOR INSPECTION: Surety Related	BOND CALCULATION TYPE: None	BOND AMOUNT: \$2,000.00	
DATE OF COMPLAINT: NA	POST INSP. CONTACTS: None	JOINT INSP. AGENCY: None	
WEATHER: Clear	INSPECTOR'S SIGNATURE:

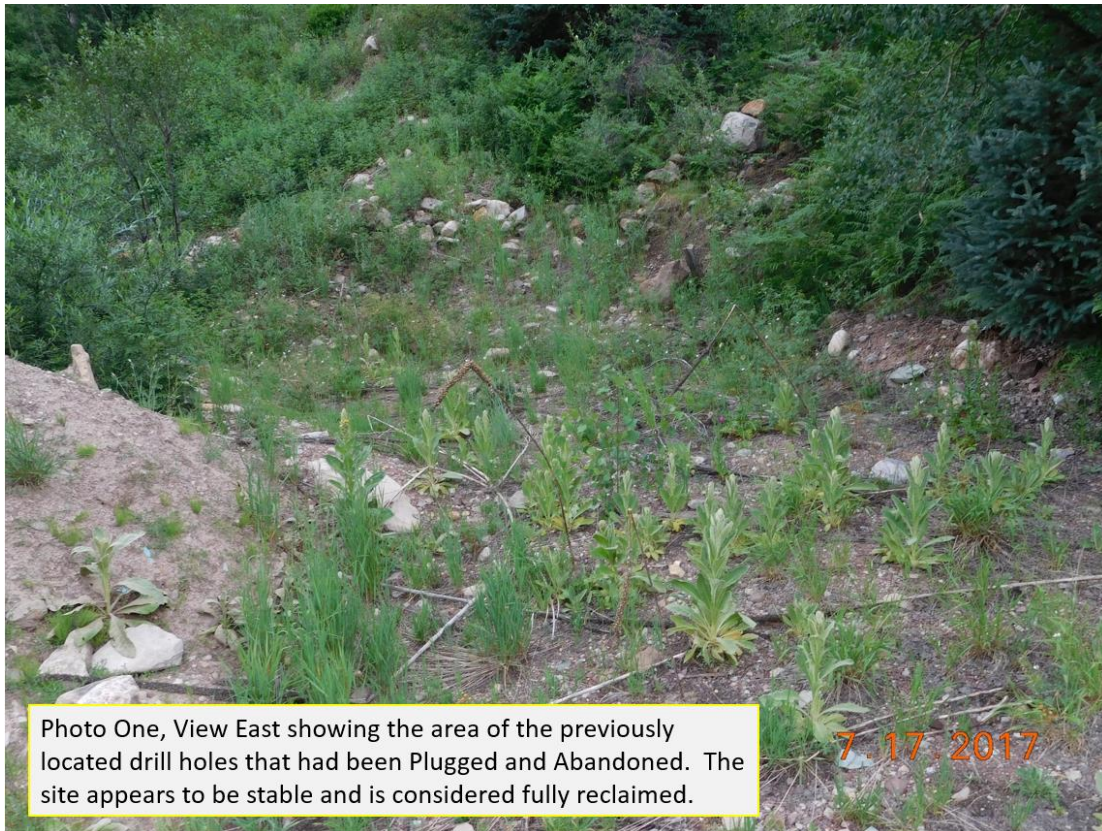
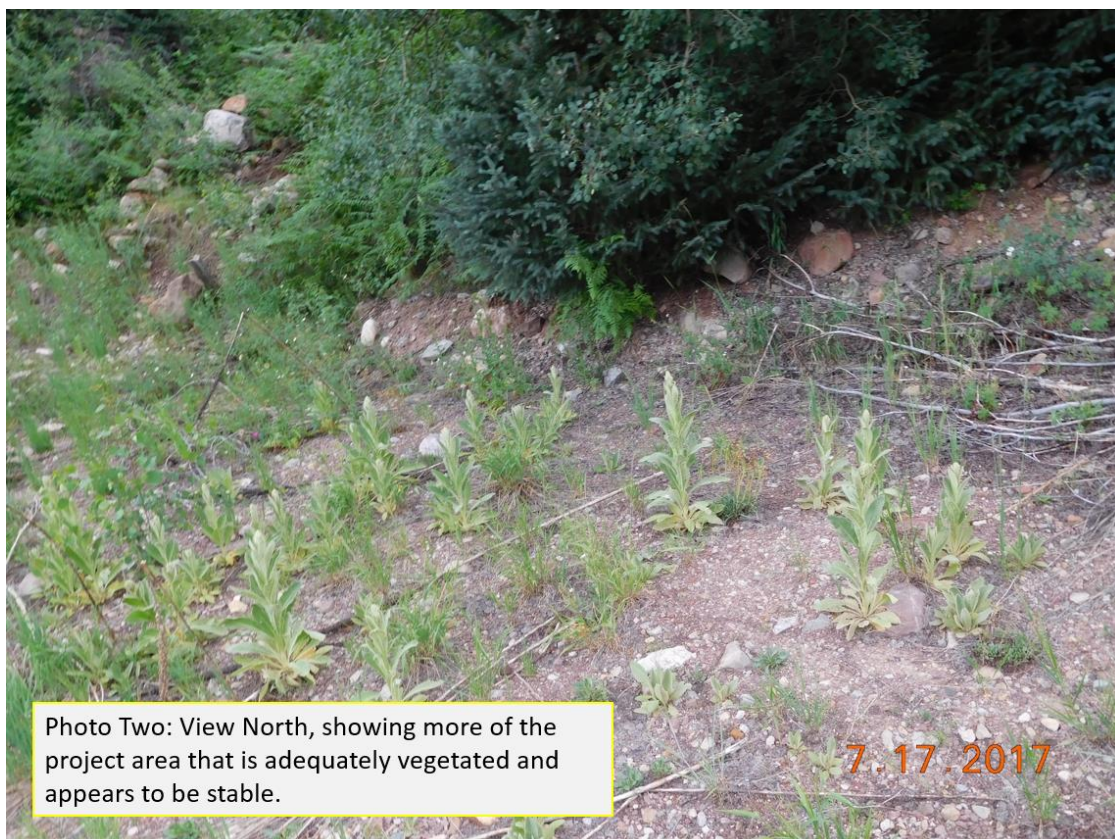
PHOTOGRAPHS

The project involved drilling up to ten drill holes along a bench on the historic Red Arrow Mine property. There was no prospecting equipment on site, no any cuttings, drilling debris or other project related features. Photos One and Two show the project area. Debris and sediment flows have covered up the previously located drill holes that had been capped. The project area showed no signs of settling, slumping or erosion and appeared to be stable and is adequately vegetated. The site is considered fully reclaimed at this time.
