### MINERALS PROGRAM INSPECTION REPORT

<b>MINE NAME:</b> Incas Mine	<b>MINE/PROSPECTING ID#:</b> M-1986-076	<b>MINERAL:</b> Gold and silver	<b>COUNTY:</b> La Plata
<b>INSPECTION TYPE:</b> Multi Person Inspection	<b>INSPECTOR(S):</b> Lucas J. West	<b>INSP. DATE:</b> July 18, 2017	<b>INSP. TIME:</b> 09:30
<b>OPERATOR:</b> Michael McClure	<b>OPERATOR REPRESENTATIVE:</b> None	<b>TYPE OF OPERATION:</b> 110d - Designated Limited Impact	
<b>REASON FOR INSPECTION:</b> Normal I&E Program	<b>BOND CALCULATION TYPE:</b> None	<b>BOND AMOUNT:</b> \$29,902.68	
<b>DATE OF COMPLAINT:</b> NA	<b>POST INSP. CONTACTS:</b> None	<b>JOINT INSP. AGENCY:</b> None	
<b>WEATHER:</b> Clear	<b>INSPECTOR'S SIGNATURE:</b>

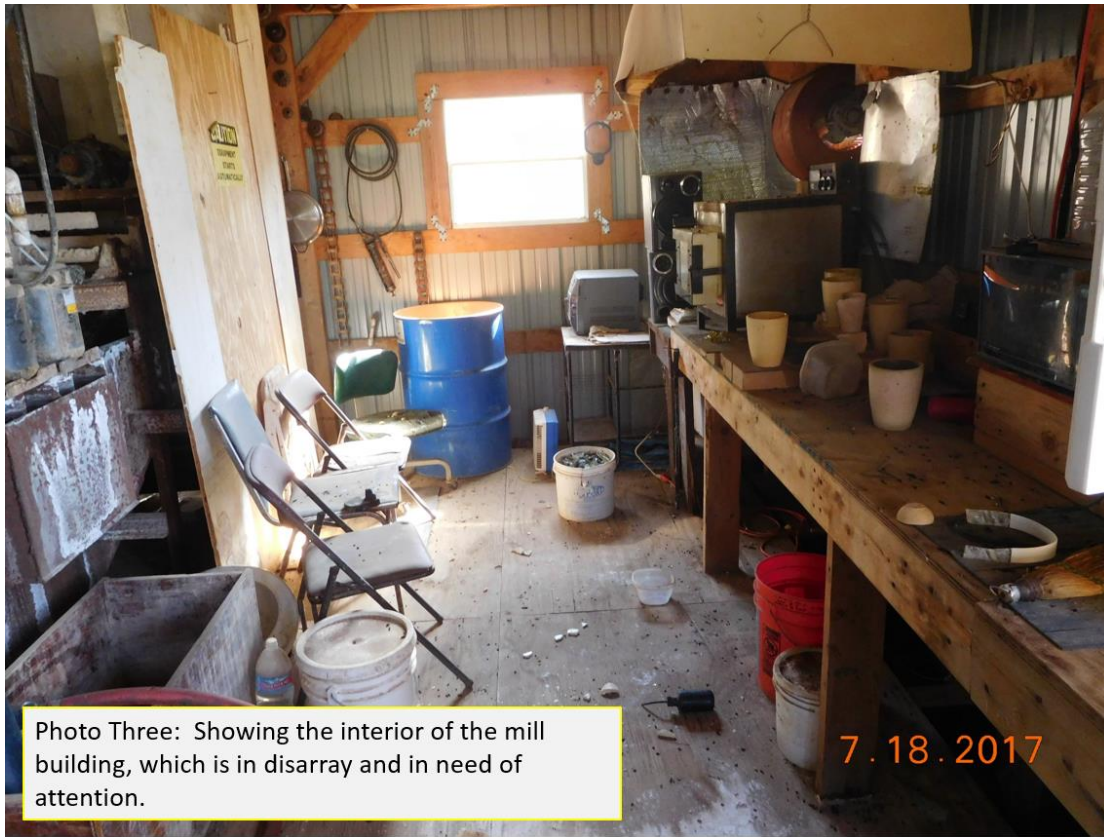
Access to the mill building was gained through an unlocked back door. Photos Three and Four show the mill building. The mill equipment, processing and testing equipment were observed throughout the building. Much of the equipment and the mill building itself is in serious disrepair and requires immediate attention. The rest of the site is in poor condition and requires attention.

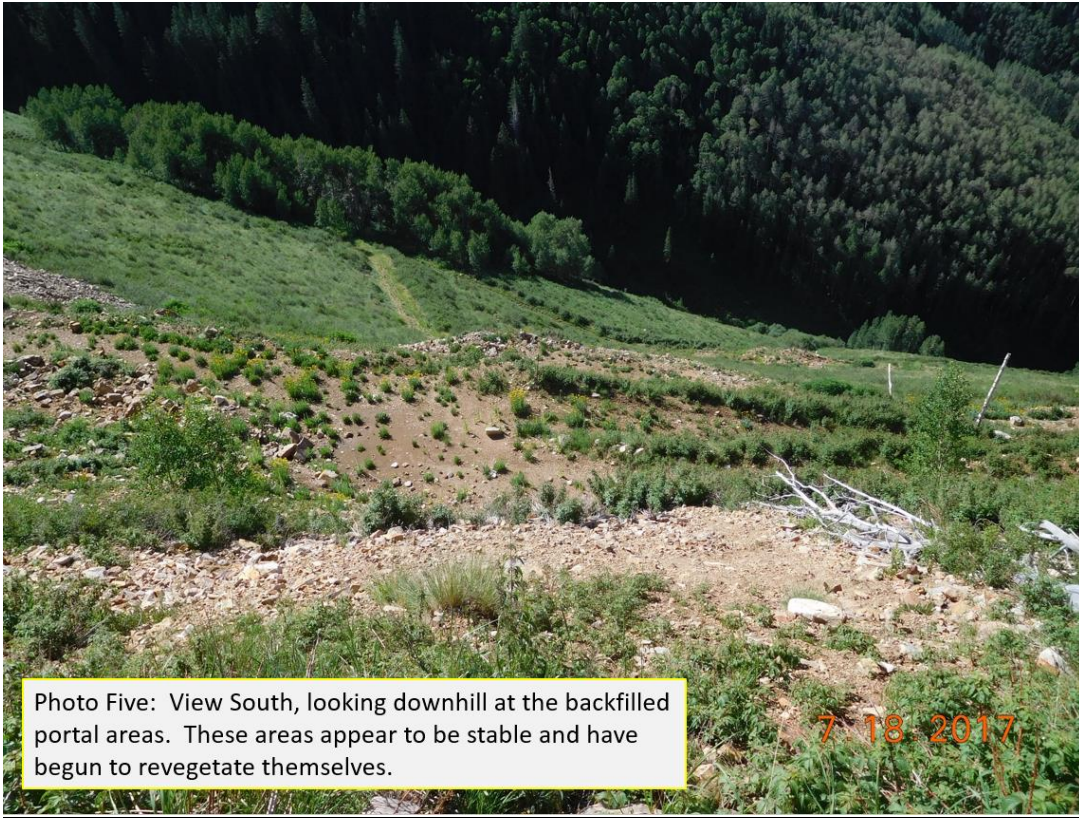
The portals appear to have been backfilled by the previous operator and can be seen in Photo Five, and a majority of the site is revegetated with volunteer species. The main excavation area is shown in Photo Six, has not been backfilled or reclaimed. The areas of the site that require further reclamation activities include the main excavation area, the mill building and general site cleanup of all mining related debris and equipment.
