PERMIT INFORMATION

Permit Number: C-1981-035 Mine Name: King Coal Mine Operator: GCC Energy, LLC Operator Address: Mr. Tom Bird 6473 County Road 120 Hesperus, CO 81326	County: La Plata Operation Type: Underground Permit Status: Active Ownership: Federal
	Operator Representative Present: M. McFarland
Operator Representative Signature: (Field Issuance Only)

INSPECTION INFORMATION

Inspection Start Date: July 25, 2017 Inspection Start Time: 08:30 Inspection End Date: Inspection End Time:		Inspection Type: Coal Partial Inspection Inspection Reason: Normal I&E Program Weather: Cloudy	
Joint Inspection Agency: None		Joint Inspection Contacts:	
Post Inspection Agency: None		Post Inspection Contacts:	
Inspector(s): Robert D. Zuber, P.E.	Inspector's Signature:

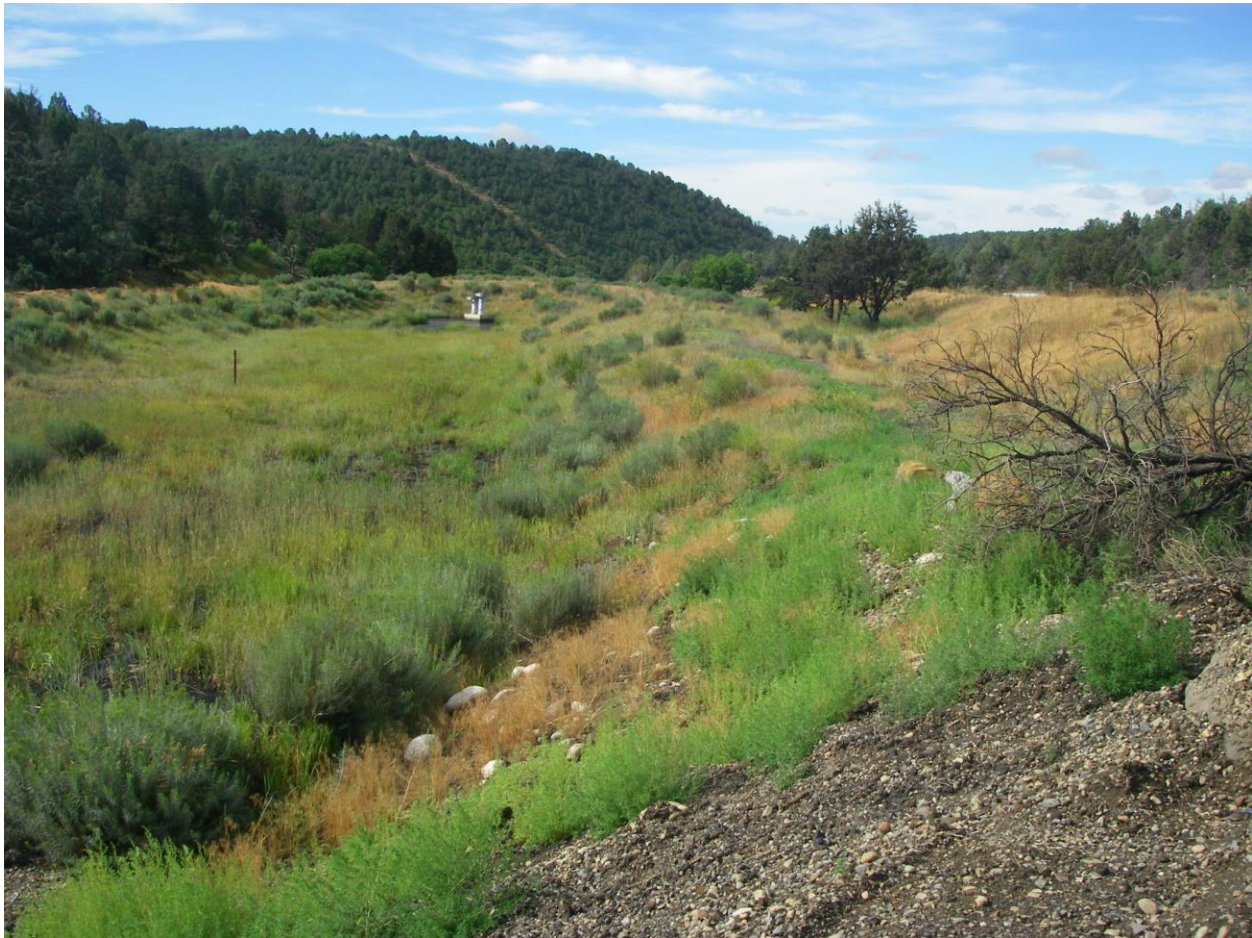
Only a small amount of water was in the King II pond, and no problems were seen with the structures.

King II Pond

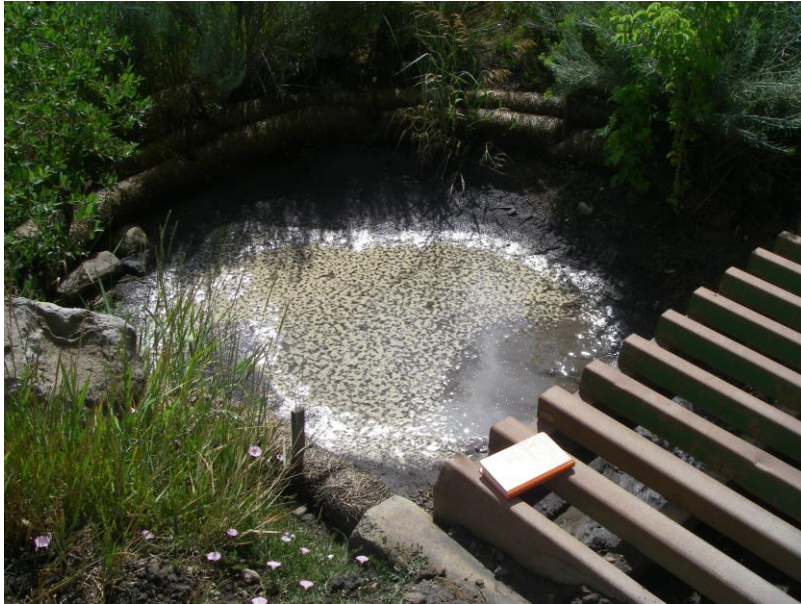
The West Clearwater Ditch at King II (CWD-2) was found to be generally in good shape. The BMPs below this ditch (sumps at the King II entrance) appear to be functioning well. However, the ditch below this area (CWD-1D) is overgrown with vegetation, and the bottom of the channel could not be seen, so it is unclear if sediment is being transported into the ditch through the BMPs. It is recommended that some of this vegetation be removed to insure that the ditch has flow capacity and (perhaps more importantly) to allow inspection of this ditch.

Sediment sump at King II entrance

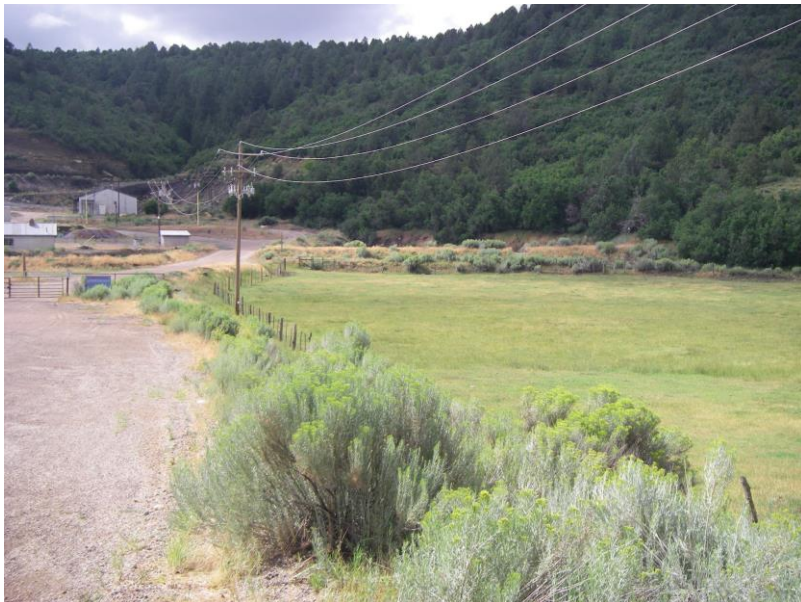
No issues were found at the SAE near the King I entrance; the silt fences appear to be in good shape.

King I entrance and adjacent field

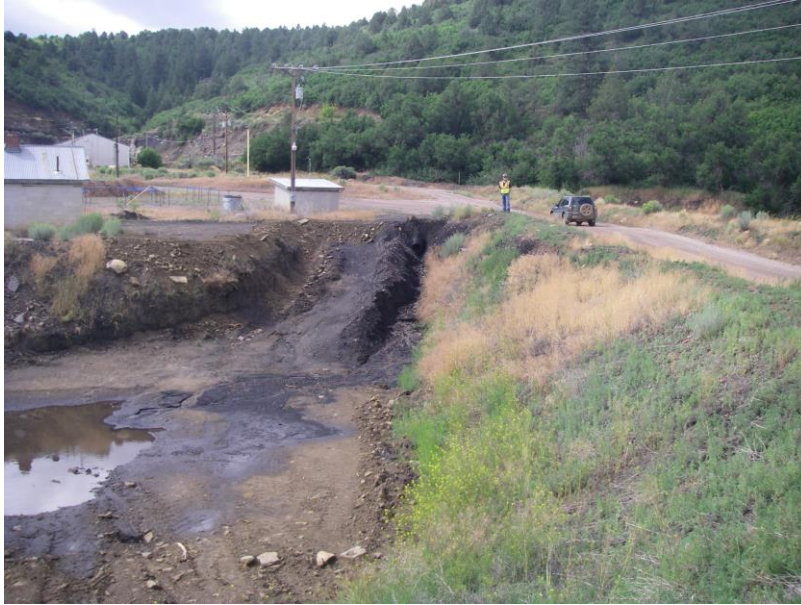
At the King I Mine, the East Pond was holding a very small water and not discharging, nor were there any signs that water has discharged from this pond in recent times. It is likely the water was from recent storms rather than alluvial water. Continual monitoring will determine if the addition of material to this pond has stopped the pond from intercepting groundwater. Work on this pond needs to continue. This includes cleaning up the vehicle entrance and making sure the pond meets the PAP specifications.

East Pond at King I

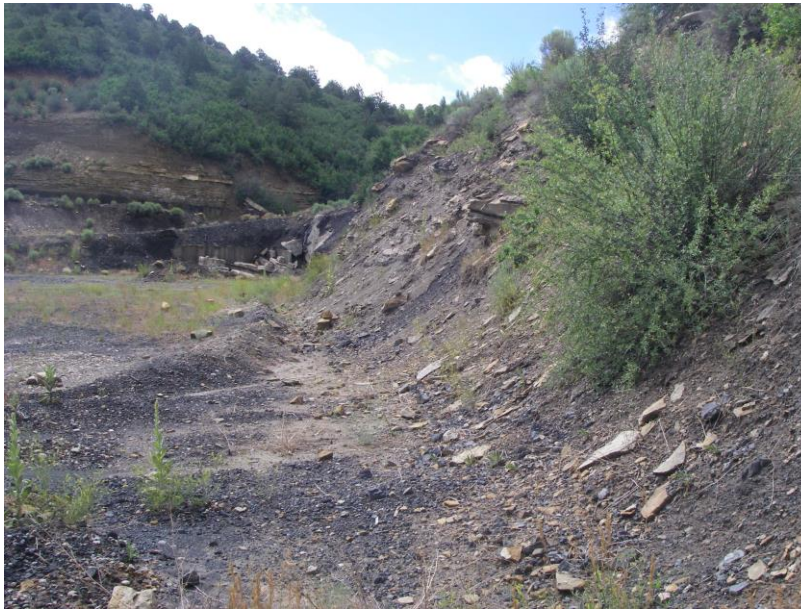
Cut slope at Fan Bench

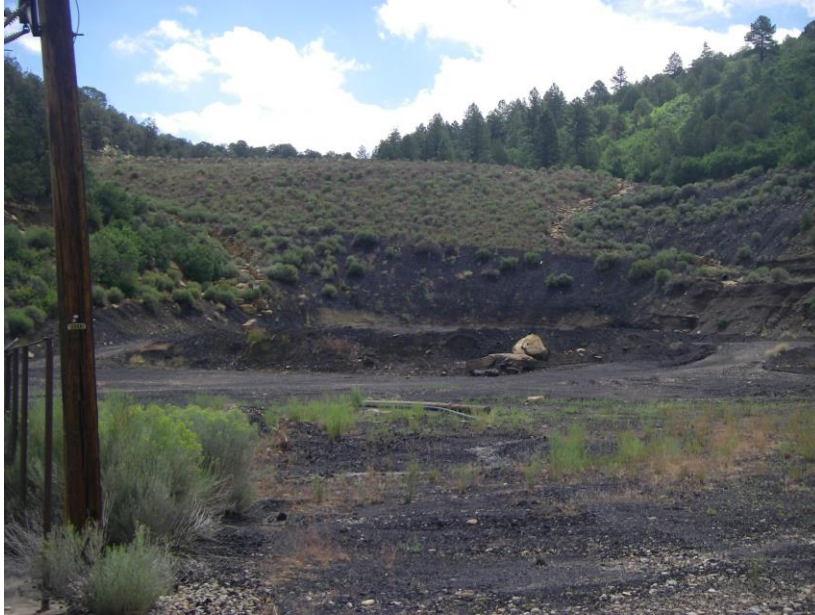
The un-reclaimed portion of the Refuse Pile (upper portion) has been graded to spread the piles of waste rock from previous months. There appears to be an adequate slope from north to south across the pile. No trash was seen in the recently graded area.

Refuse Pile face

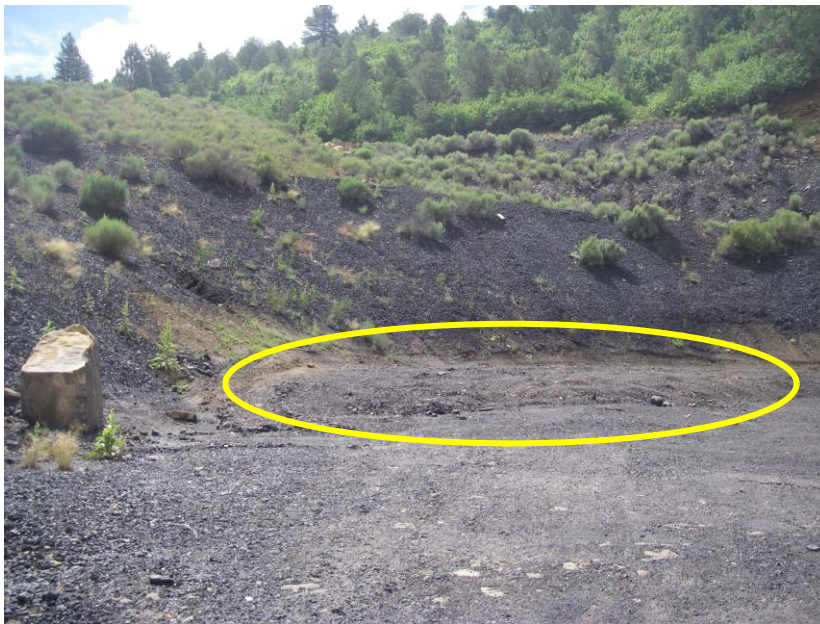
GCC is adding material to the lower portion of the Refuse Pile because the slope of this portion is steeper than the design (2.5:1). The lower lift appears to be well compacted (from visual observation and walking on it). As part of this work, the rock underdrain (as opposed to the pipe underdrain) needs to be extended.

**Lower part of Refuse Pile face where the slope is being flattened
(recently graded and compacted material within oval)**

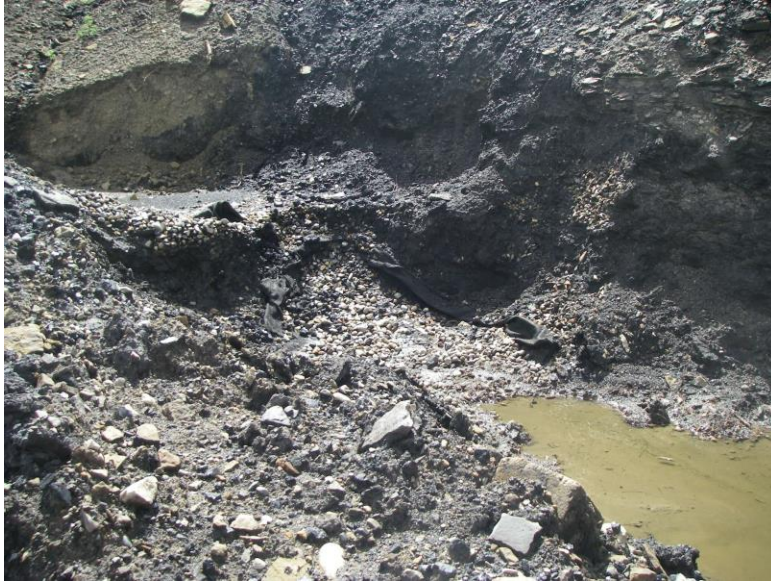
End of underdrain that needs to be extended as slope is extended away from Refuse Pile

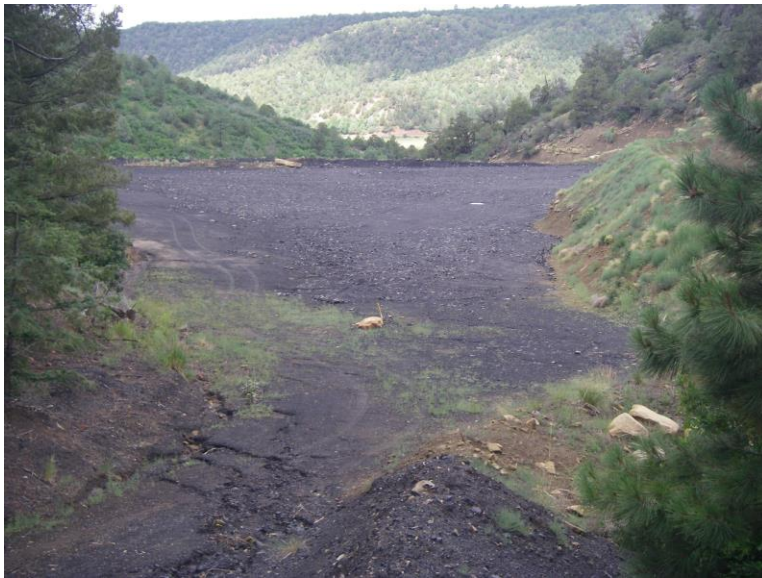
Refuse Pile

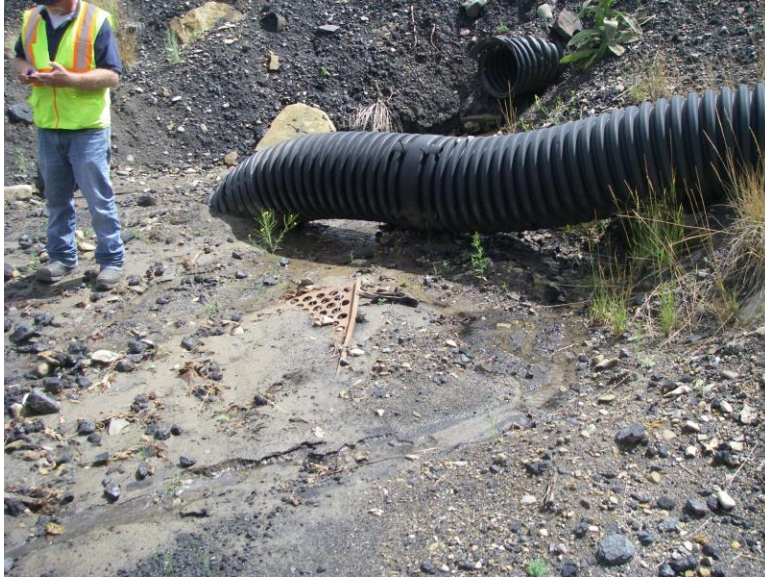
Broken pipe at King I (Reach 3)

- At the lower end of Reach 3, holes in the pipe need to be patched.
- The lower end of Reach 7 (and possibly the upper portion of the pipe as well) needed to be cleaned of sediment (it was nearly full).

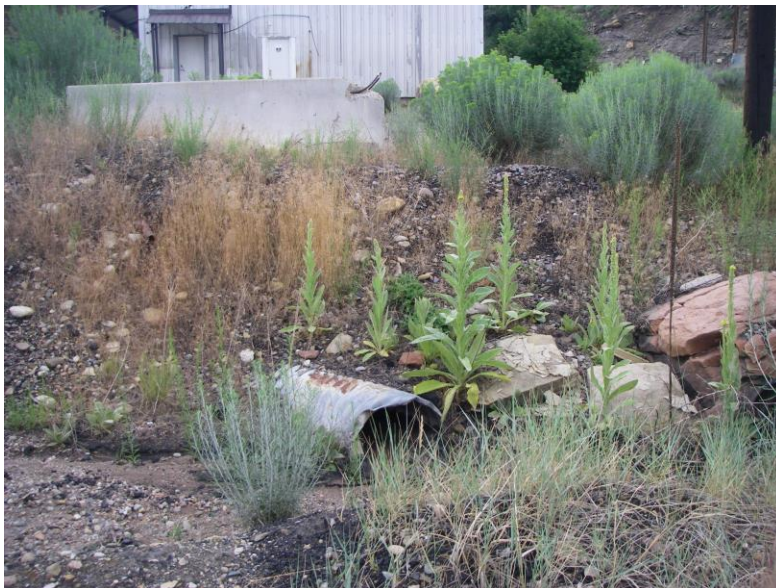
Clogged culvert at King I (lower end of Reach 7)

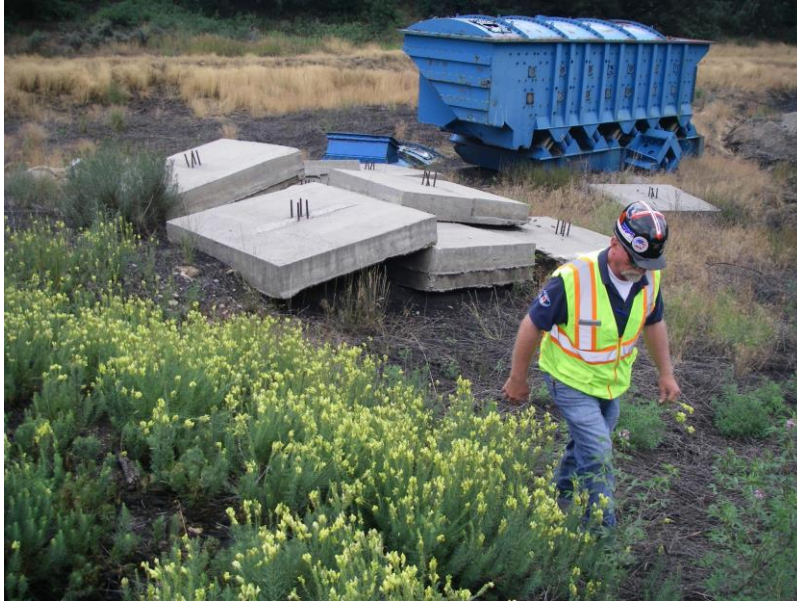
Yellow-flowered plants (likely yellow toadflax) were near the coal storage pile at Coal Stack Tube #2. GCC staff were instructed to pull the weeds that day.

Likely yellow toadflax near topsoil stockpile at King II
