**MINERALS PROGRAM INSPECTION REPORT**  
**PHONE: (303) 866-3567**

<b>MINE NAME:</b> Bulldog Mine Operation	<b>MINE/PROSPECTING ID#:</b> M-1977-215	<b>MINERAL:</b> Lead and silver	<b>COUNTY:</b> Mineral
<b>INSPECTION TYPE:</b> Monitoring	<b>INSPECTOR(S):</b> Travis H. Marshall	<b>INSP. DATE:</b> July 18, 2017	<b>INSP. TIME:</b> 08:00
<b>OPERATOR:</b> Rio Grande Silver, Inc.	<b>OPERATOR REPRESENTATIVE:</b> Randy McClure	<b>TYPE OF OPERATION:</b> 112d-2 - Designated Mining Operation	
<b>REASON FOR INSPECTION:</b> Normal I&E Program	<b>BOND CALCULATION TYPE:</b> Complete Bond	<b>BOND AMOUNT:</b> \$163,228.13	
<b>DATE OF COMPLAINT:</b> NA	<b>POST INSP. CONTACTS:</b> None	<b>JOINT INSP. AGENCY:</b> None	
<b>WEATHER:</b> Clear	<b>INSPECTOR'S SIGNATURE:</b>

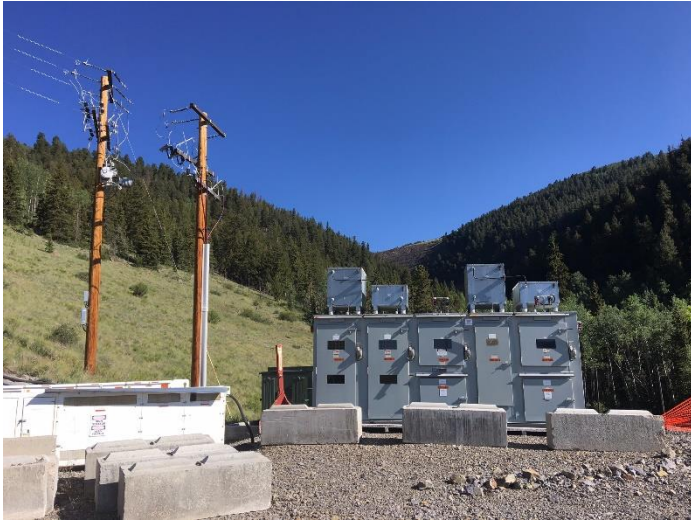
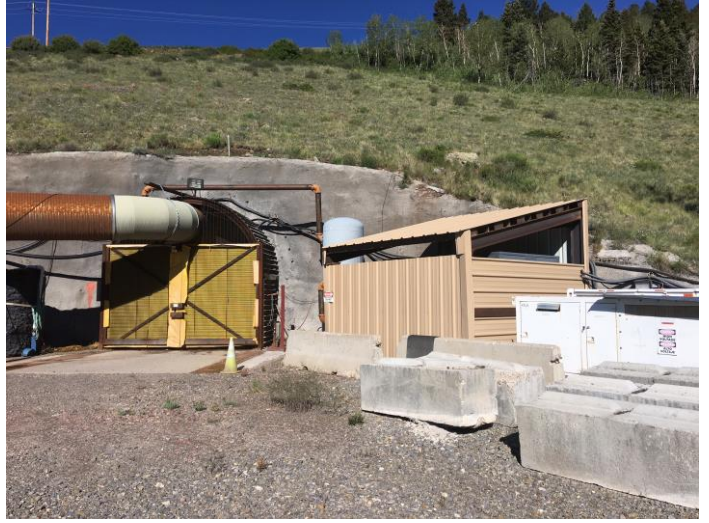
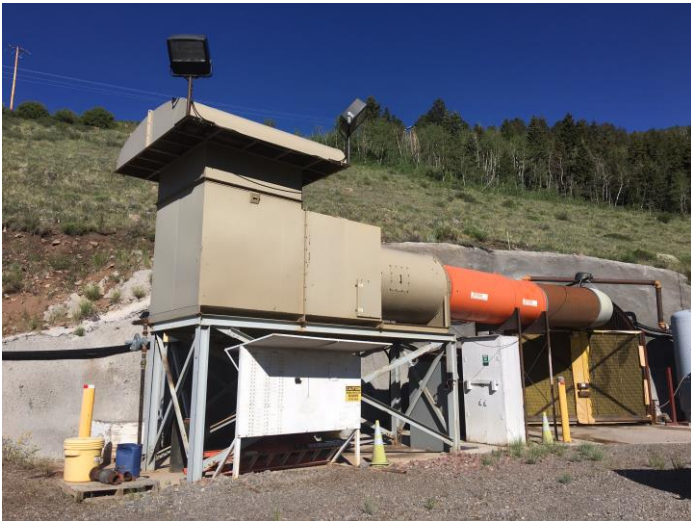
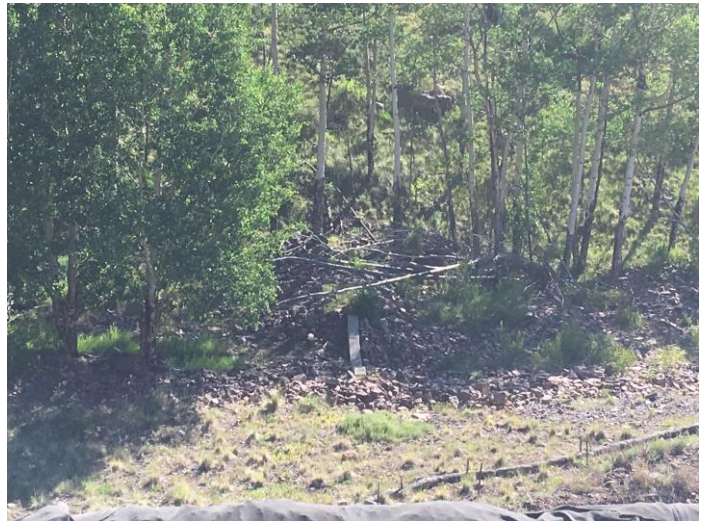
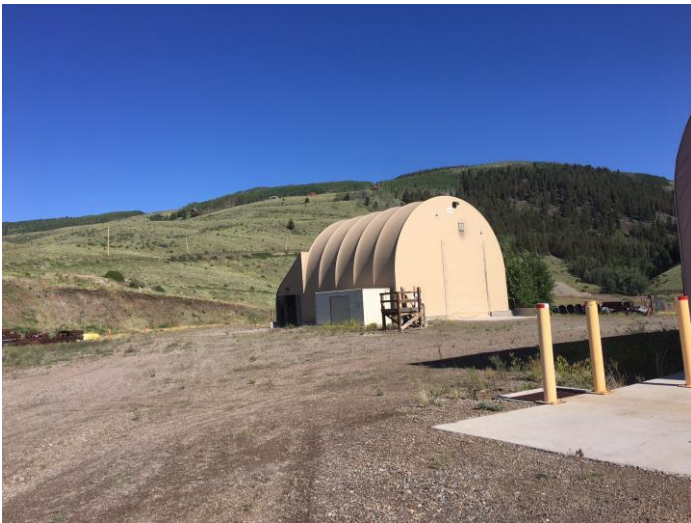
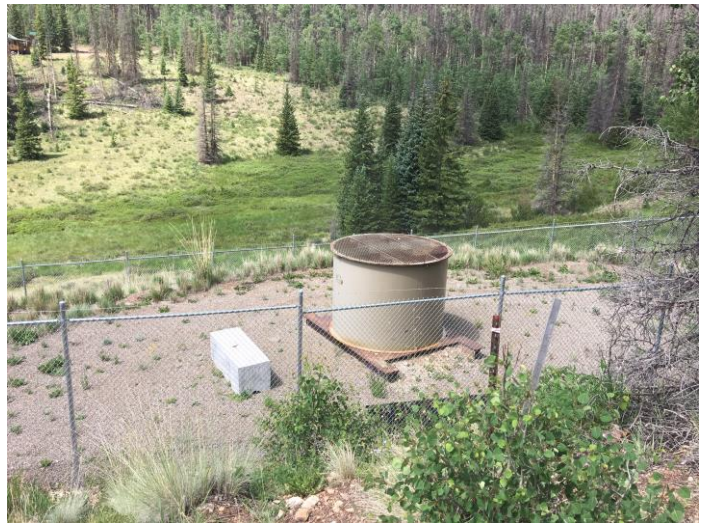
**PHOTOGRAPHS**

Overall the operation was in good condition and no unnecessary debris or trash was observed during the inspection.

No erosion or sedimentation issues were noted. There are no major or minor drainage issues within the permit area that warrant addressing.

Photos that show the conditions observed during the inspection are included at the end of this report.
