MINERALS PROGRAM INSPECTION REPORT
PHONE: (303) 866-3567

| MINE NAME: Airport Corner Pit | MINE/PROSPECTING ID#: M-2007-057 | MINERAL: Borrow material for | COUNTY: Mineral |
| INSPECTION TYPE: Monitoring | INSPECTOR(S): Travis H. Marshall | INSP. DATE: July 18, 2017 | INSP. TIME: 12:15 |

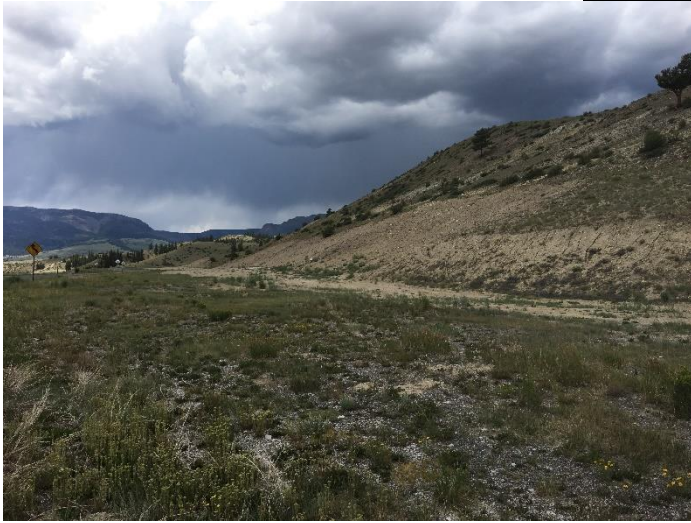
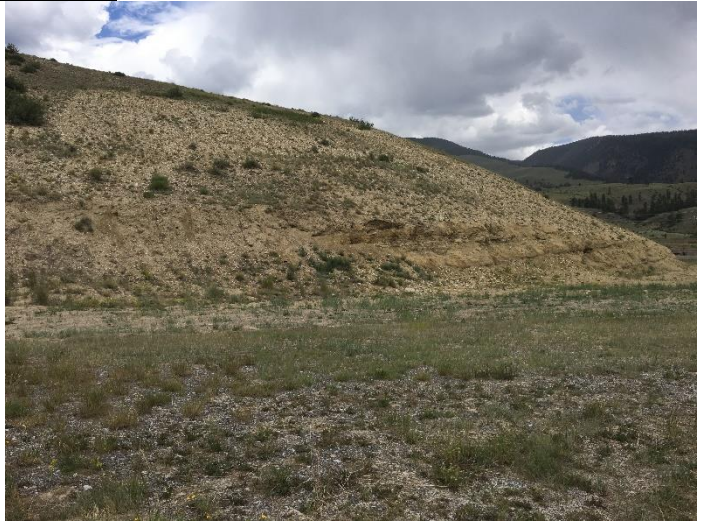
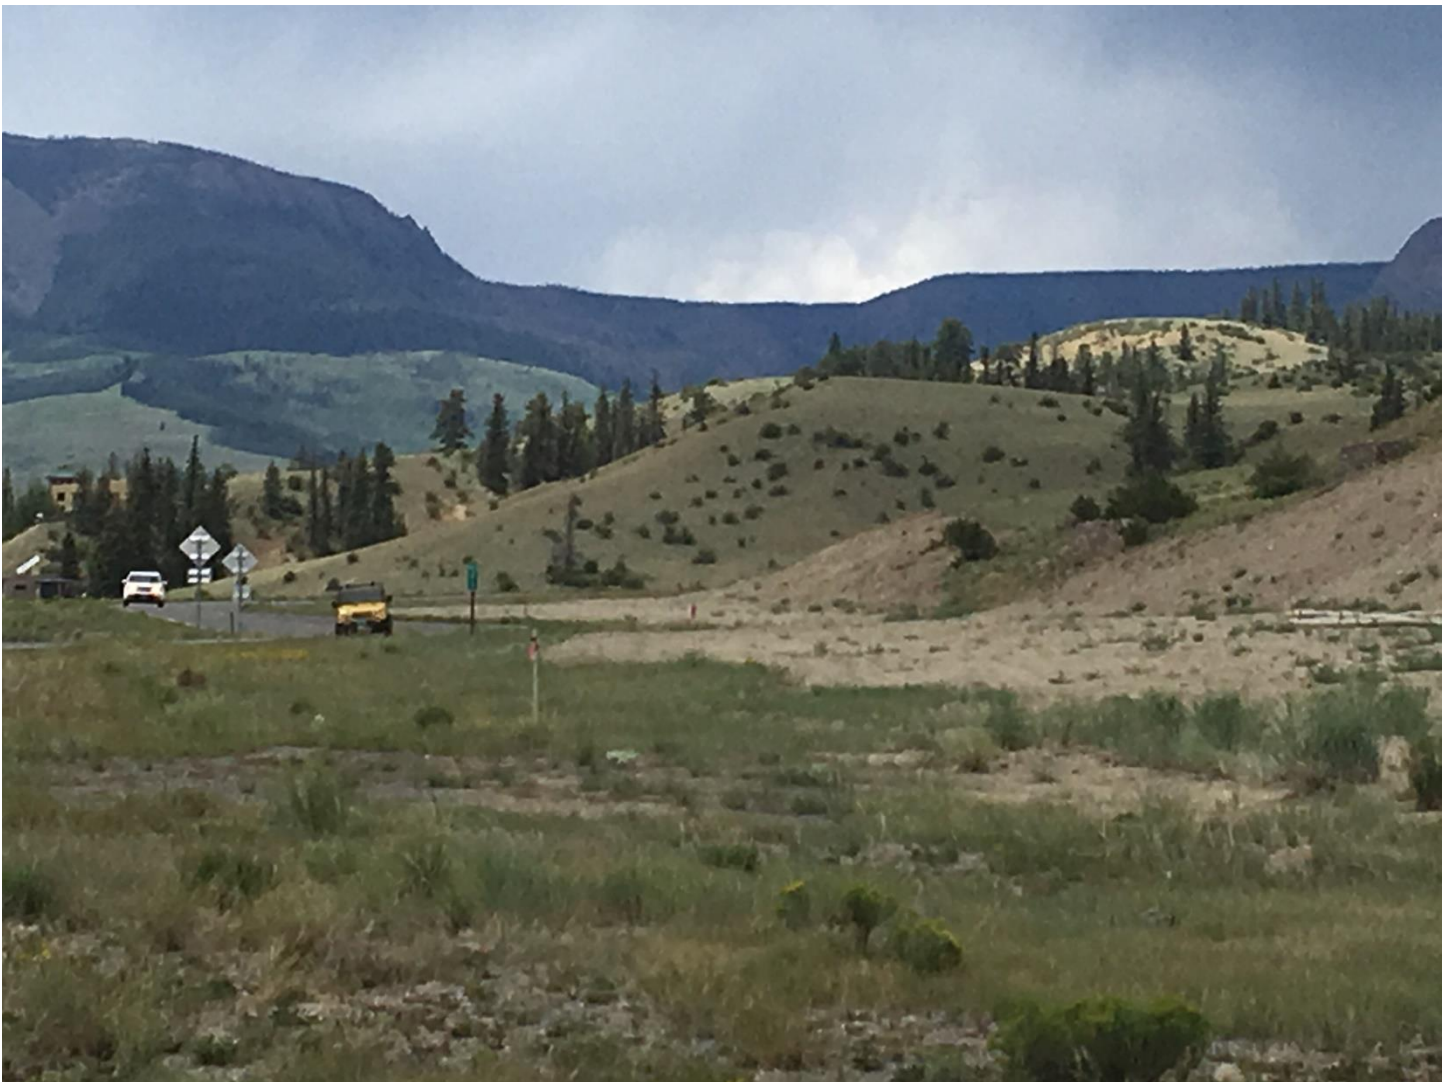
PHOTOGRAPHS

The site was inactive during the inspection. Of the 9.24 acres permitted only 5.54 acres have been excavated. The remaining unmined area was used for re-grading during the reclamation of the site. All final sloping appeared to be completed and vegetation was beginning to be established. It may take a few growing seasons and additional seeding efforts to get the required amount of vegetation due to the slopes being south facing.

No off-site damage, significant erosional features or unnecessary debris was observed within the permit area. The site was in a very orderly condition during the inspection.
