MINERALS PROGRAM INSPECTION REPORT
PHONE: (303) 866-3567

MINE NAME: West Equity Project	MINE/PROSPECTING ID#: P-2010-015	MINERAL: Zinc, lead, gold and s	COUNTY: Mineral
INSPECTION TYPE: Mineral Prospect Inspection	INSPECTOR(S): Travis H. Marshall	INSP. DATE: July 18, 2017	INSP. TIME: 08:45
OPERATOR: Rio Grande Silver, Inc.	OPERATOR REPRESENTATIVE: Randy McClure	TYPE OF OPERATION: MP - Mineral Prospecting	
REASON FOR INSPECTION: Normal I&e Program	BOND CALCULATION TYPE: Complete Bond	BOND AMOUNT: \$34,500.00	
DATE OF COMPLAINT: NA	POST INSP. CONTACTS: U.S.Forest Service	JOINT INSP. AGENCY: None	
WEATHER: Clear	INSPECTOR'S SIGNATURE:

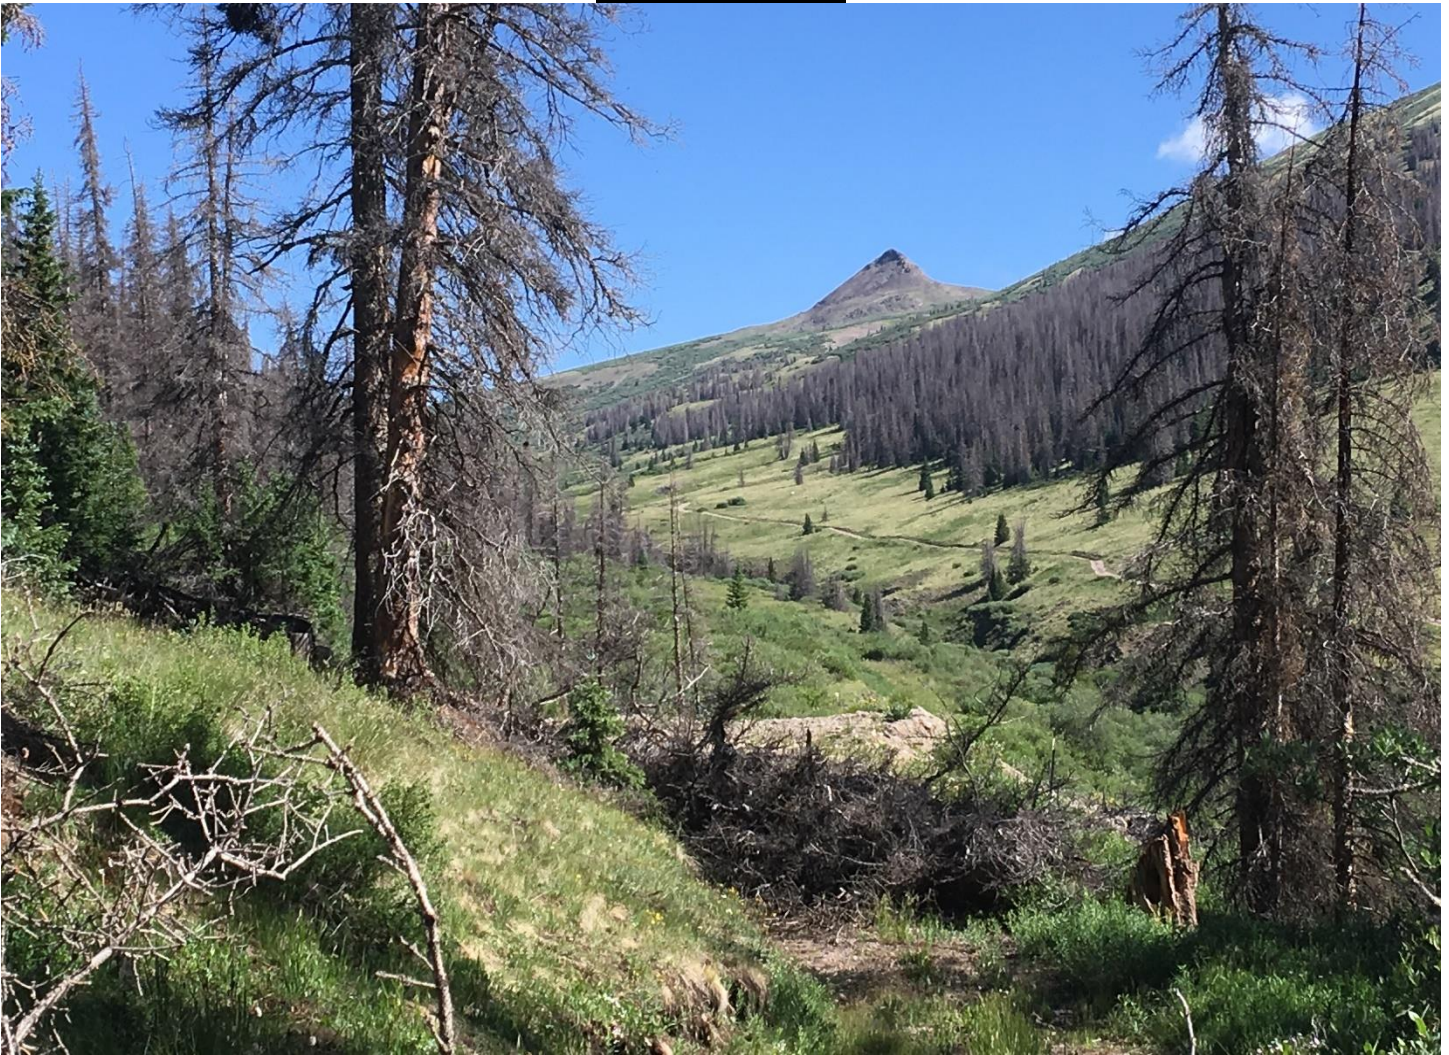
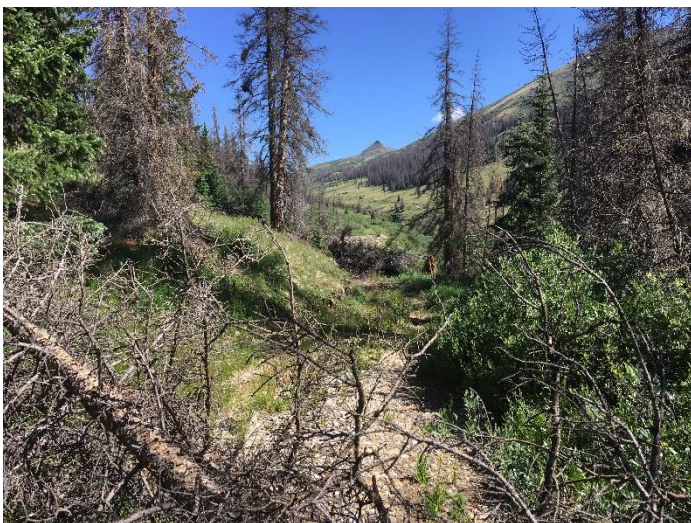
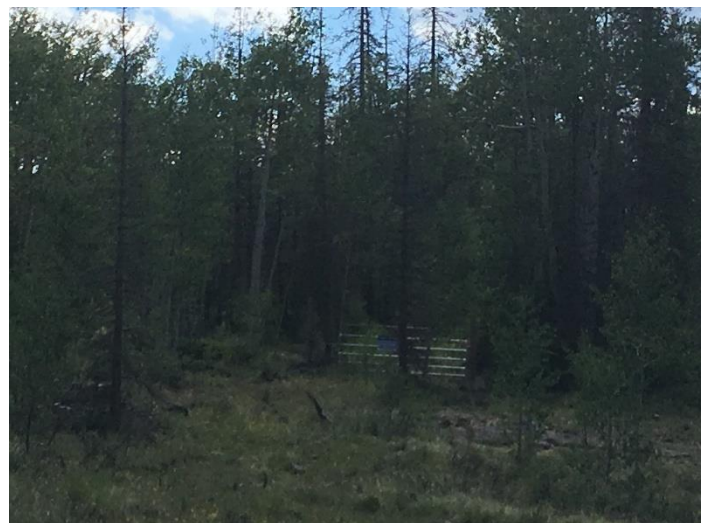
The drilling location observed is still in a drillable condition. The operator stated that the pads associated with the NOI will be reclaimed in 2018.

No erosion or sedimentation issues were noted. There are no major or minor drainage issues within the prospect area that warrant addressing.
