COLORADO
Division of Reclamation,
Mining and Safety
Department of Natural Resources

Permit Number: C-1981-008 Mine Name: New Horizon Mine Operator: Elk Ridge Mining and Reclamation, LLC Operator Address: Mr. Tony Tennyson 5731 State Highway 13 Meeker, CO 81641	County: Montrose Operation Type: Surface Permit Status: Active Ownership: Private
	Operator Representative Present: Frank Ferris and Tom Fry
Operator Representative Signature: (Field Issuance Only)

Inspection Start Date: July 19, 2017 Inspection Start Time: 09:00 Inspection End Date: July 20, 2017 Inspection End Time: 16:00		Inspection Type: Coal Complete Inspection Inspection Reason: Normal I&E Program Weather: Clear	
Joint Inspection Agency: None		Joint Inspection Contacts: 	
Post Inspection Agency: None		Post Inspection Contacts: 	
Inspector(s): Brock F. Bowles	Inspector's Signature:

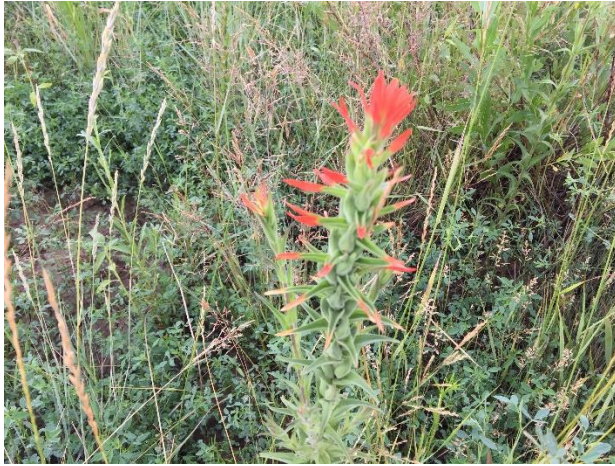
Photo 1 – Wildflowers in Pond 012

Pond 012 contained water but was not discharging. The embankment appeared to be in good condition. Several plants of scarlet paintbrush (Castilleja miniata) (photo 1) were growing at the waterline.

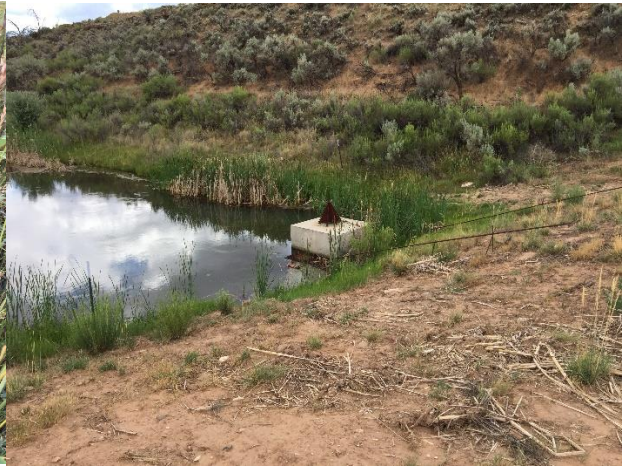
Photo 2 – Pond 013

Pond 013 contained water and was discharging as was the trench drain. The embankment appeared to be in good condition (photo 2).

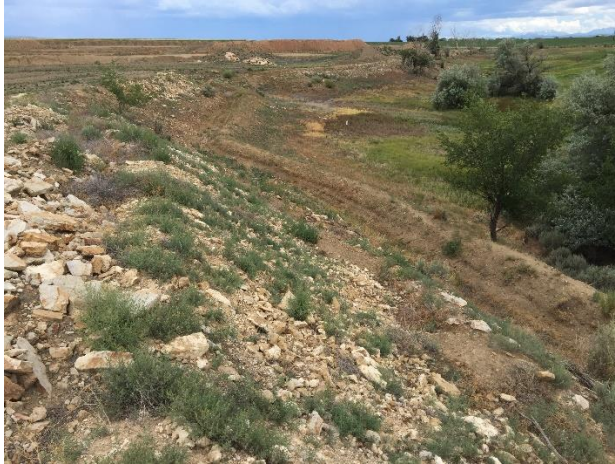
Photo 3 – Ditch C29

Pond 15 did not contain water. Ditch C29 was in good condition (photo 3).

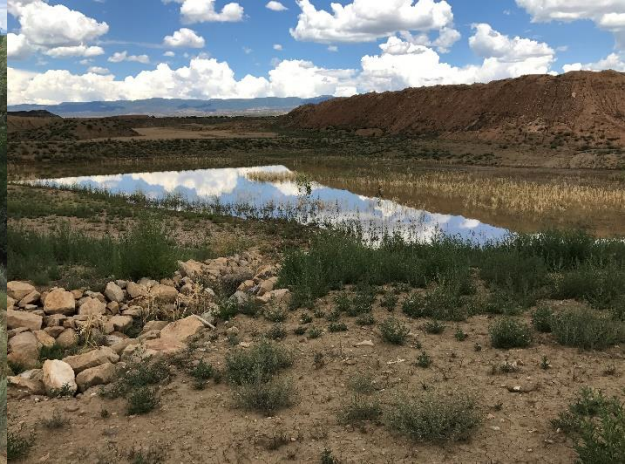
Photo 4 – Pond 16

Pond 16 contained water but was not discharging (photo 4). The source of the water was irrigation tail water from the irrigated pasture on the ERMR/Lloyd and ERMR/Benson properties.

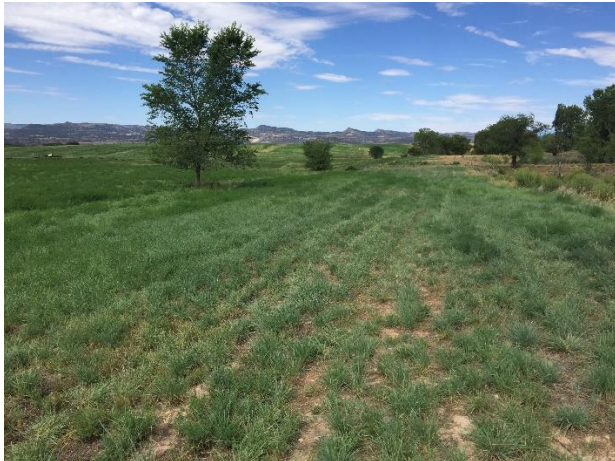
The vegetation on the former NE haul road area appeared to be doing well and was consistent with the surrounding areas (photo 5). There were no signs of erosion. The irrigation system was not in operation on this area of the reclamation during the inspection. The irrigation wheel-lines were in operation on the reclaimed areas south of the haul road area.
