**MINERALS PROGRAM INSPECTION REPORT**  
**PHONE: (303) 866-3567**

<b>MINE NAME:</b> Golden Rose Complex	<b>MINE/PROSPECTING ID#:</b> M-2017-023	<b>MINERAL:</b> UNK	<b>COUNTY:</b> La Plata
<b>INSPECTION TYPE:</b> Illegal(Unpermitted Operation)	<b>INSPECTOR(S):</b> Lucas J. West, Russ Means	<b>INSP. DATE:</b> July 19, 2017	<b>INSP. TIME:</b> 09:00
<b>OPERATOR:</b> UNK	<b>OPERATOR REPRESENTATIVE:</b> None	<b>TYPE OF OPERATION:</b> ILL - Illegal	
<b>REASON FOR INSPECTION:</b> Citizen Complaint	<b>BOND CALCULATION TYPE:</b> None	<b>BOND AMOUNT:</b> No Bond Held	
<b>DATE OF COMPLAINT:</b> NA	<b>POST INSP. CONTACTS:</b> None	<b>JOINT INSP. AGENCY:</b> None	
<b>WEATHER:</b> Clear	<b>INSPECTOR'S SIGNATURE:</b>

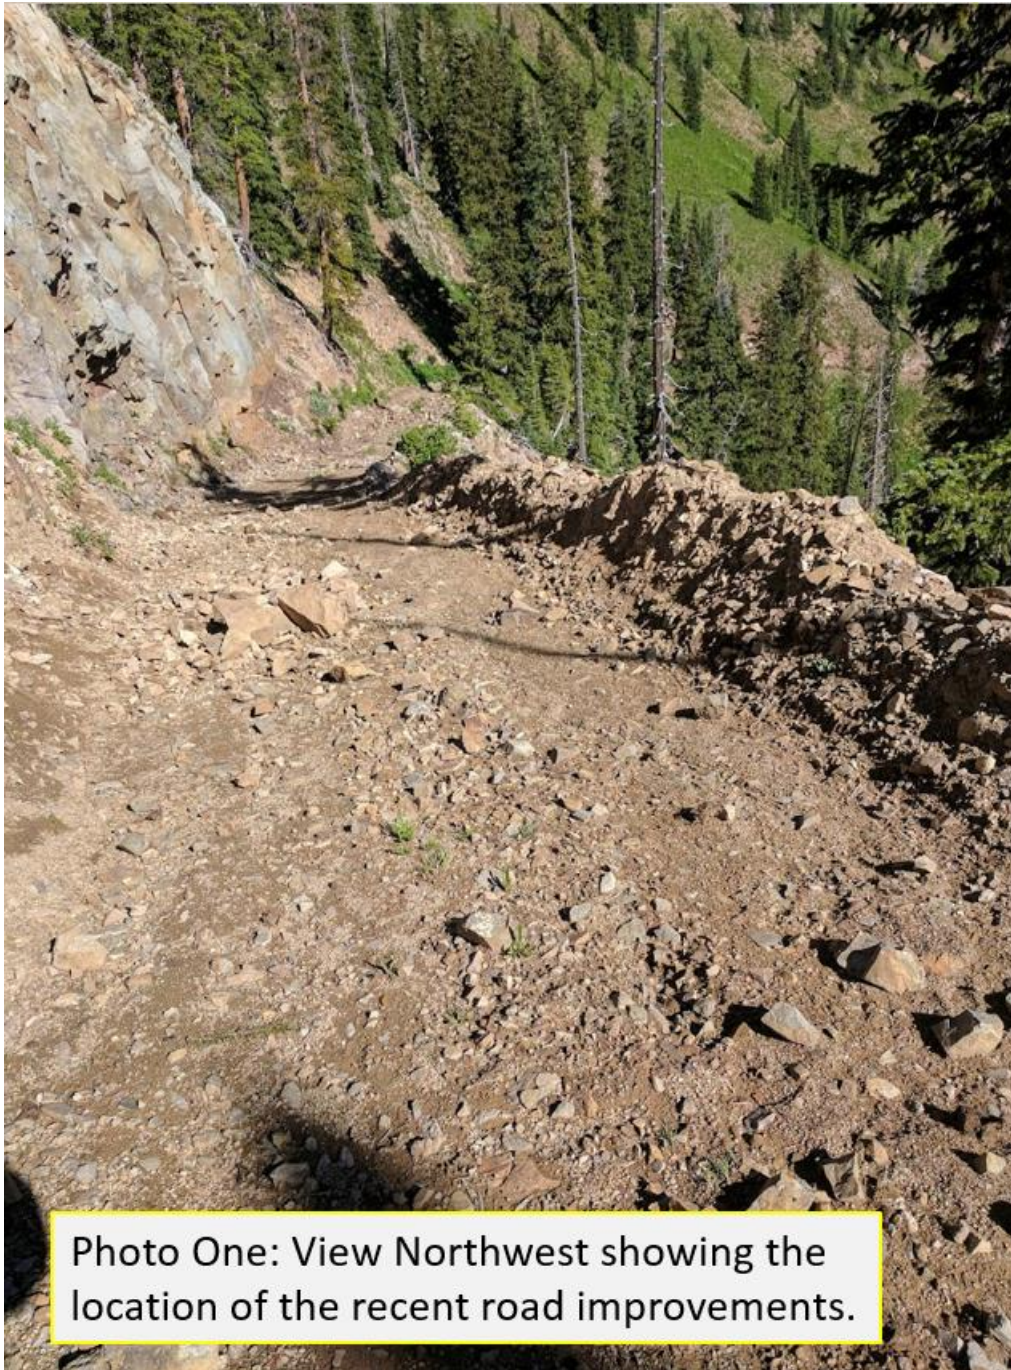
Photo One: View Northwest showing the location of the recent road improvements.

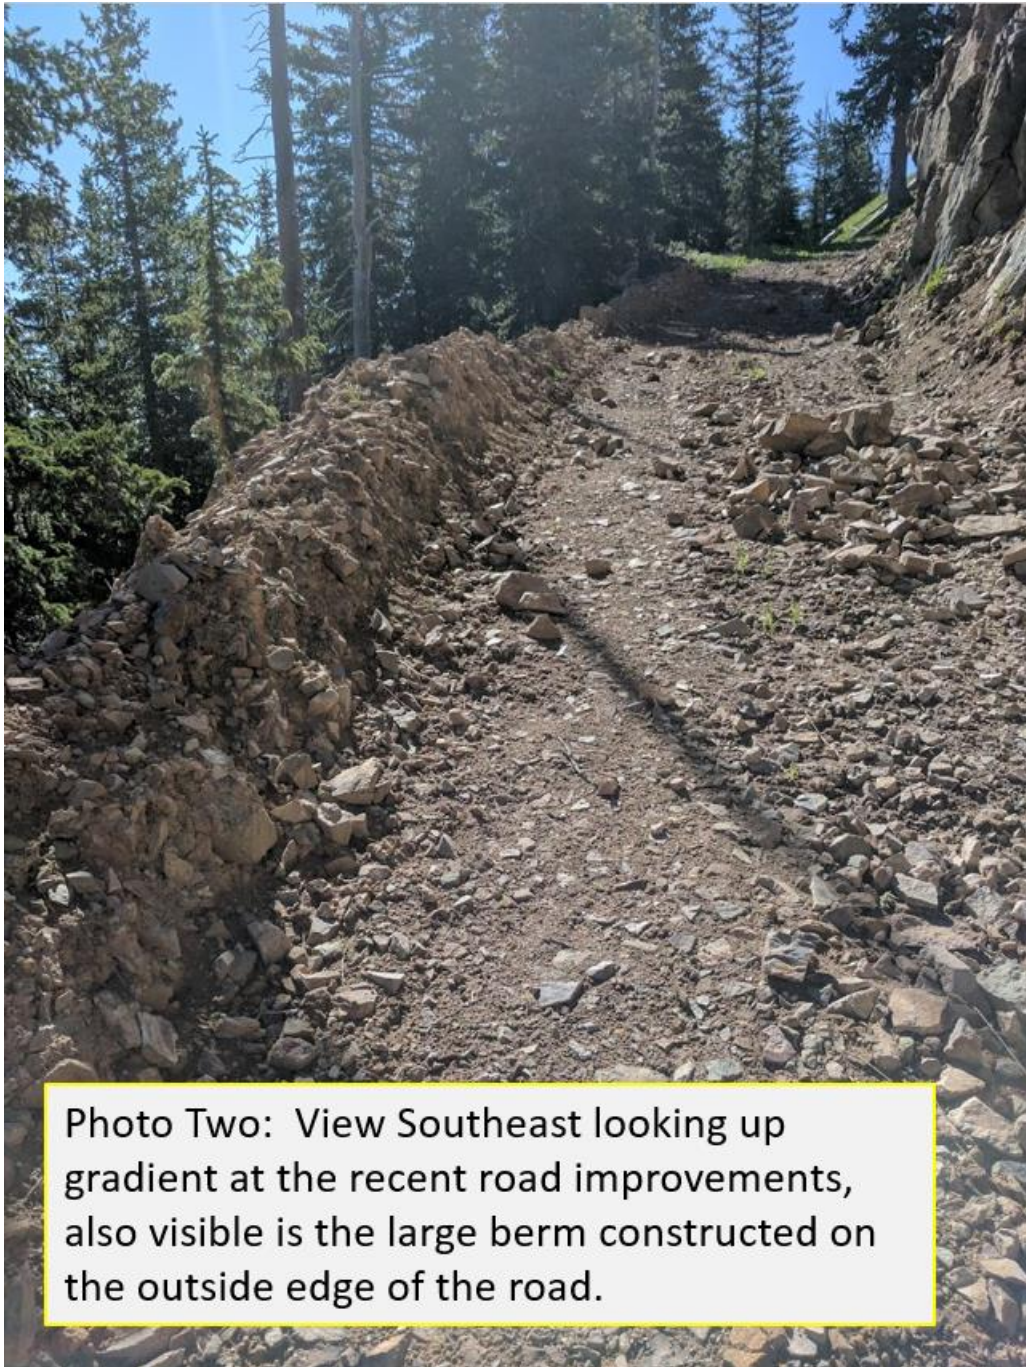
Photo Two: View Southeast looking up gradient at the recent road improvements, also visible is the large berm constructed on the outside edge of the road.
