**MINERALS PROGRAM INSPECTION REPORT**  
**PHONE: (303) 866-3567**

<b>MINE NAME:</b> Kate	<b>MINE/PROSPECTING ID#:</b> P-2016-019	<b>MINERAL:</b> Silver	<b>COUNTY:</b> Custer
<b>INSPECTION TYPE:</b> Surety-Related Inspection	<b>INSPECTOR(S):</b> Timothy A. Cazier	<b>INSP. DATE:</b> May 2, 2017	<b>INSP. TIME:</b> 13:00
<b>OPERATOR:</b> Viscount Colorado Holdings, LTD	<b>OPERATOR REPRESENTATIVE:</b> Bob Ebisch	<b>TYPE OF OPERATION:</b> MP - Mineral Prospecting	
<b>REASON FOR INSPECTION:</b> Surety Related	<b>BOND CALCULATION TYPE:</b> Complete Bond	<b>BOND AMOUNT:</b> \$16,134.00	
<b>DATE OF COMPLAINT:</b> NA	<b>POST INSP. CONTACTS:</b> Local Government	<b>JOINT INSP. AGENCY:</b> Local Government	
<b>WEATHER:</b> Cloudy	<b>INSPECTOR'S SIGNATURE:</b>

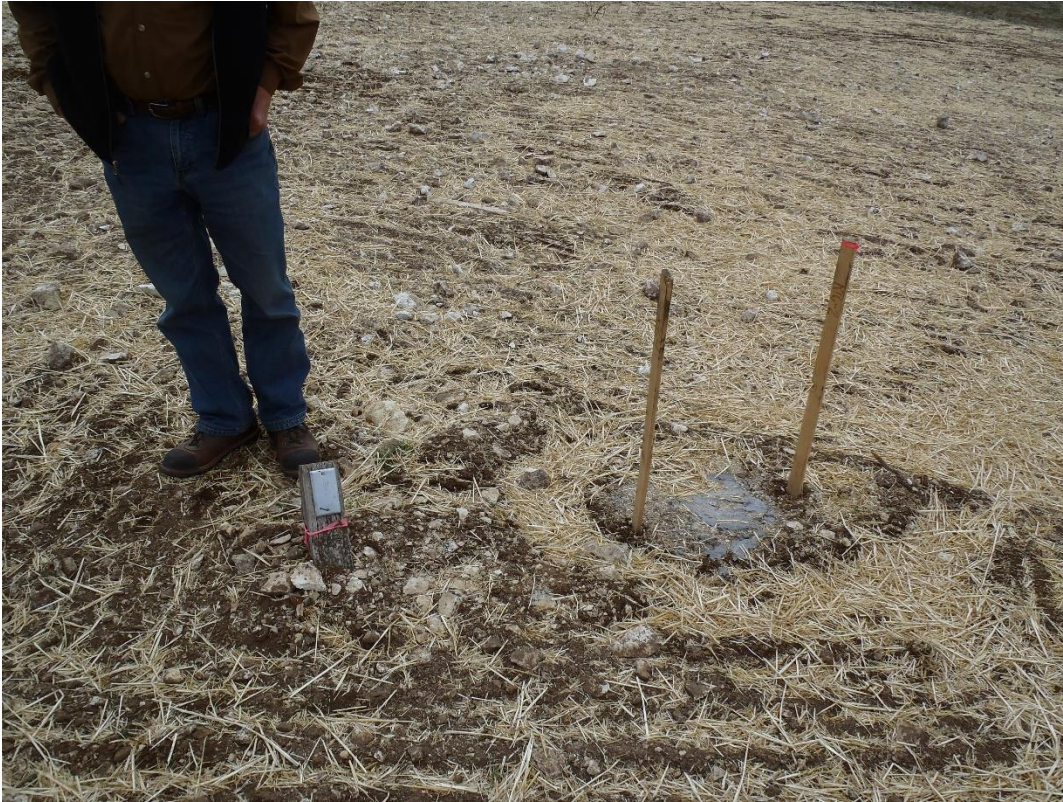
The party was able to locate eight drilling sites with nine holes. Holes K16-1 and K16-2 were drilled from the same location (see **Photo 1**). Each hole appeared to be sealed at the surface (see **Photo 2**). A hand held GPS unit (Juno 3B) was used to record the locations of each borehole. A map with these locations is included as **Figure 1**.

Photo 1. Boreholes K16-1 and -2.

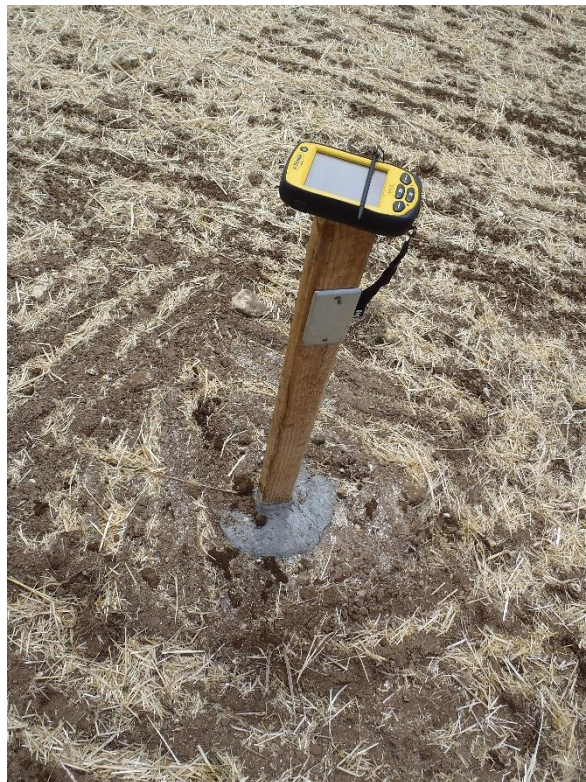
- This was the first site inspection by the Division.
- The first anniversary date is November 4, 2017. The Annual fees and map are due at that time.
- Abandonment reports were submitted with the surety reduction request. These reports indicate water was encountered in all nine boreholes, ranging from between 40 and 100 feet bgs. The reports also indicate all holes were abandoned using sodium bentonite from the bottom of each hole and the top 20 feet of each hole plugged and sealed with Portland cement. This method of abandonment complies with Rule 5.4.2.

Photo 2. Portland cement seal: Borehole K16-5 (Juno 3B GPS unit on marker).

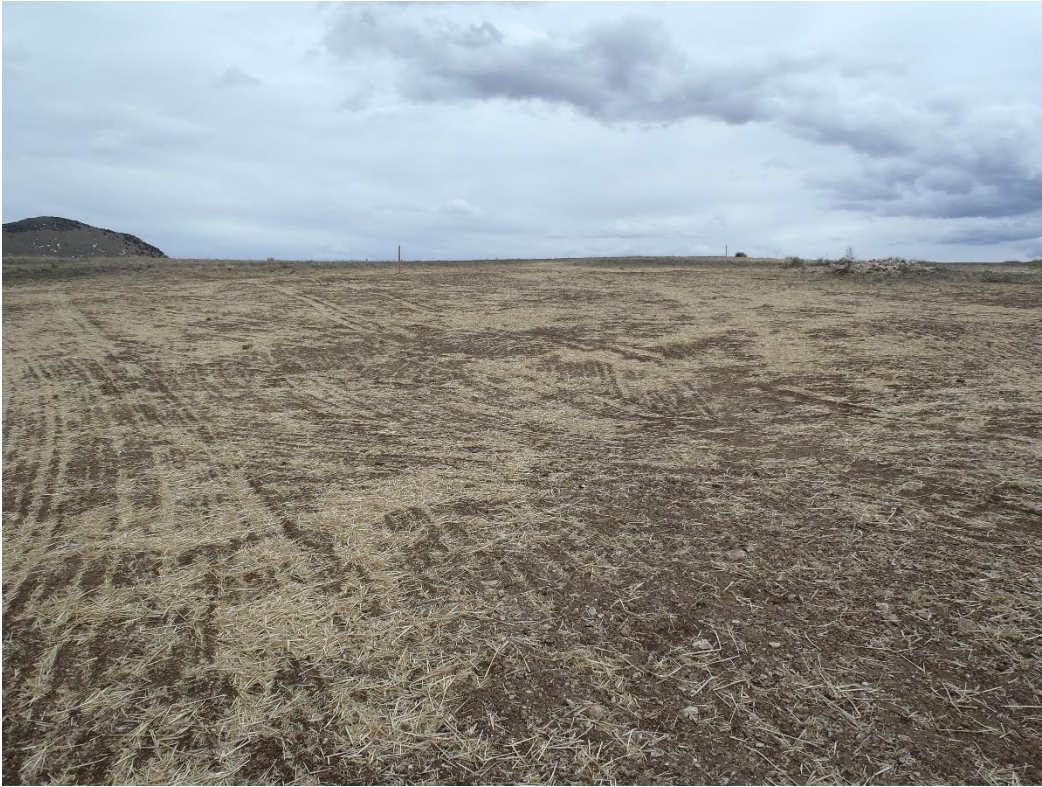
Mr. Klco stated approximately two acres were seeded and mulched (see **Photo 3**). This is greater than the 0.32 acres the NOI indicates would be disturbed. However, given the sparse vegetation of the area, the additional seeding is considered beneficial. No noxious weeds were observed. No oil or fuel spills observed.

Photo 3. Recent revegetation effort: seeded and mulched (looking SE).

The Division currently holds a \$16,134. The surety reduction requests the bond be reduced to \$1,997.64. Based on the inspection, the division needs only hold a bond for revegetation in case the seeded area fails to establish vegetation. The Division is required to hold a minimum \$2,000.00 bond for NOIs. Therefore, this inspector will recommend the bond be reduced to \$2,000. You will be notified under separate cover.
