**MINERALS PROGRAM INSPECTION REPORT**  
**PHONE: (303) 866-3567**

<b>MINE NAME:</b> T.H.E. Aggregate Source	<b>MINE/PROSPECTING ID#:</b> M-1977-193	<b>MINERAL:</b> Granite, granite gneiss, sand and gravel	<b>COUNTY:</b> Fremont
<b>INSPECTION TYPE:</b> Monitoring	<b>INSPECTOR(S):</b> Timothy A. Cazier	<b>INSP. DATE:</b> July 26, 2017	<b>INSP. TIME:</b> 15:30
<b>OPERATOR:</b> Tezak Heavy Equipment Co. Inc.	<b>OPERATOR REPRESENTATIVE:</b> Randy DiLuzio	<b>TYPE OF OPERATION:</b> 112c - Construction Regular Operation	
<b>REASON FOR INSPECTION:</b> Normal I&E Program	<b>BOND CALCULATION TYPE:</b> None	<b>BOND AMOUNT:</b> \$732,350.00	
<b>DATE OF COMPLAINT:</b> NA	<b>POST INSP. CONTACTS:</b> None	<b>JOINT INSP. AGENCY:</b> None	
<b>WEATHER:</b> Cloudy	<b>INSPECTOR'S SIGNATURE:</b>

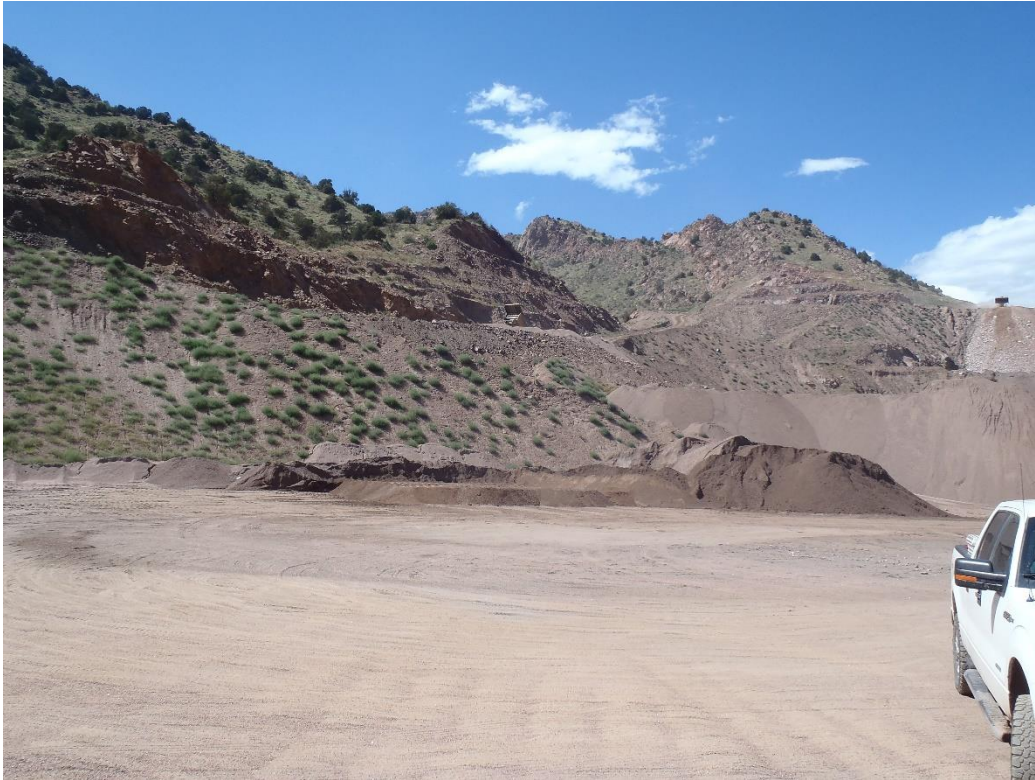
**Backfilling and Grading:** The area where the permanent process fines stockpile approved under TR-09 was observed. The stockpile will be designed to cover the existing working area (see **Photo 1**) and the bench below it (see **Photo 2**).

Photo 1. Existing phase 1 working area to be covered by TR-09 approved fines stockpile (looking NW)

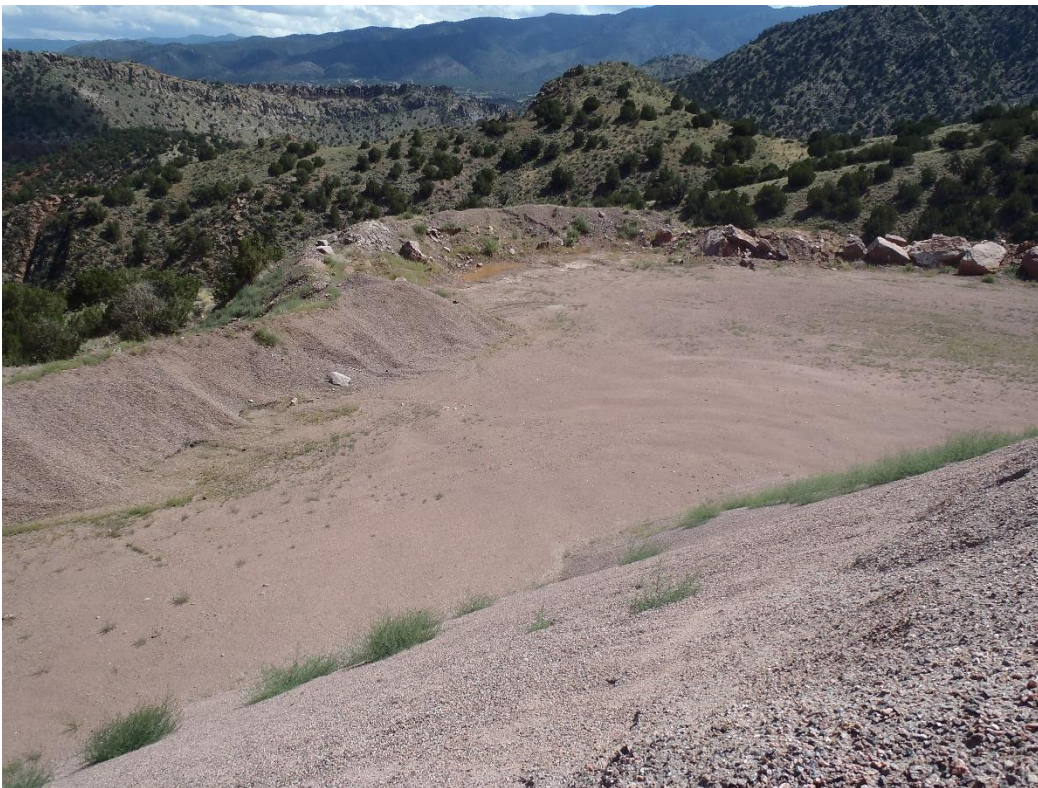
Photo 2. Bench below phase 1 working area to be covered by TR-09 approved fines stockpile (Looking SE).

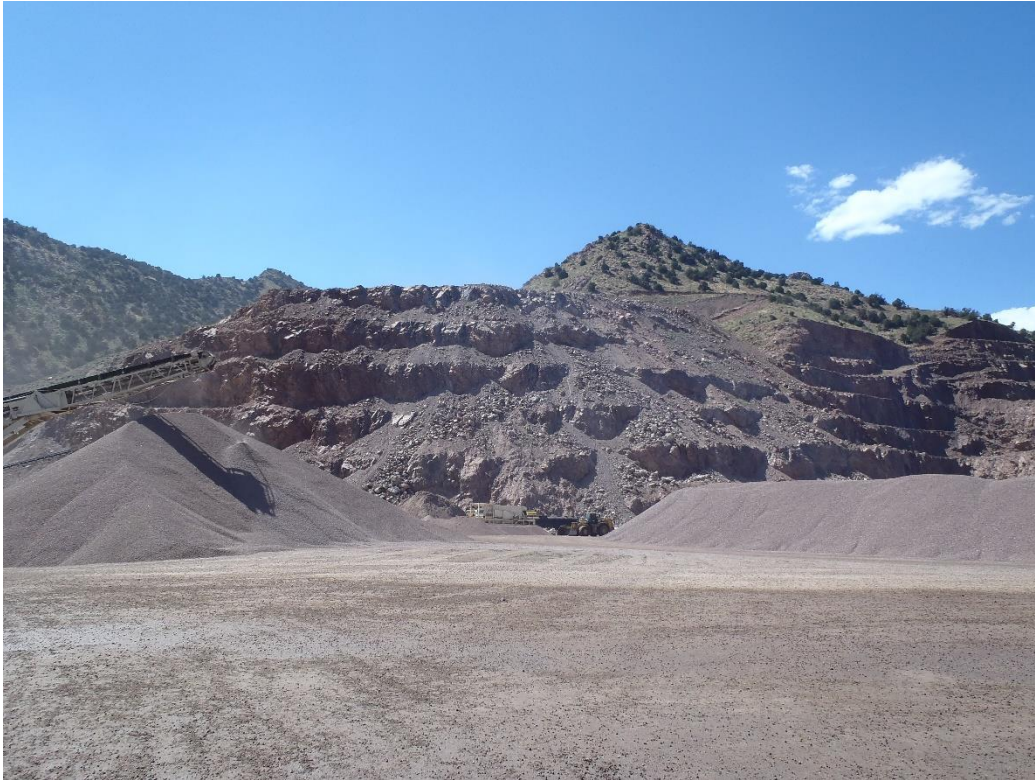
**Gen. Compliance with Mine Plan:** The east facing highwall in Phase 2 was observed to have pushed material on the lower five benches (see **Photo 3**). The Division will need to discuss reclamation further during the early fall inspection.

Photo 3. East facing Phase 2 highwall (looking west).

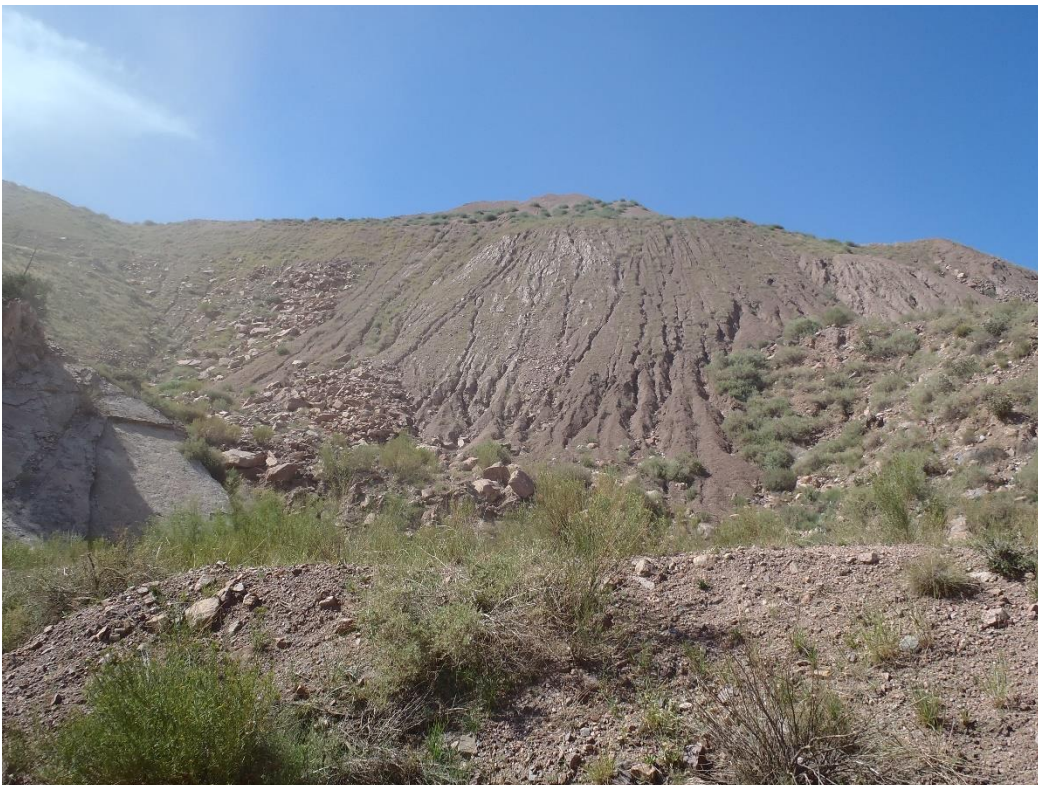
**Sediment Control:** While leaving the site, this inspector noted an eroded slope (see **Photo 4**) that is likely to be below the newly approved TR-09 process fines stockpile. The slope appears to be at angle of repose. Eroded sediment is currently being captured by a sediment pond below this slope, but long term reclamation in conjunction with the process fines stockpile need to be discussed during the next inspection.

Photo 4. Eroded slope likely below newly approved TR-09 process fines stockpile (looking north).

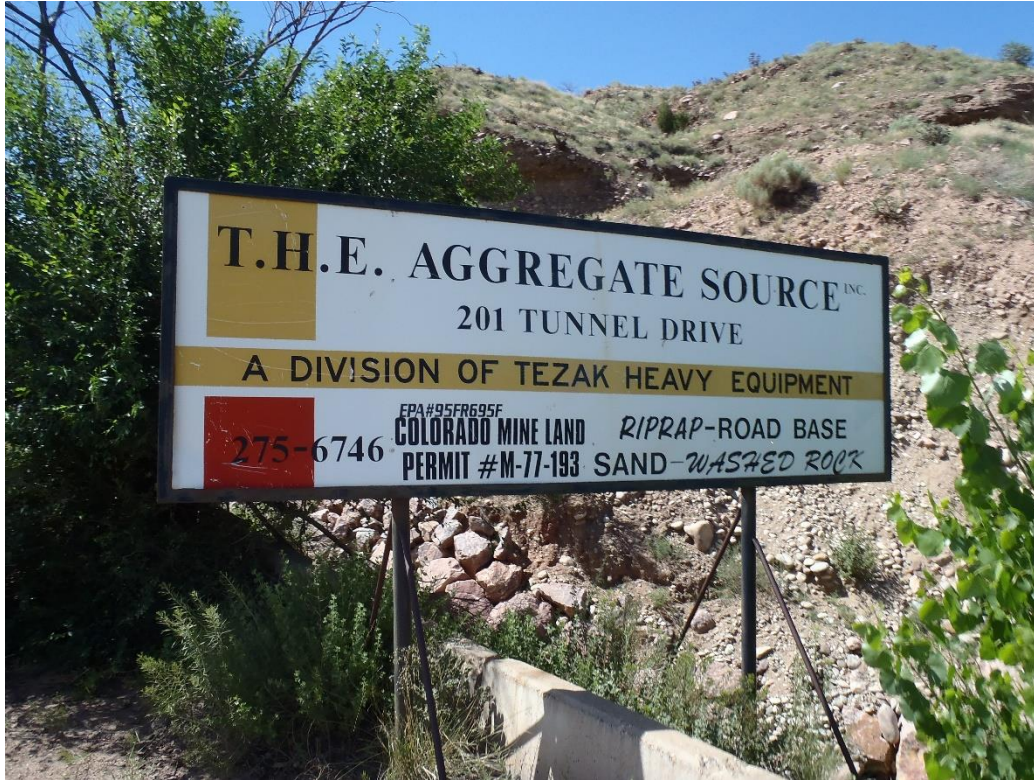
**Signs and Markers:** The permit sign was properly posted (see **Photo 5**).

Photo 5. Permit sign.
