MINERALS PROGRAM INSPECTION REPORT
PHONE: (303) 866-3567

MINE NAME: Henderson Mine	MINE/PROSPECTING ID#: M-1977-342	MINERAL: Molybdenum	COUNTY: Clear Creek, Grand
INSPECTION TYPE: Monitoring	INSPECTOR(S): Peter S. Hays	INSP. DATE: July 27, 2017	INSP. TIME: 09:00
OPERATOR: Climax Molybdenum Company	OPERATOR REPRESENTATIVE: Miguel Hamarat	TYPE OF OPERATION: 112d-3 - Designated Mining Operation	
REASON FOR INSPECTION: Normal I&E Program	BOND CALCULATION TYPE: Partial Bond	BOND AMOUNT: \$37,993,785.00	
DATE OF COMPLAINT: NA	POST INSP. CONTACTS: None	JOINT INSP. AGENCY: None	
WEATHER: Clear	INSPECTOR'S SIGNATURE:

The Henderson Mine was inspected by Peter Hays with the Division of Reclamation, Mining and Safety (Division/DRMS) as part of the Division's monitoring inspection program. Mr. Miguel Hamarat with Climax Molybdenum - Henderson Operations (Henderson) was present during the inspection. The purpose of the inspection was to observe the stormwater structures located around the mine facility.

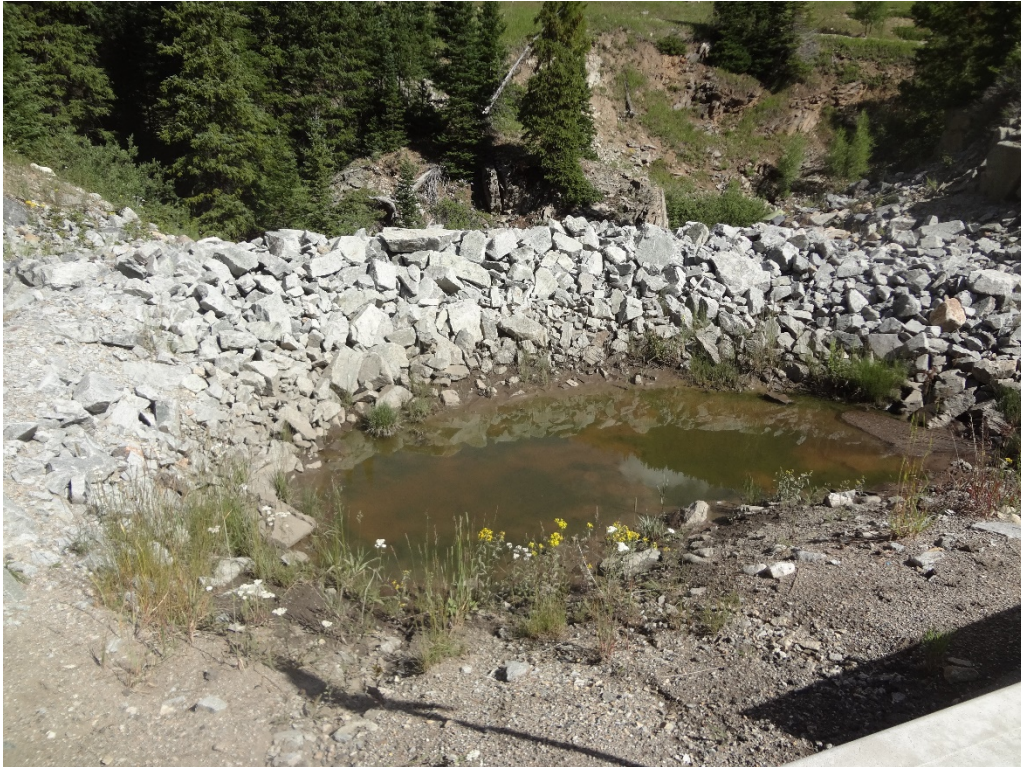
Stormwater Outfall OF-2

OF-2: BMP's at this outfall location consist of a series of rock check dams leading to a sedimentation pond above the rip-rap outfall. The sedimentation pond contained water above the outfall. The outfall appeared to be functioning properly.

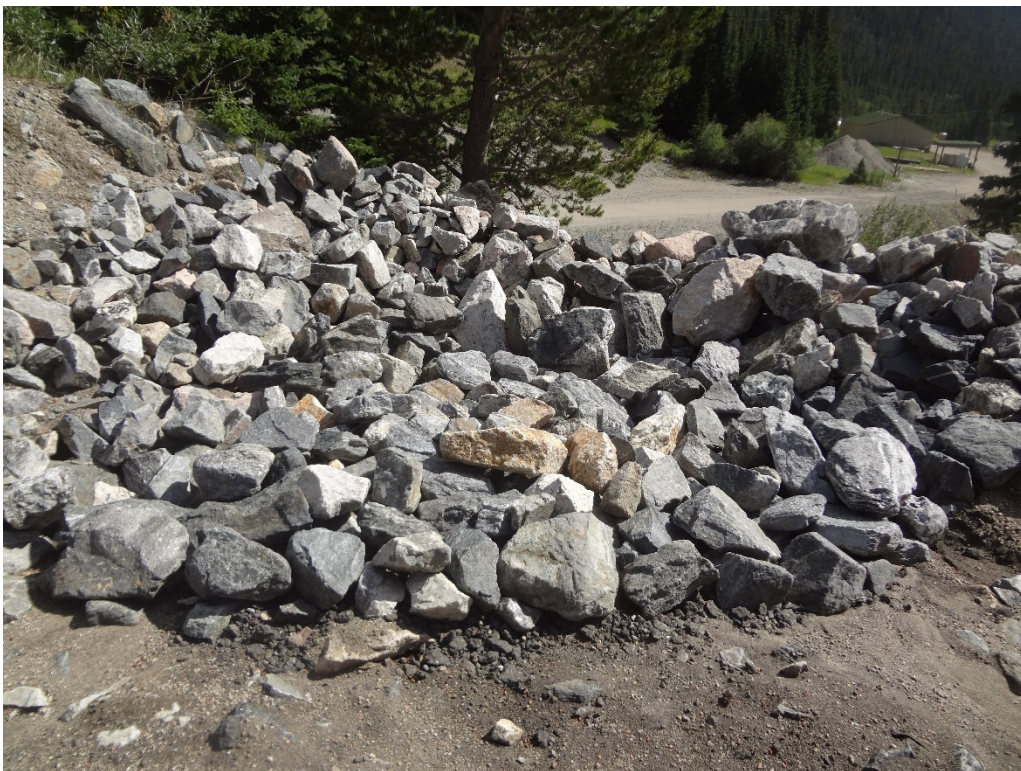
Stormwater Outfall OF-13

OF-13: BMP's at this outfall location consist of a rip-rap check dam. The outfall was dry and appeared to be functioning properly.

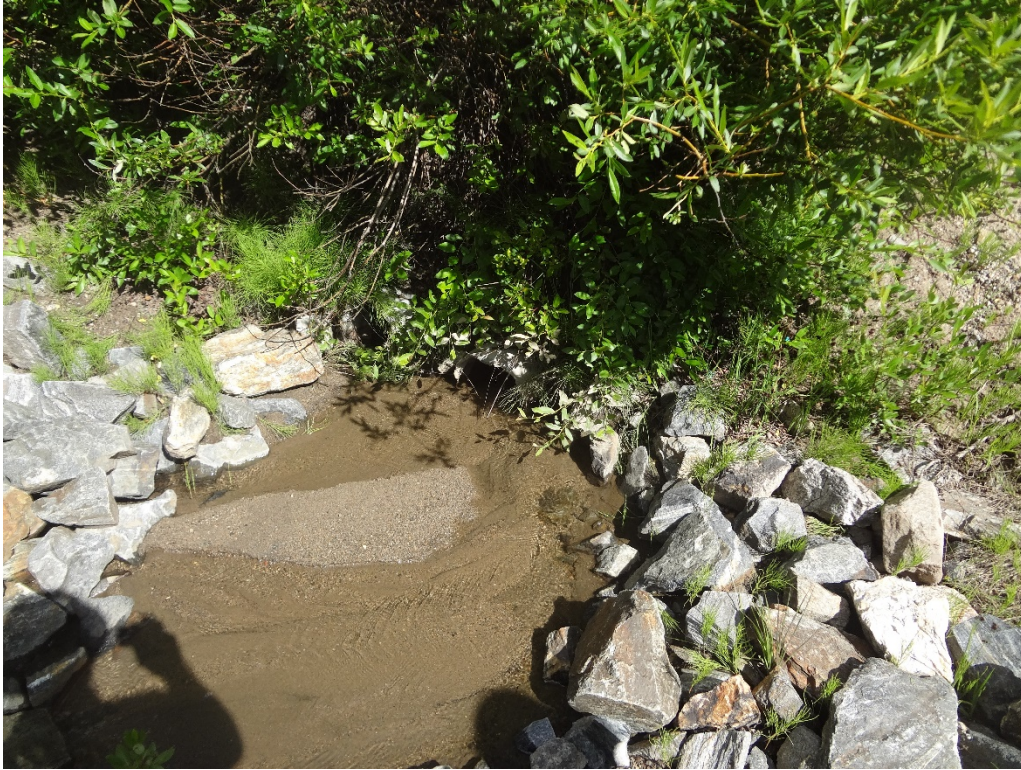
OF-16: BMP's at this outfall location consist of rip-rap and vegetation below the discharge pipe. The inlet of the culvert above the outfall was partially filled with sediment. The Division recommends are culvert is cleaned out to maintain the function of the culvert. The outfall appeared to be functioning properly.

Inlet culvert for Stormwater Outfall OF-16, partially filled with sediment

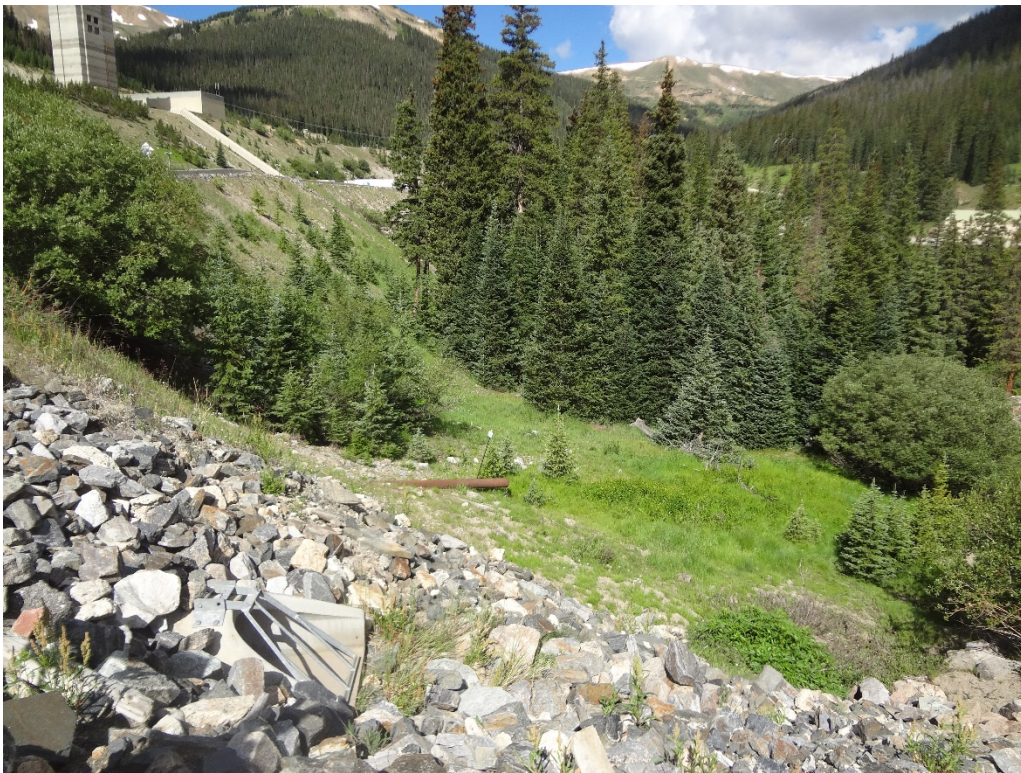
Stormwater Outfalls OF-9 (near) and OF-16 (far)

OF-9: BMP's at this outfall location consist of rip-rap and vegetation below the discharge pipe. The outfall was dry and appeared to be functioning properly.

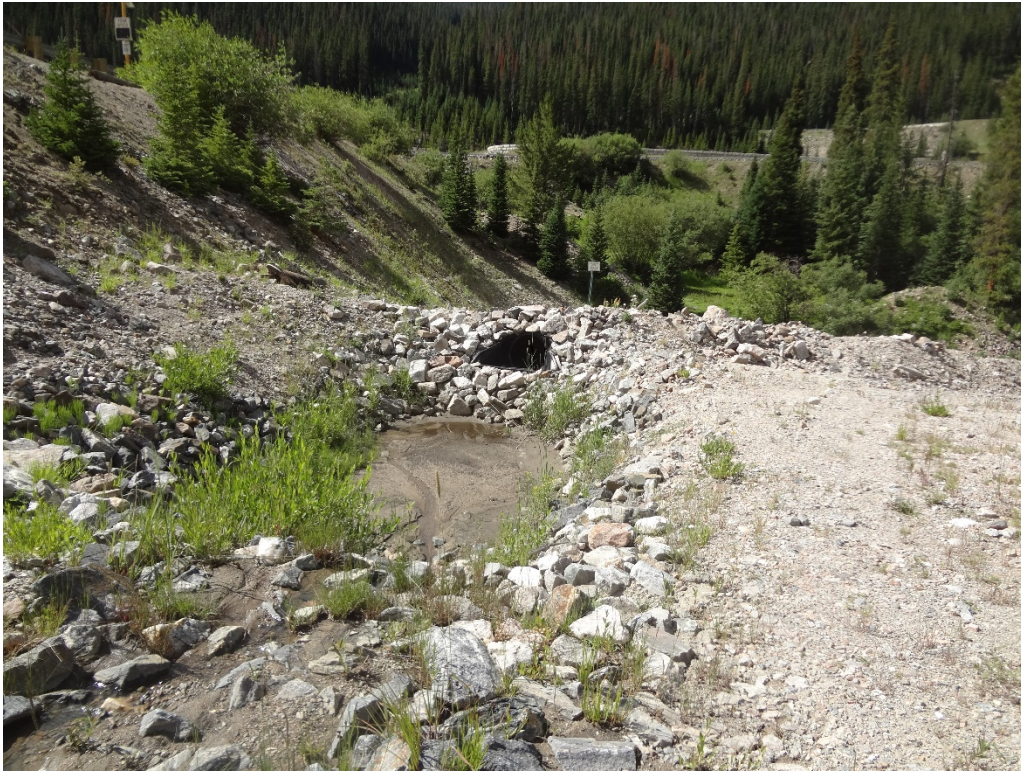
Stormwater Outfall OF-15

OF-15: BMP's at this outfall location consist of a series of rock check dams leading to a sedimentation pond above a culvert. The sedimentation pond contained water and appeared to be functioning properly.

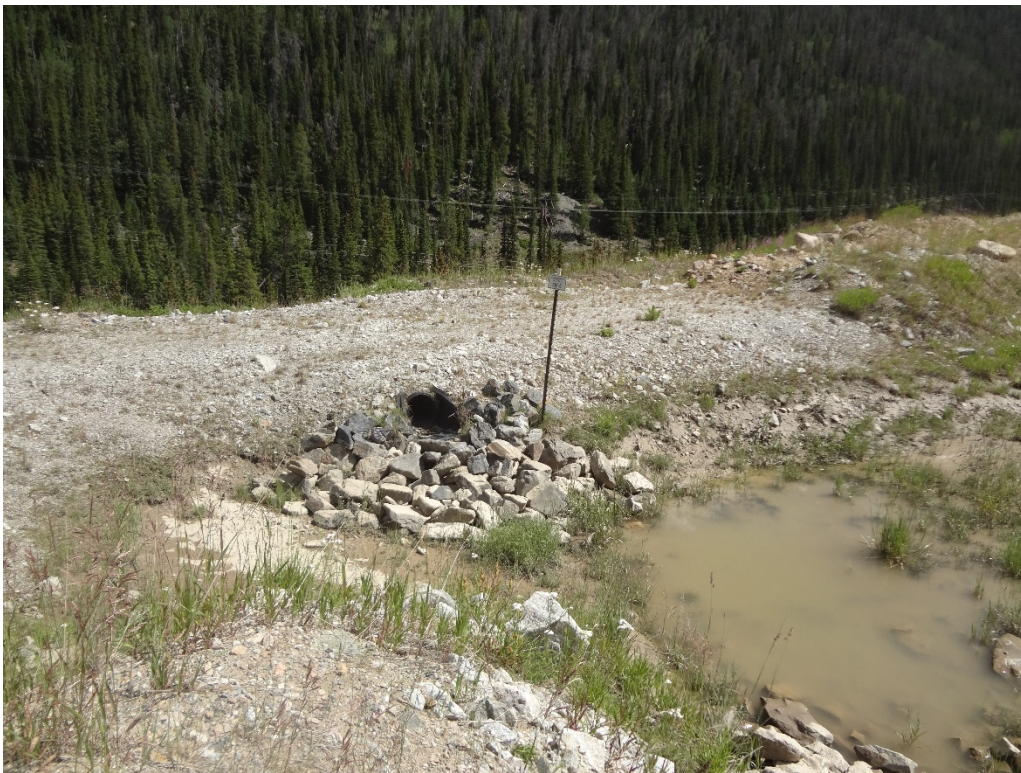
Stormwater Outfall OF-5

OF-5: BMP's at this outfall location consist of rip-rap and vegetation leading to a sedimentation pond above a culvert. The sedimentation pond contained water and appeared to be functioning properly.

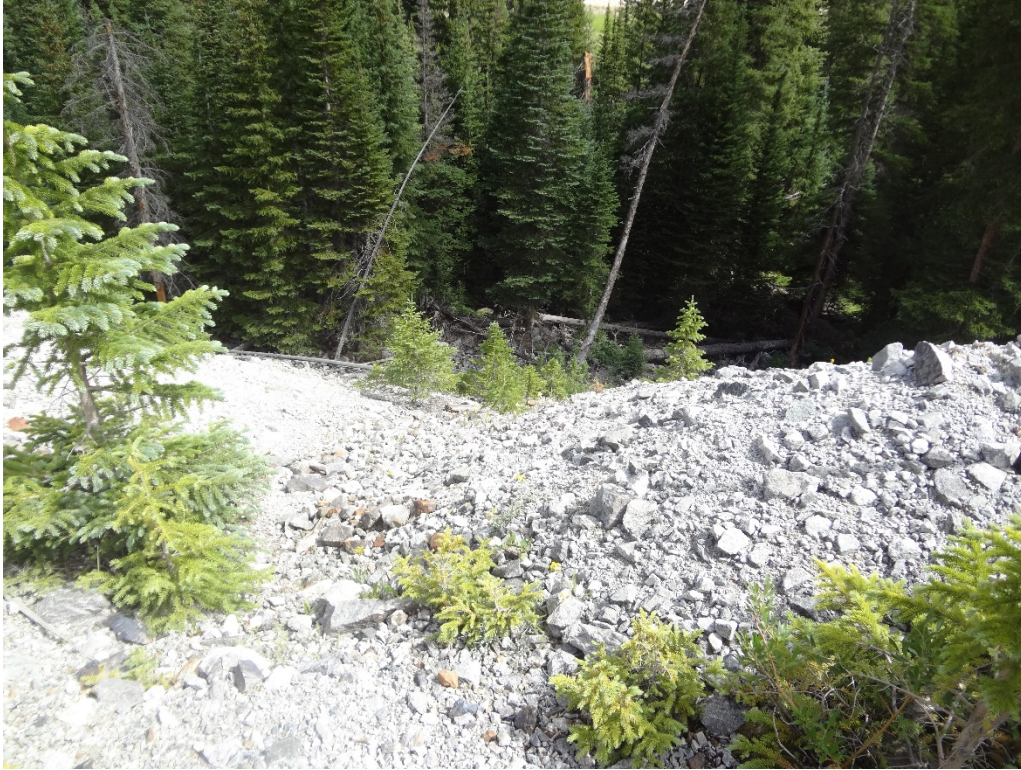
Stormwater Outfall OF-12

OF-12: BMP's at this outfall location consist of a rip-rap check dam above a creek. The outfall was dry and appeared to be functioning properly.

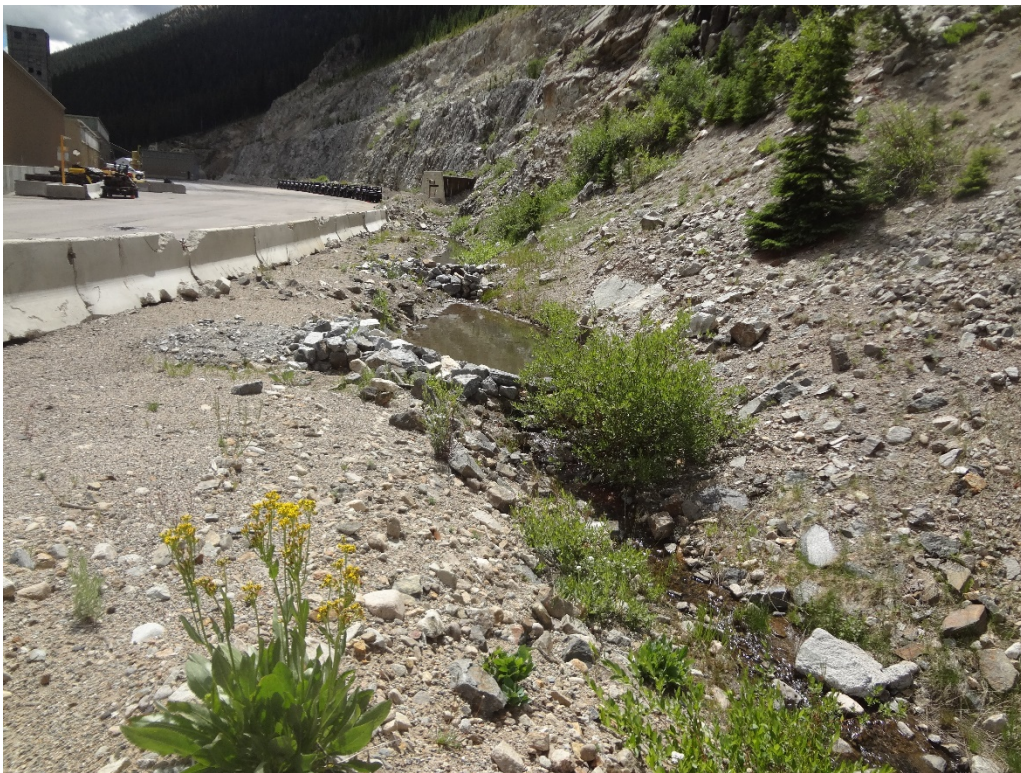
Rock check dams above Stormwater Outfall OF-8a

OF-8a: BMP's at this outfall location consist of ditch with a series of rock check dams leading to a sedimentation pond. The ditch and sedimentation pond contained water and appeared to be functioning properly.

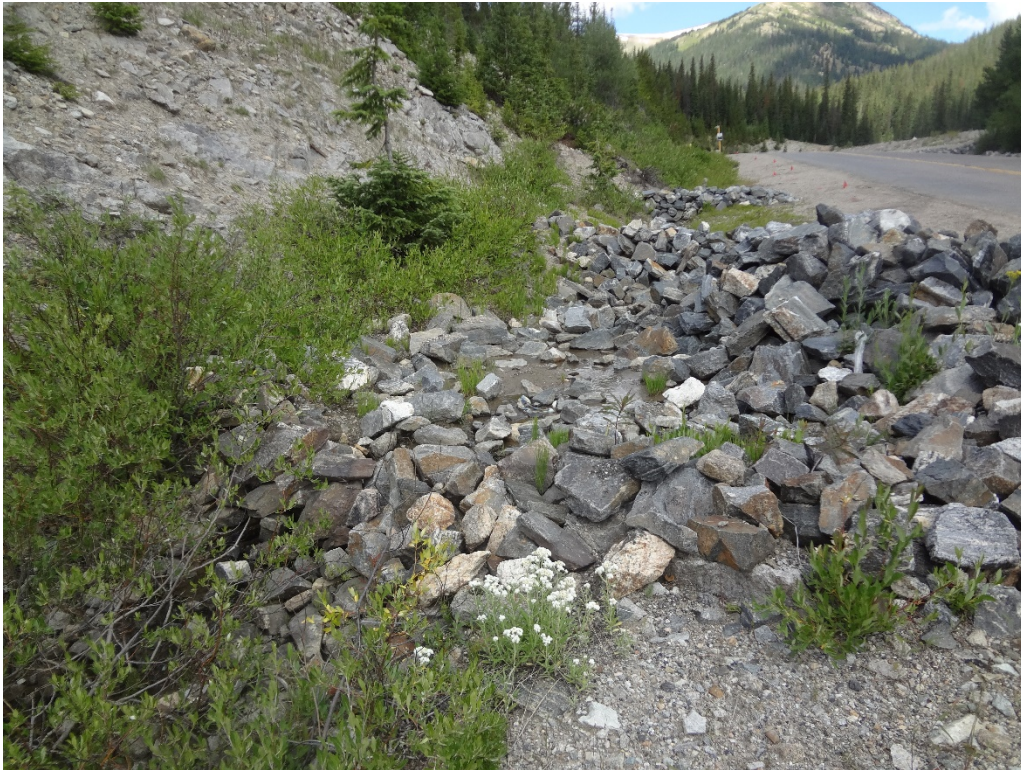
Stormwater Outfall OF-8b

OF-8b: BMP's at this outfall location consist of a series of ditch with a series of rock check dams leading to a rip-rap outfall. The ditch leading to the outfall contained water and appeared to be functioning properly. Sediment was observed in the road crossing culverts above the outfall. The Division recommends are culverts are cleaned out to maintain the function of the culverts.

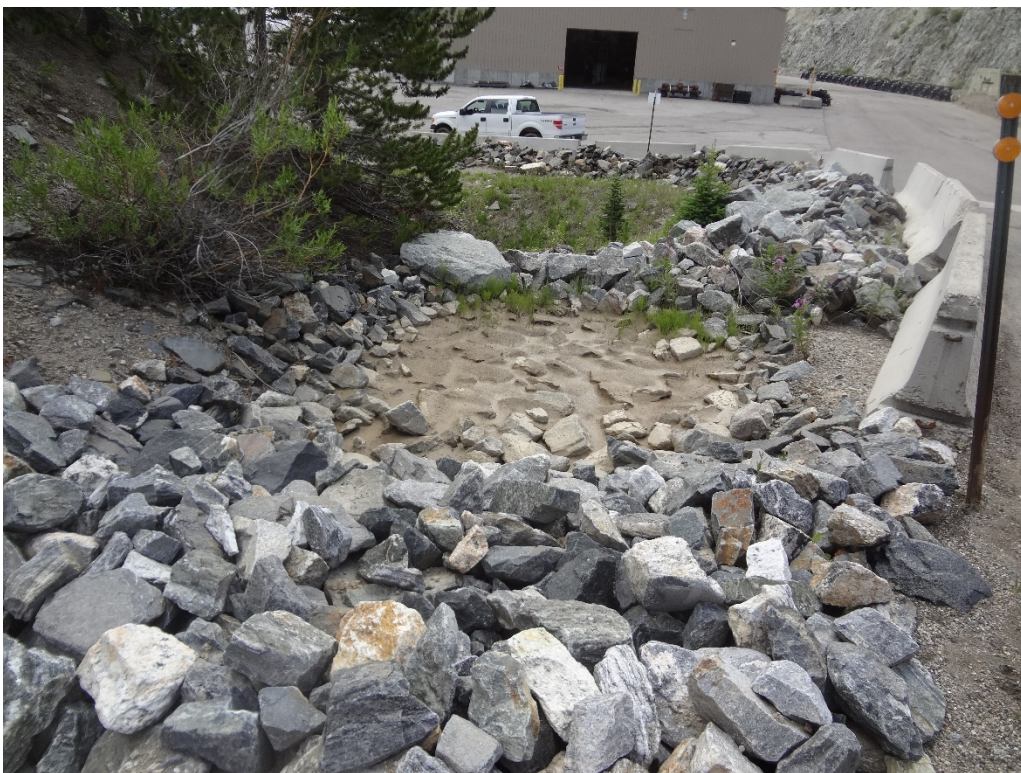
Stormwater Outfall OF-8c

OF-8c: BMP's at this outfall location consist of a ditch with a series of rock check dams leading to a rip-rap outfall. The outfall was wet and contained sediment above the rip-rap outfall. A minor erosion feature was observed below the outfall. The Division recommends the outfall is evaluated for the addition of a straw waddle at the outfall to prevent erosion.

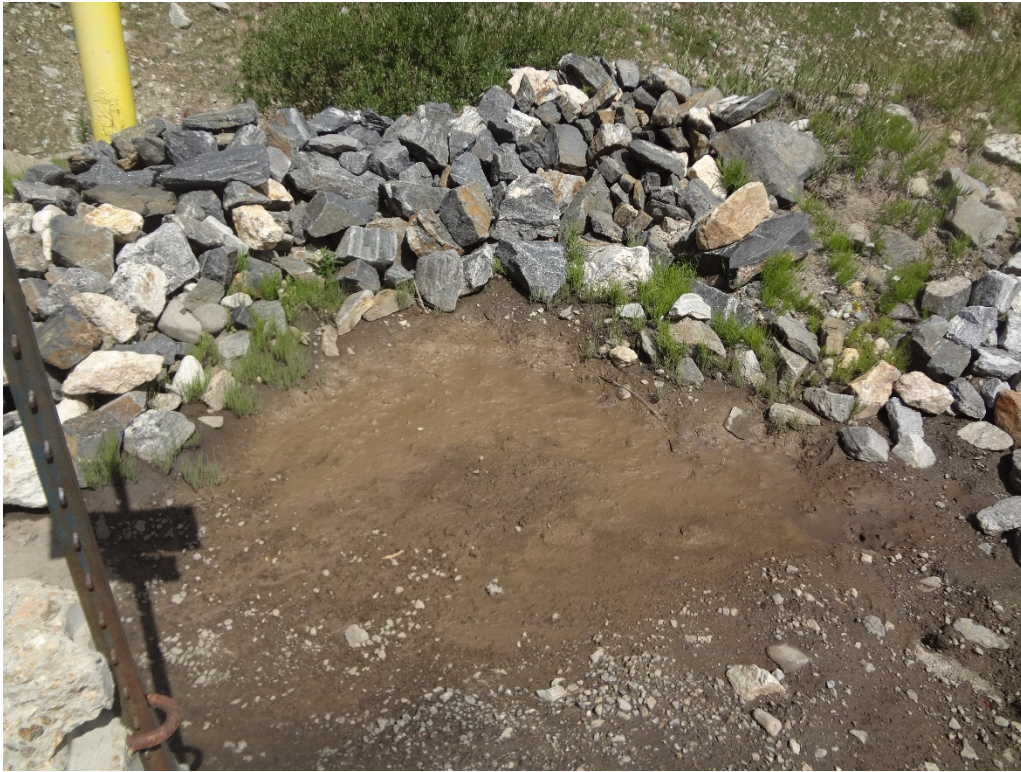
Stormwater Outfall OF-14

OF-14: BMP's at this outfall location consist of a ditch with a series of rock check dams leading to a rip-rap outfall. The outfall was damp and contained sediment above the outfall. The Division recommends the outfall is evaluated for the addition of a straw waddle at the outfall due to the amount of sediment behind the outfall.

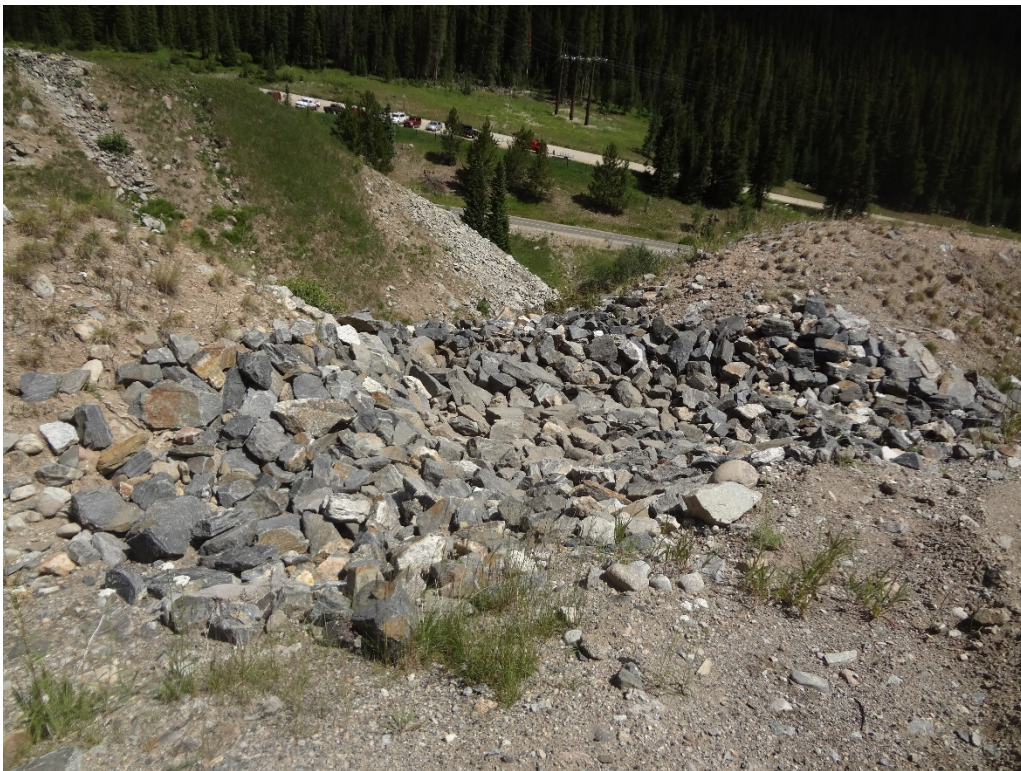
Stormwater Outfall OF-7

OF-7: BMP's at this outfall location consist of rip-rap and rock check dams. The outfall was dry and appeared to be functioning properly.

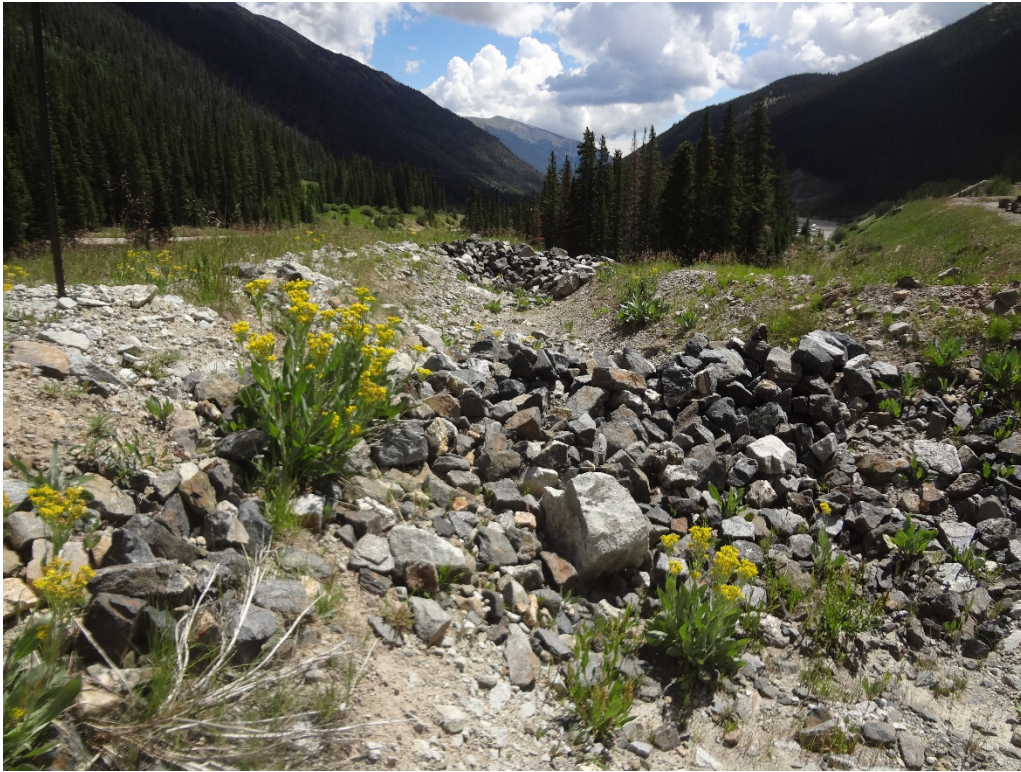
Rock check dams above Stormwater Outfall OF-1

OF-1: BMP's at this outfall location consist of a series of rock check dams leading to a rip-rap outfall. The outfall was dry and appeared to be functioning properly.
