COLORADO DIVISION OF RECLAMATION, MINING AND SAFETY
MINERALS PROGRAM INSPECTION REPORT
PHONE: (303) 866-3567

| MINE NAME: Vagneur Site | MINE/PROSPECTING ID#: M-1980-085 | MINERAL: Sand and gravel | COUNTY: Pitkin |
| INSPECTION TYPE: Monitoring | INSPECTOR(S): Dustin M. Czapla | INSP. DATE: June 10, 2014 | INSP. TIME: 10:00 |

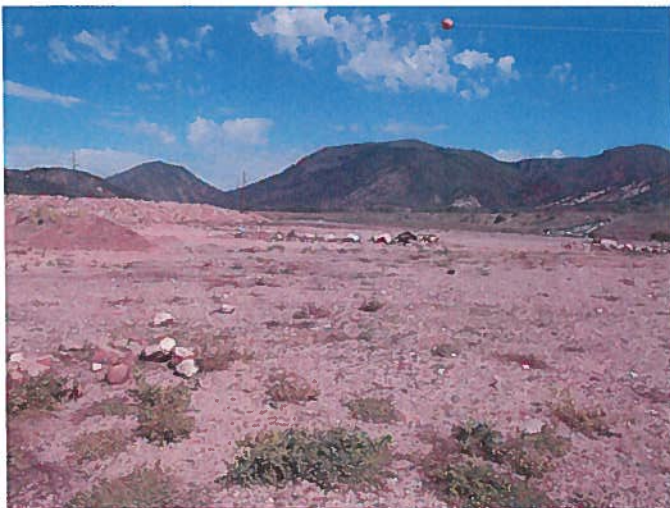
Backfilling in the Phase 1 area continues. Materials stockpiles are located on the south side of the backfilled highwall.

Figure 1: Backfilled area in north side of Phase 1

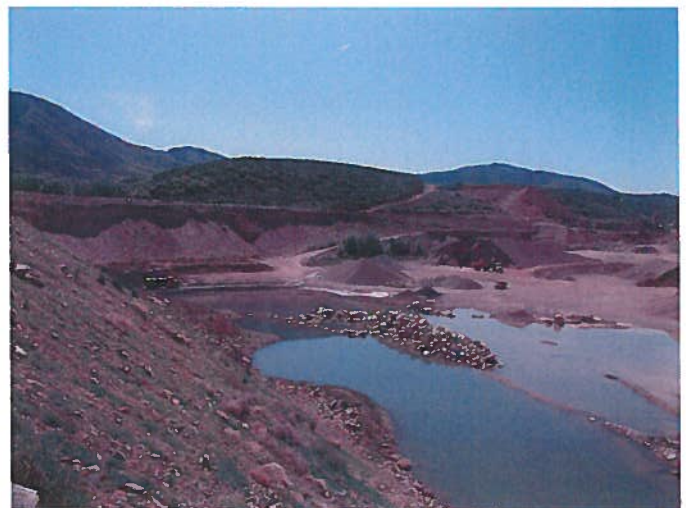
Figure 2: Facing south from the backfilled highwall

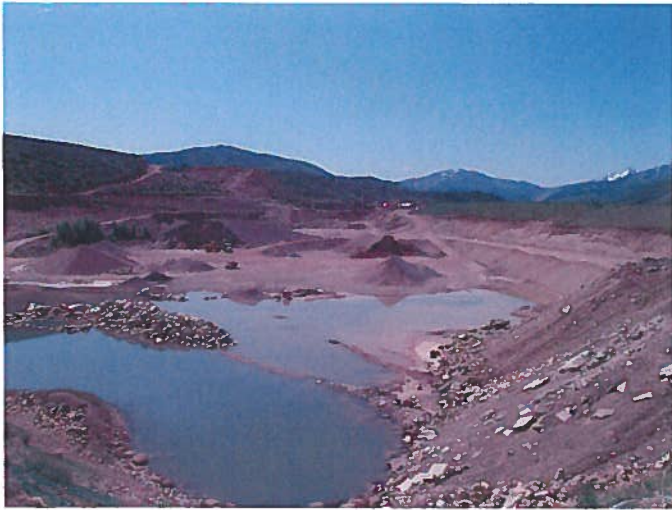
Figure 3: Facing south from the backfilled highwall

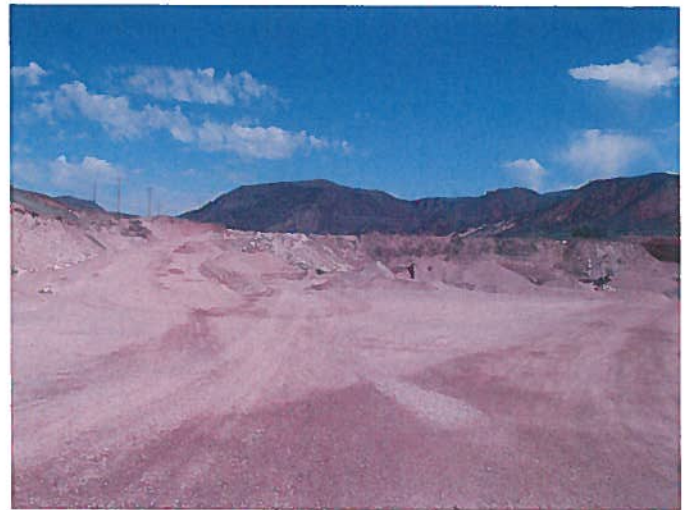
Figure 4: Facing north toward the backfilled highwall in the Phase 1 area.

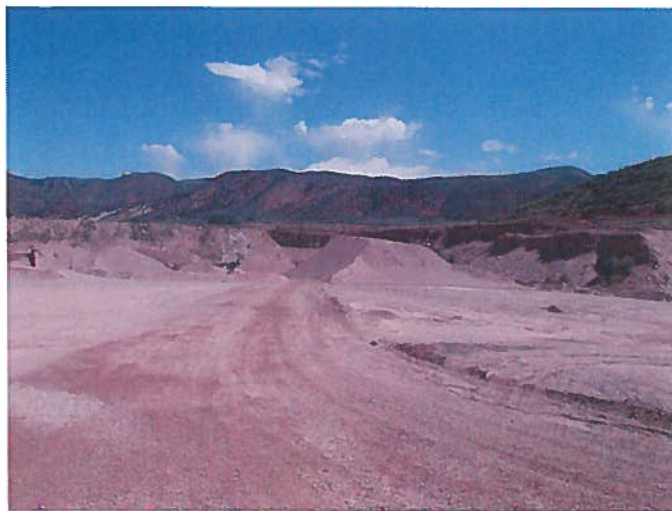
Figure 5: Facing north toward the backfilled highwall in the Phase 1 area.

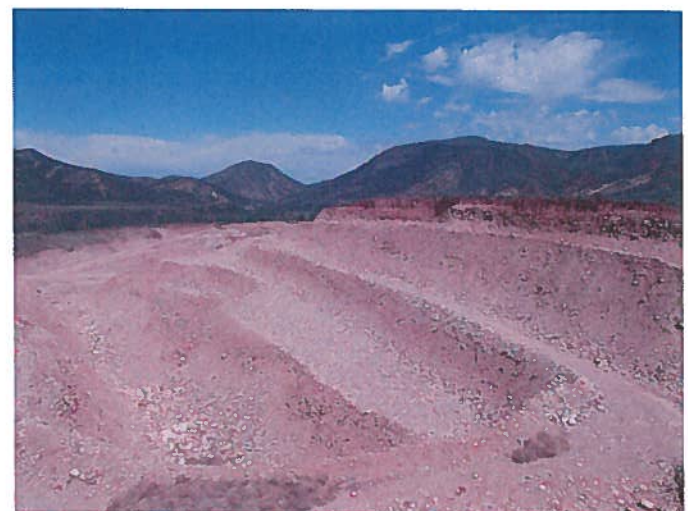
Mining has progressed into the Phase 2 expansion area. Mining in the expansion area is benched down to a depth of approximately 60-70 feet.

Figure 6: Phase 2 expansion area

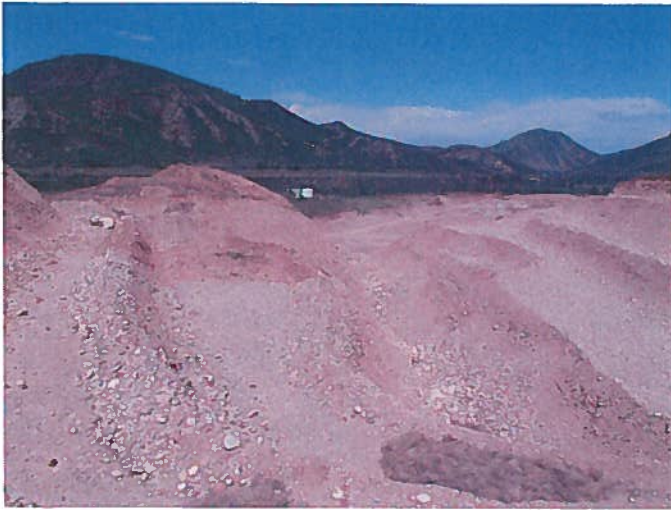
Figure 7: Phase 2 expansion area

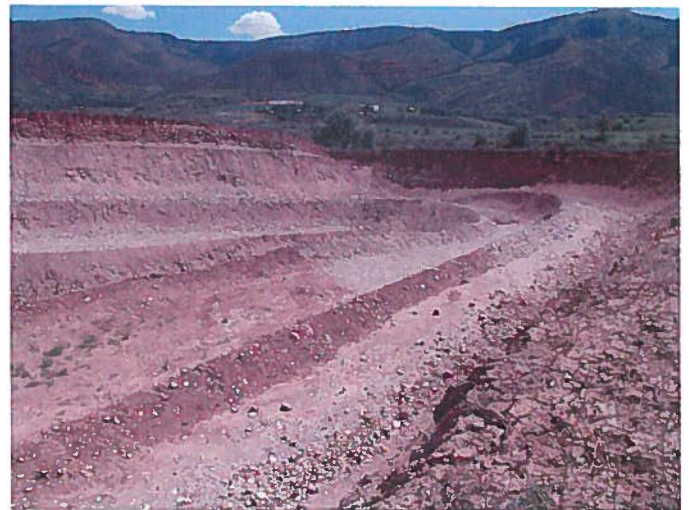
Figure 8: Phase 2 expansion area

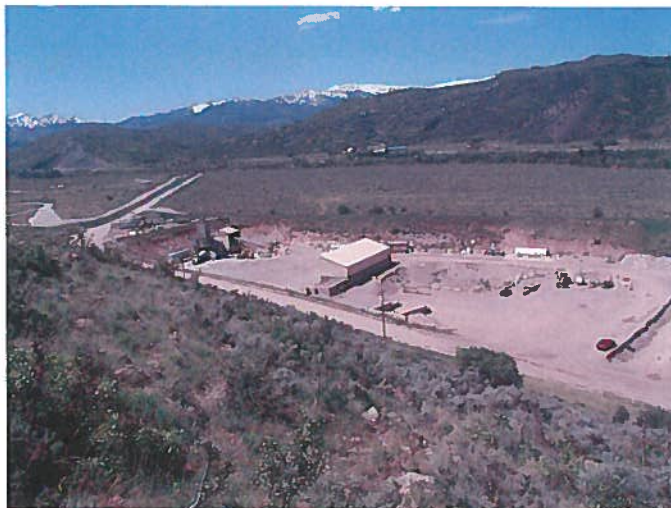
Fuels observed on site were appropriately stored. The concrete and asphalt plants appeared to be in good order.

Figure 9: Concrete batch plant

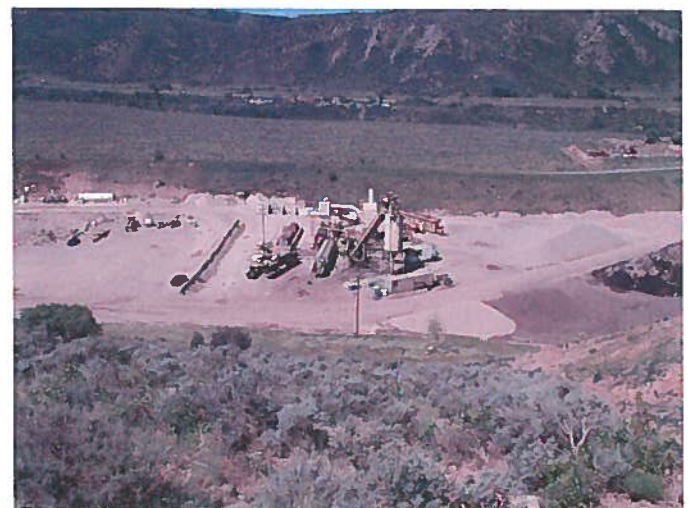
Figure 10: Asphalt plant
