COLORADO
Division of Reclamation,
Mining and Safety
Department of Natural Resources

PERMIT INFORMATION

Permit Number: C-1981-041 Mine Name: Roadside Portals Operator: Snowcap Coal Company, Inc Operator Address: Ms Tonya Hammond P.O. Box 1430 Palisade, CO 81526	County: Mesa Operation Type: Underground Permit Status: Active Ownership: Federal
	Operator Representative Present: Tonya Hammond
Operator Representative Signature: (Field Issuance Only)

Inspection Start Date: July 18, 2017 Inspection Start Time: 08:00 Inspection End Date: July 18, 2017 Inspection End Time: 12:00		Inspection Type: Coal Complete Inspection Inspection Reason: Normal I&E Program Weather: Clear	
Joint Inspection Agency: U.S.BLM		Joint Inspection Contacts:	
Post Inspection Agency:		Post Inspection Contacts:	
Inspector(s): Janet H. Binns	Inspector's Signature:

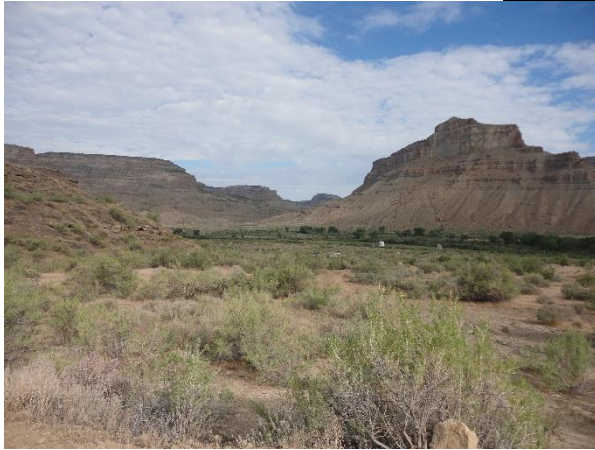
Area overlying underground workings at the north decline were walked and no evidence of surface expression of subsidence were noted in this area. The clean water ditch on the east side of this area remains in good condition.

Photo 1: Surface at North Decline area

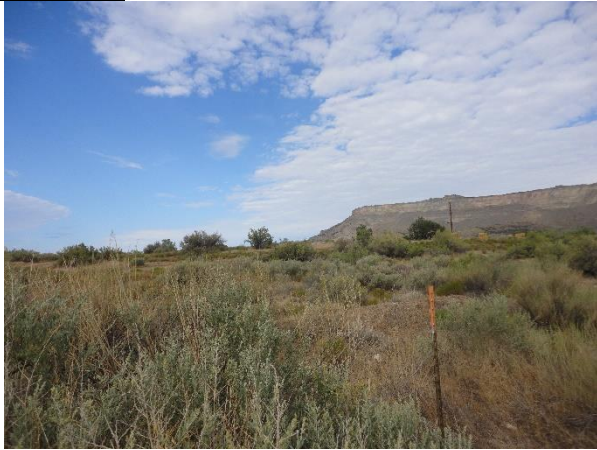
Substation A is well vegetated, boundaries are marked, and no new disturbances have occurred on this small parcel.

Photo 2: Reclaimed Substation A

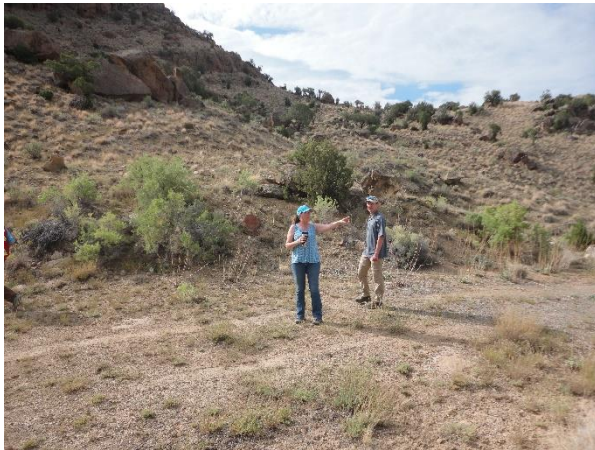
Substation B was inspected. Substation B is located on property managed by the Bureau of Land Management in the SW 1/4 of Section 35. There were tracks from a previous vehicle on the roadway. Public Service has access along this roadway for the powerline. Perimeter markers are placed and visible at the reclaimed substation parcel. Vegetation was good with no concerns noted.

Photo 3: Reclaimed Substation B

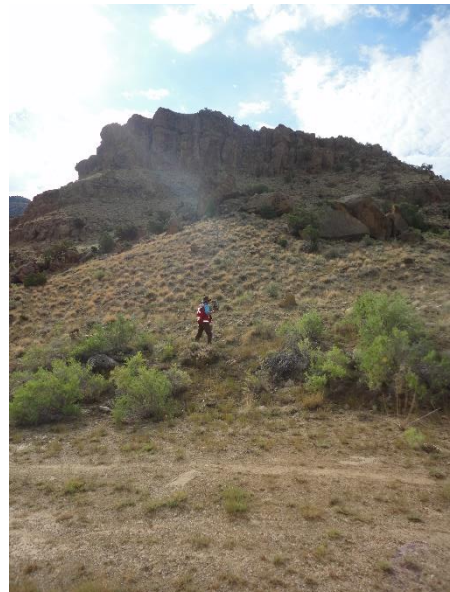
Photo 4: Reclaimed substation B

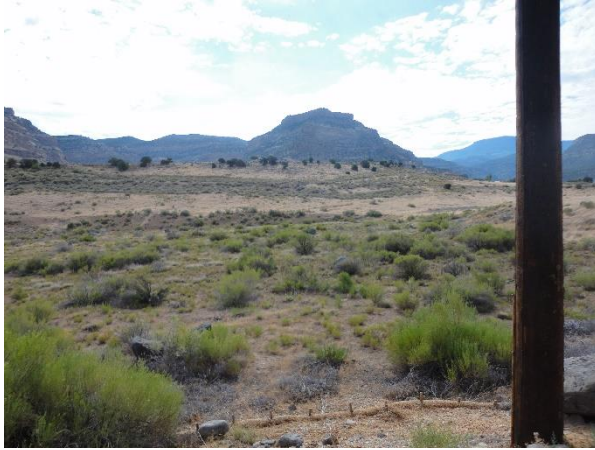
The soil borrow area in Section 34 continues to exhibit good vegetation establishment with no obvious signs of erosion.

Photo 5: Reclaimed topsoil borrow area

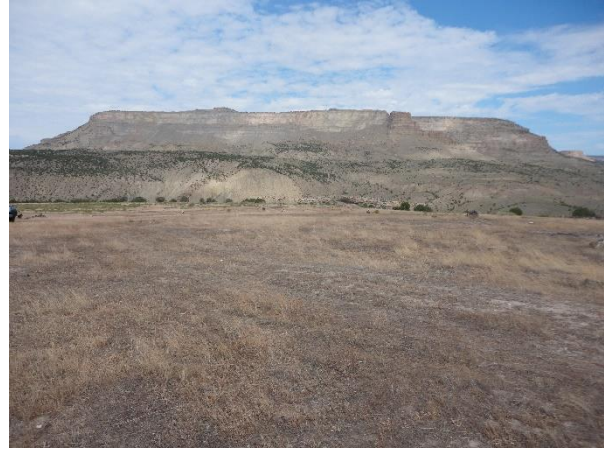
The area in Section 34 approved for repair in TR69 was visited. No new activity appears to have occurred at this location since the June 1, 2017 inspection. As previously noted, Cheatgrass dominates the area. Tree roots and trunks continue to be stored to the east of the area of concern. The northern portion of the "trench" remains unfilled while the north-south segment of trench has been filled in. No water was in the "Carey pit", and there has been no evidence of water flow in the irrigation ditch.

TR69 final decision was issued by the Mine Land Reclamation Board on June 25, 2017. The landowner has appealed the Board's decision. No implementation of the repair plan approved in TR69 has occurred.

Photo 6: Section 34 looking west towards TR69
Approved repair area. Vegetation is cheatgrass

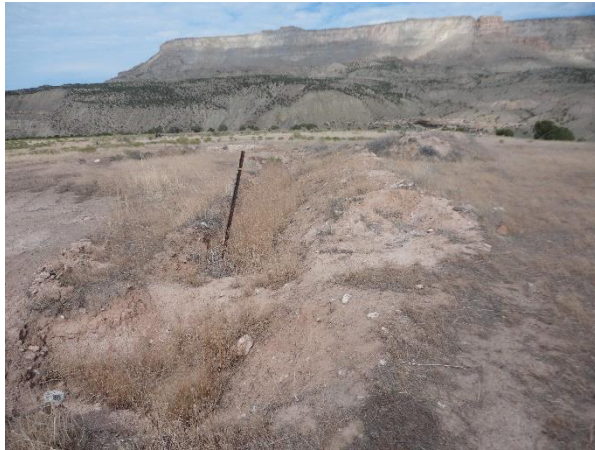
Photo 7: E-W trench at north end of area of concern
Section 34

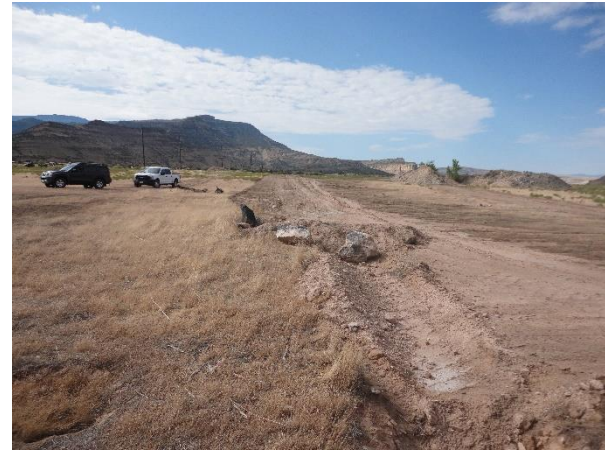
Photo 8: Filled in N-S Trench Section 34

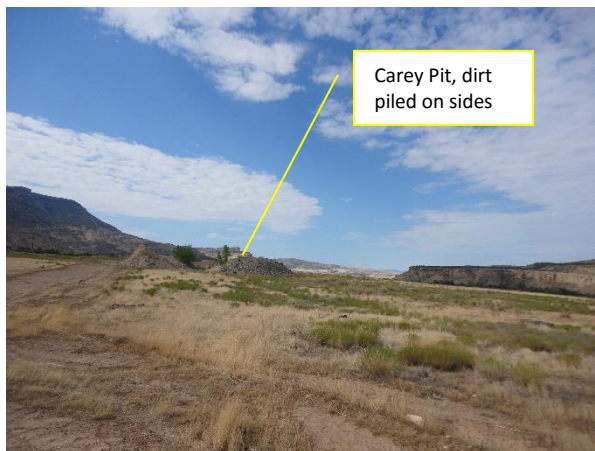
Photo 9: filled in N-S trench with Carey Pit in background
With dirt piled on sides of pit.

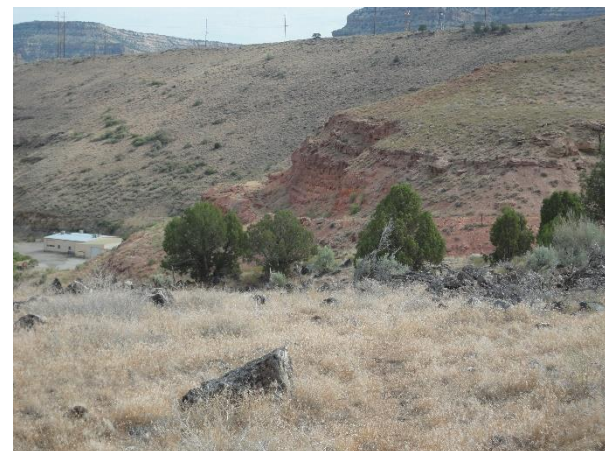
Photo 10: Reclaimed access road to borrow area

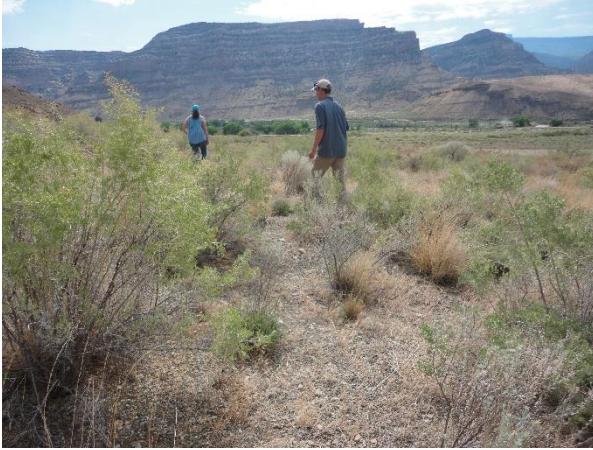
Photo 11: Reclaimed Substation G

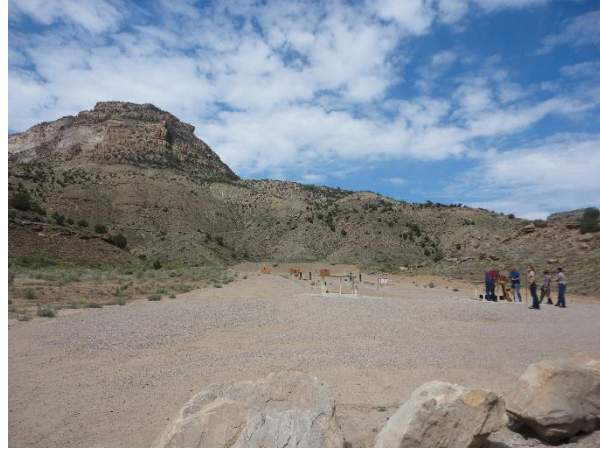
Colorado Parks and Wildlife were on site at the shooting lanes located just west of the permit area at the north portals. There were several individuals using the shooting benches and targets. CPW representatives were replacing some of the plywood target backstops. This initial portion of the shooting facility is being utilized by the public. No further development of the portions of the shooting facility within the SL10 application had occurred since previous inspections.

Photo 12: CPW/TOP shooting lanes west of permit

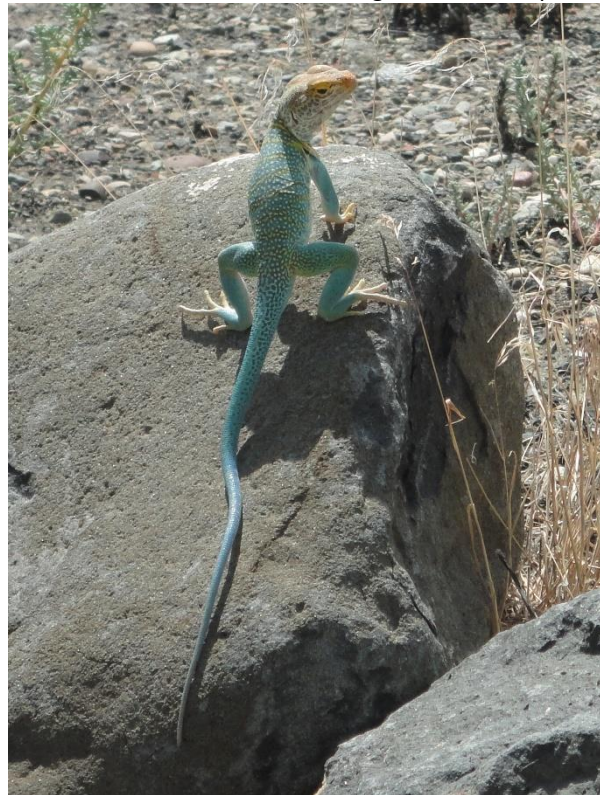
A Collared lizard was encountered along the reclaimed road to CRDA 1.

Photo 14: Collared lizard at CRDA1
